## Influence of Lightning Discharge on Microstructure, Mechanical Properties and Failure of Armature Steel

Influence of lightning discharge on microstructure, mechanical properties and failure of armature steel was investigated. The studied specimens were picked out from the reinforcement construction destroyed during storm. Metallographic analysis by optical microscope LMA combined with video camera YCH15 was carried out. Pictures of the affected structure were picked out by electron scanning microscope SEM EVO 50 as well using secondary electron detector SE. Chemical composition was determined with the dispersive energy spectrometer INCAx-sight EDS. Micro hardness of the specimens was measured by IIMT 3 device with load 0.49 N (in some cases 0.196 N and 0.098 N). Grey, black or white zones in the cross-section of steel samples were determined. It was found that these zones might be hard or brittle, may vary in shape, size and phase composition. It may have or not metallic properties. The article presents analysis of the chemical composition changes at the affected zones, but it also requires for further investigations of lightning discharge effect on armature steel.

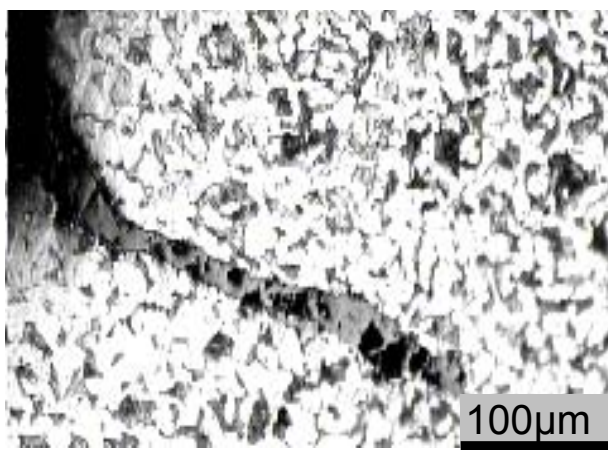
Depth of wedge-shaped formation varies from several tens of micrometers to 2–3.8 millimetres. Width of the wedge is several micrometers and often admits in the range of grain size. Small grey wedge-shaped insertions are generally homogeneous at the surface of rod (Fig. 1, a), but black colour areas are observable in deeper insertions (Fig. 2, a, c), showing that metallic material is changed by non-metallic insertions. Black insertions are also visible at the dividing line between the main metal and grey formations or can locate as series of small black insertions in the grey one (Fig. 1). There was assumption, that lightning discharge affected this part of specimen more than one time. Especially clear black dividing line between the main metal and grey formation is observable in the specimen made from bottom part of armature rod lied in the foundation of reinforced concrete. Deep grey formation with centres of fragmentation is apparent (Fig. 3). Investigating by electron scanning microscope SEM EVO 50, micro cracks and separate white non-metallic zones were detected (Fig. 4).

**Fig. 2.** Cracks caused by lightning discharge in armature rods No 1: a – across the rod (magnification  $\times 16$ ); b – along the rod. Etching by 3 %  $\text{HNO}_3$  solution in ethanol

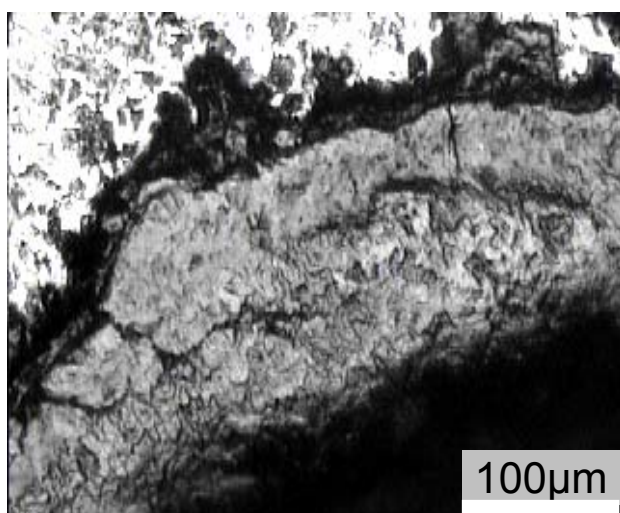
**Fig. 3.** Microstructure of surface of armature rod No 1 affected by lightning discharge picked up by optical microscope LMA. Etched by 3 %  $\text{HNO}_3$  solution in ethanol. Structure: ferrite, pearlite, grey and black formations

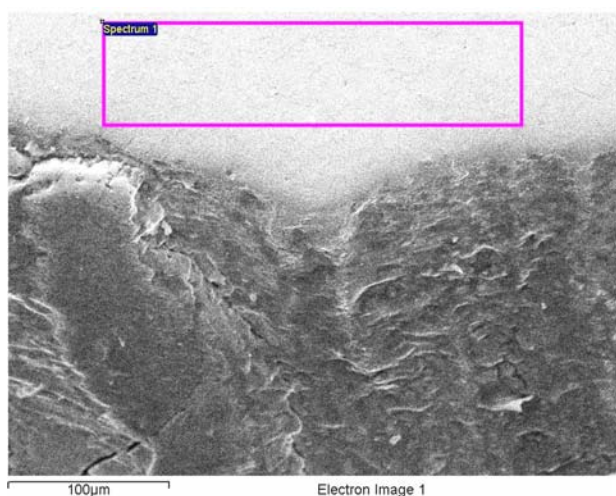
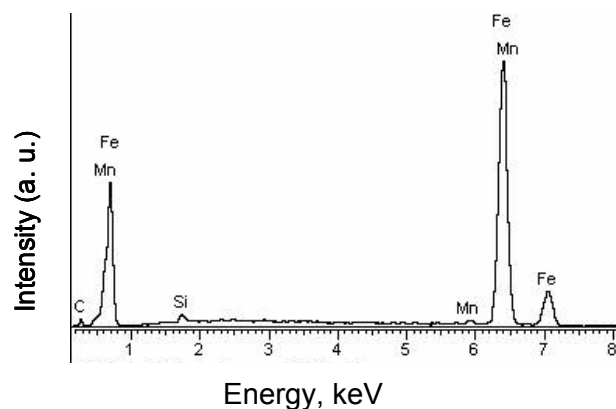
Analyzing element composition by INCAx-sight EDS in  $200\text{ }\mu\text{m}^2$  zone of unchanged microstructure, which locates about  $50\text{ }\mu\text{m}$  from the zone affected by lightning discharge (Fig. 5, Table 1) carbon amount was found 4.3 %. Determining element composition of the  $500\text{ }\mu\text{m}^2$  affected zone (Fig. 6, Table 2) that locates approximately  $90\text{ }\mu\text{m}$  from the dividing line, amount of carbon has increased up to 17.49 %. Content of silicon and manganese changed fractionally near the affected zone.

**Fig. 5.** Influence of lightning discharge on chemical composition of at the surface armature steel rod No 1: a – zone of spectrum analysis; b – spectrum analysis of elemental composition of the main metal. SEM EVO 50 (chemical composition is presented in Table 1)

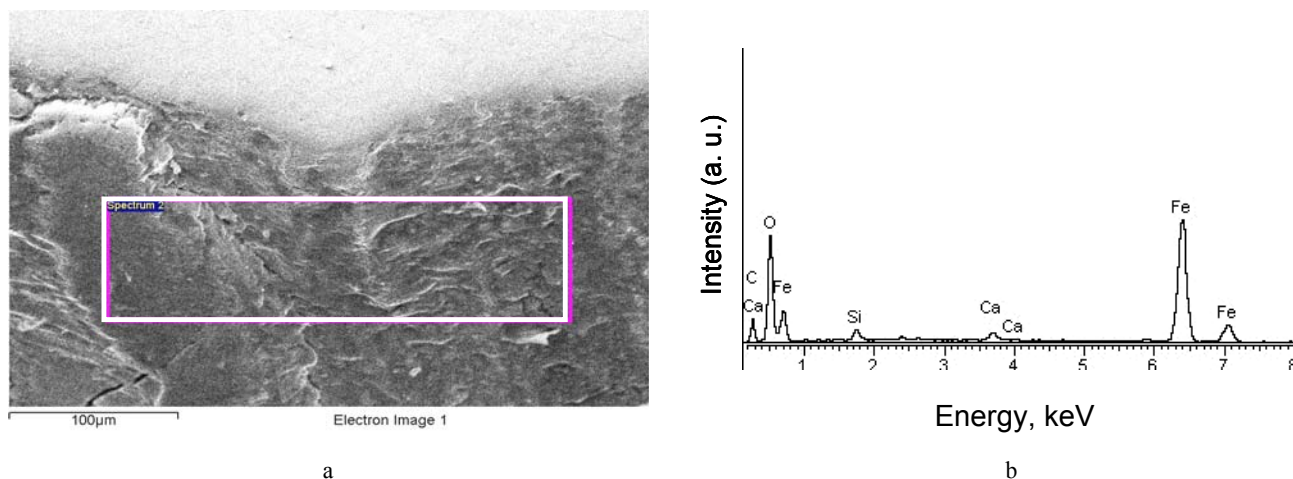
This formation contains also oxygen (26.32 weight percent), calcium (1.06 weight percent), an amount of silicon has increased from 0.73 % until 1.07 %, but manganese has disappeared (Table 2).

**Fig. 6.** Influence of lightning discharge on chemical composition of at the dividing line between main metal and affected zone (rod No 1): a – zone of spectrum analysis; b – spectrum analysis of elemental composition of the main metal. SEM EVO 50 (chemical composition is presented in Table 2)

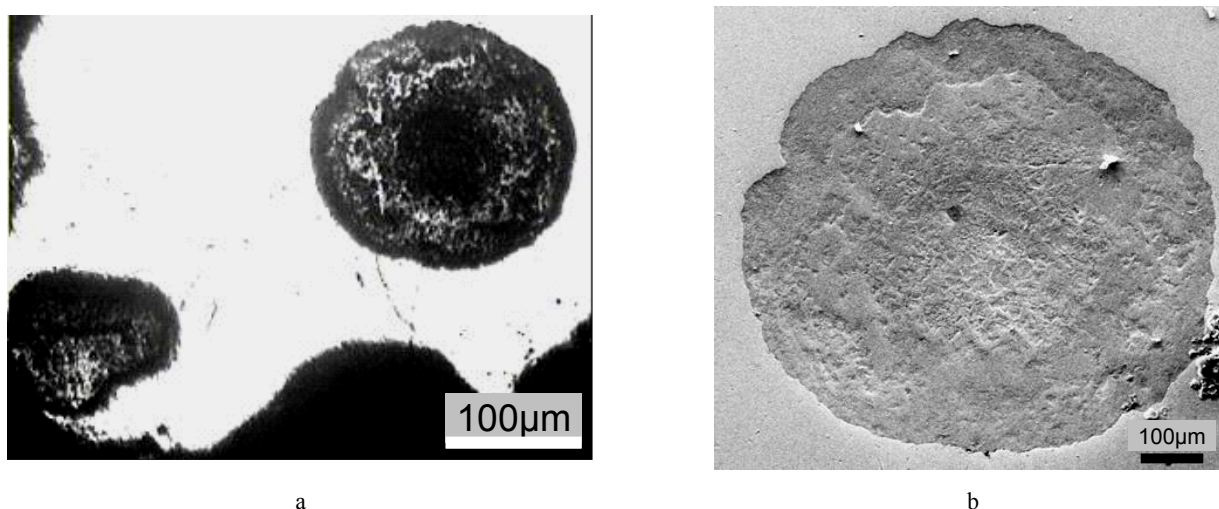
Cylindrical formation as  $700\text{ }\mu\text{m}$  diameter circle and located about  $300\text{ }\mu\text{m}$  from the surface was dedicated (Fig. 7). Distribution of its chemical composition was determined and is listed in Table 3. There was no carbon found near this formation. Itself it has contained decreasing amount of carbon – from 5.57 % till 6.90 %. This formation has not contained magnesium, although the investigated steel has 1.10 % Mn.

**Fig. 7.** Surface structure of specimen rod No 2 affected by lightning discharge observing by optical microscope (a) and by SEM EVO-50 (b)
