# Resistance of ETICS with Fire Barriers to Cyclic Hygrothermal Impact

**Abstract:** The article presents the results of a set of hygrothermal experiments of an external wall insulated with an ETICS. As an add-on to previous studies, thermal insulation in the form of polystyrene with an additional horizontal strip of mineral wool was used. Laboratory tests were carried out in accordance with ETAG 004. The ETICS test rig was composed of combustible expanded polystyrene foam (EPS) and horizontal strips of noncombustible mineral wool (MW) fire barriers over windows. The physical and mechanical properties of four types of finishing renders (without an additional reinforcement mesh in base coat of the fire barriers) were analyzed across full hygrothermal cycles in a climate chamber. Temperature sensors were mounted onto different ETICS layers to collect thermal data during the weathering. The testing of ETICS regarding their hygrothermal performance revealed that there were no visible defects on any renderings and over the junctions depending on the type of used insulation materials. Results also showed that the joints of EPS and MW have approximately half of their bond strength from p

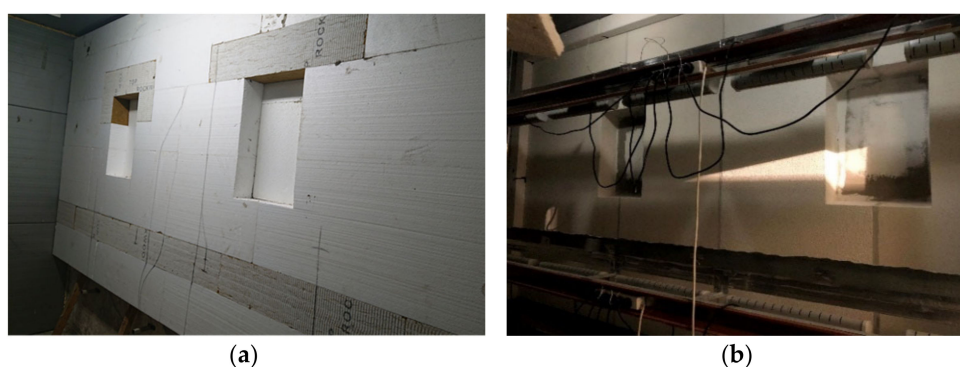
**Figure 1.** (a) EPS thermal insulation with mineral wool fire barriers; (b) test rig with 4 types of plastering during the test.

A silicate brick wall was constructed (3.0 m wide by 2.2 m high) with installed ETICS panels (Figure 1) in accordance with 5.1.3.2.1 ETAG 004 [19]. Four different types of thermal-insulation systems were applied on the wall, namely, with acrylic, silicate, mineral, and silicone finishing coats (of whitish color). Mineral rendering was painted with silicone paint. The thickness of the basecoat was 3–5 mm. In order to examine the worst-case scenario of ETICS, 1 mm thickness finishing coats were selected except for a 2 mm thickness mineral coat. Thermal-insulation boards were mechanically fixed with plastic anchors (4 pcs./m<sup>2</sup>) with supplementary adhesive.
