# A BIM-Based Method for Structural Stability Assessment and Emergency Repairs of Large-Panel Buildings Damaged by Military Actions and Explosions: Evidence from Ukraine

**Keywords:** BIM; building destruction; emergency recovery works; information–mathematical modeling; large-panel buildings; progressive collapse risk

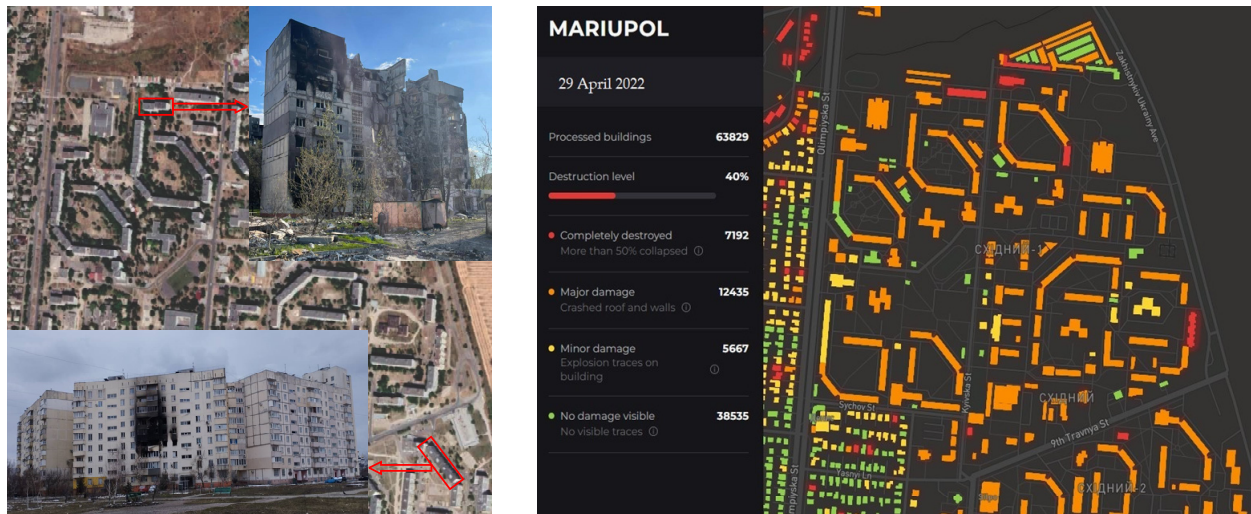
**Figure 4.** Destruction and damage to large-panel buildings of the Skhydnyi district in Mariupol city, Donetsk region [11,12].

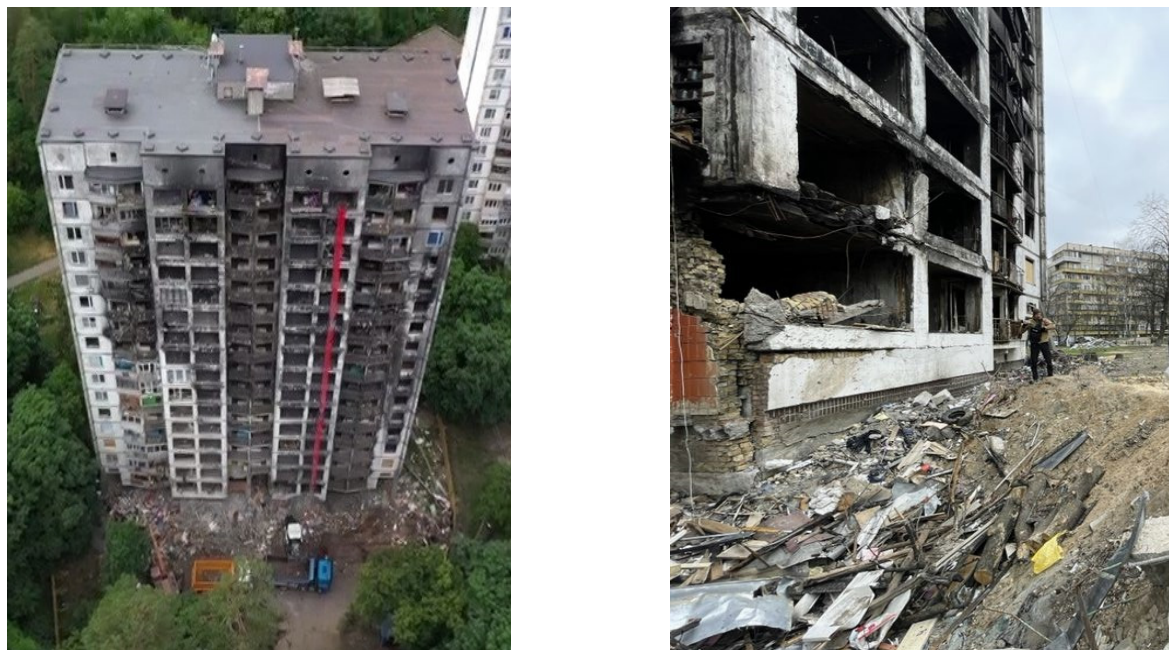
**Figure 5.** Damage to the multi-apartment large-panel building of the BPS series on Chernobylska Street, Kyiv city [13].

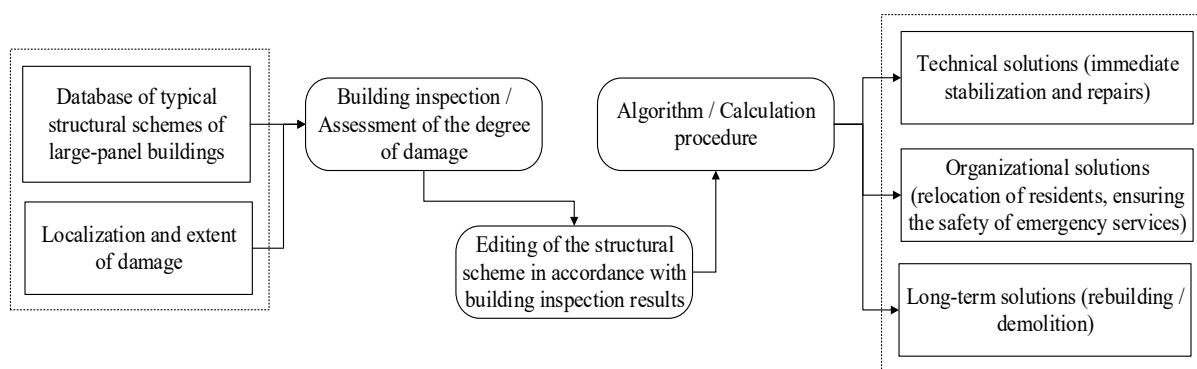
**Figure 6.** Procedure of war damage assessment of and decision-making for the large-panel building.

The optimization of the decision-making process under the conditions of uncertainty is possible with the preliminary development of typical organizational and technological emergency measures and the methodology of their use at typical facilities. Linking existing, pre-developed solutions using information–mathematical models of typical objects to a specific emergency object based on the principle of pattern recognition allows the speeding up of the choice of an option and ensures the execution of emergency rescue operations. In turn, this will contribute to the rescue of possible victims, prevent accidents, and become a part of the emergency response plan. The proposed procedure for such assessments is presented in Figure 6.

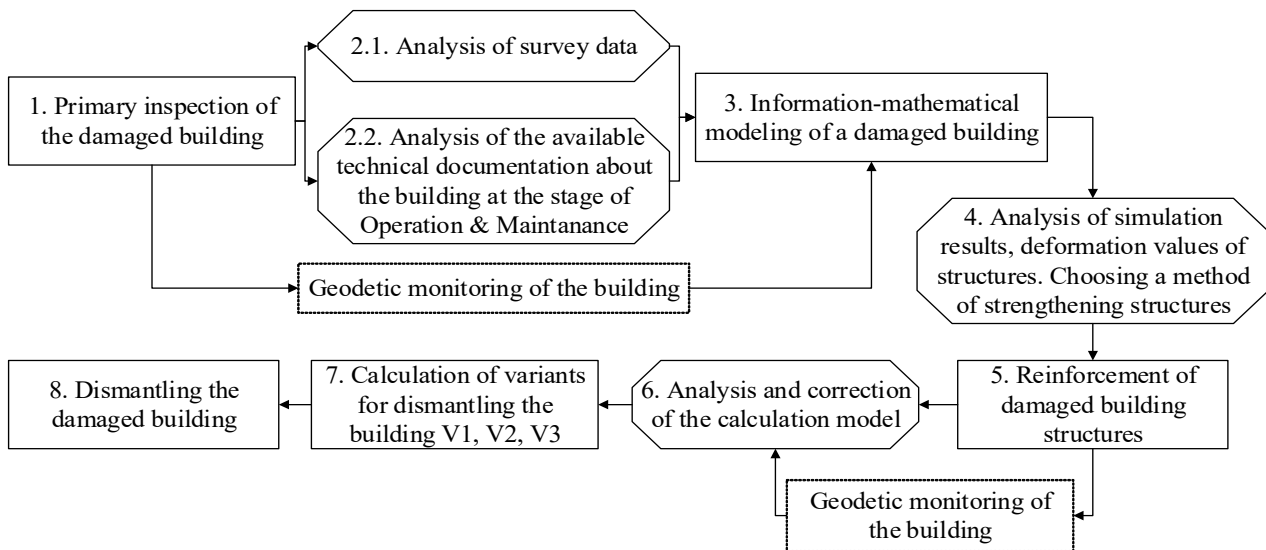
**Figure 7.** Workflow of the large-panel building damage assessment and decision-making for the case study.

Based on this case, the effectiveness of information–mathematical modeling at the stage of emergency work immediately after building damage is analyzed. Data on structural deformations is essential to predict further displacement of structural elements and to develop technical solutions for building stabilization. The workflow that was applied for assessing the technical condition of a large-panel building after a gas explosion and making a decision is shown in Figure 7.

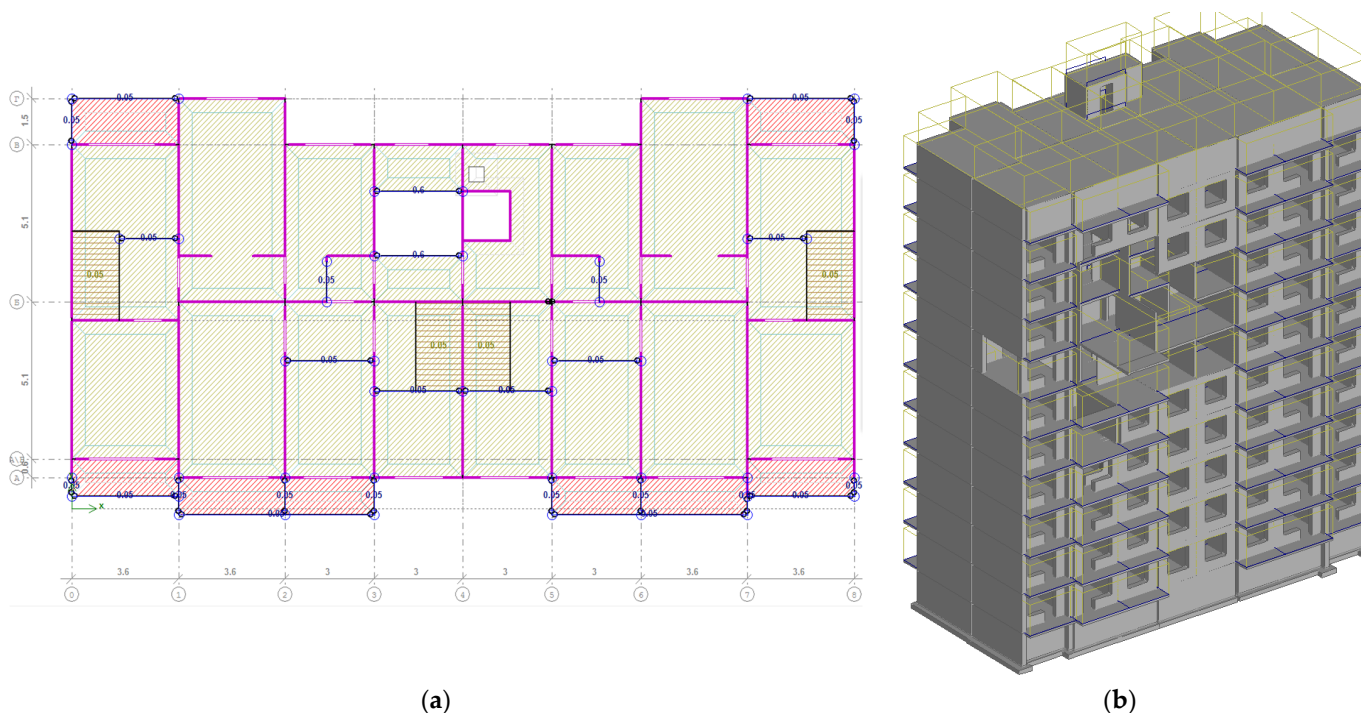
**Figure 8.** Creation of the spatial calculation scheme of the building: (a) plan of the first floor with given vertical loads of the floor slab; (b) 3D view of the structural scheme of the building with removed damaged elements (Kyiv city, S. Krushelnytska Street, June–October 2020).

On the basis of the results of an urgent inspection of the building, available materials about the structural scheme, such as floor plans (Figure 8a), and information about the technical condition of the building during its operation stage, information–mathematical modeling and stress–strain state analysis were performed. To analyze the stress–strain state of the building, the calculation scheme Finite Element Method (FEM) of the building with the removal of collapsed structural elements was created in the software complex MONOMAH CAD (Figure 8b).

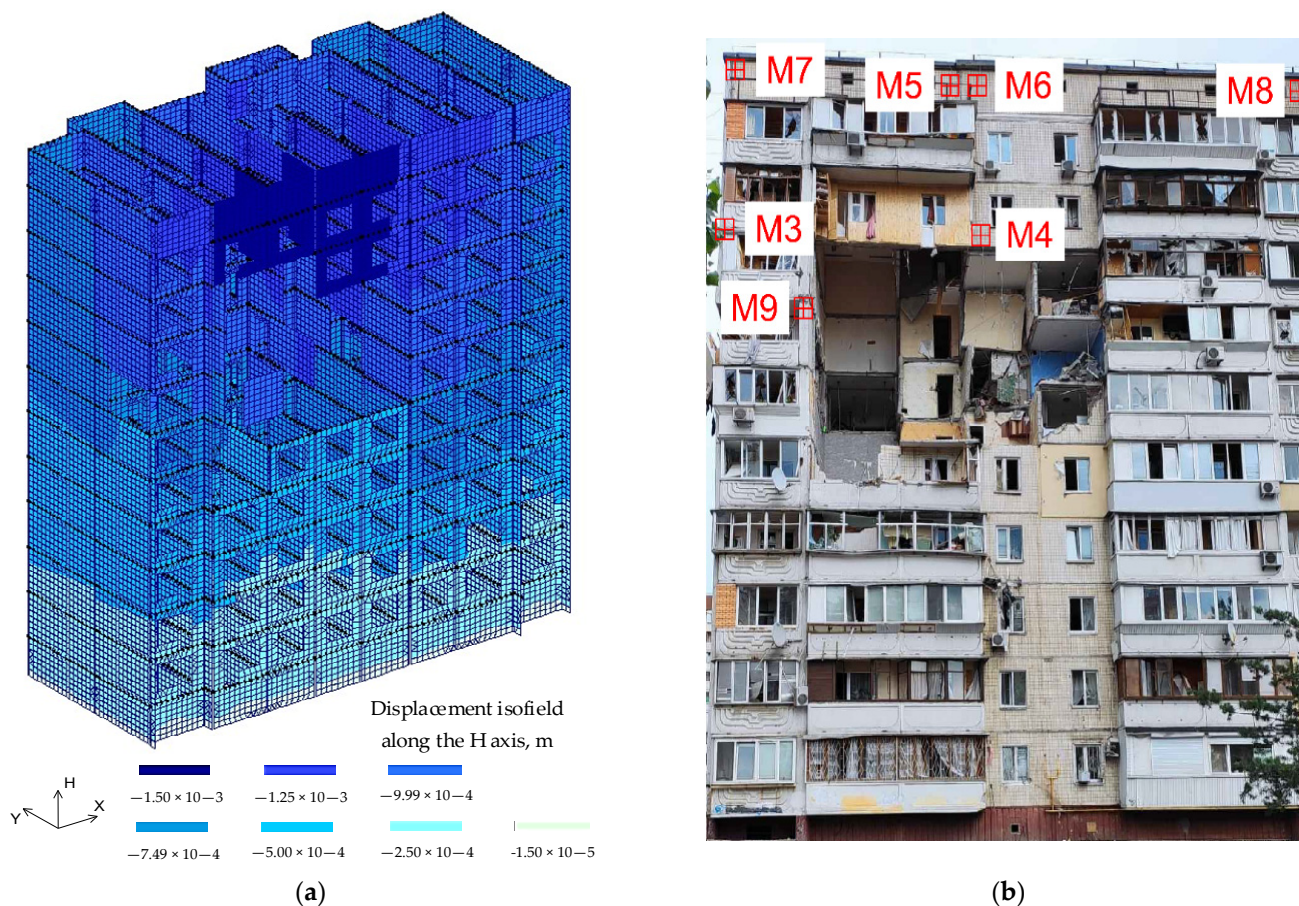
**Figure 9.** The results of frame deformation predictions of a large-panel building (a) and the scheme of the placement of observation points to the deformations of the structures (b) (Kyiv city, S.Krushelnytska Street, June–October 2020).

A preliminary analysis of the stress–strain state of the building was performed on the structure weight and long-term loads after the removal of the collapsed elements of the structures. The isofield of stresses and displacement along the X, Y, and Z axes was

determined (Figure 9a). The results of the calculations and the obtained deformation values proved that the further operation of the building section was impossible and that it should be dismantled.

Moreover, periodic geodetic monitoring was carried out to control the stability of the building and ensure the reconstruction work safety. Measurement of structural deformations and assessment of their dynamics were ensured by observing the deformation marks (M1–M9) placed on the facade of the building (Figure 9b). The first set of observa-

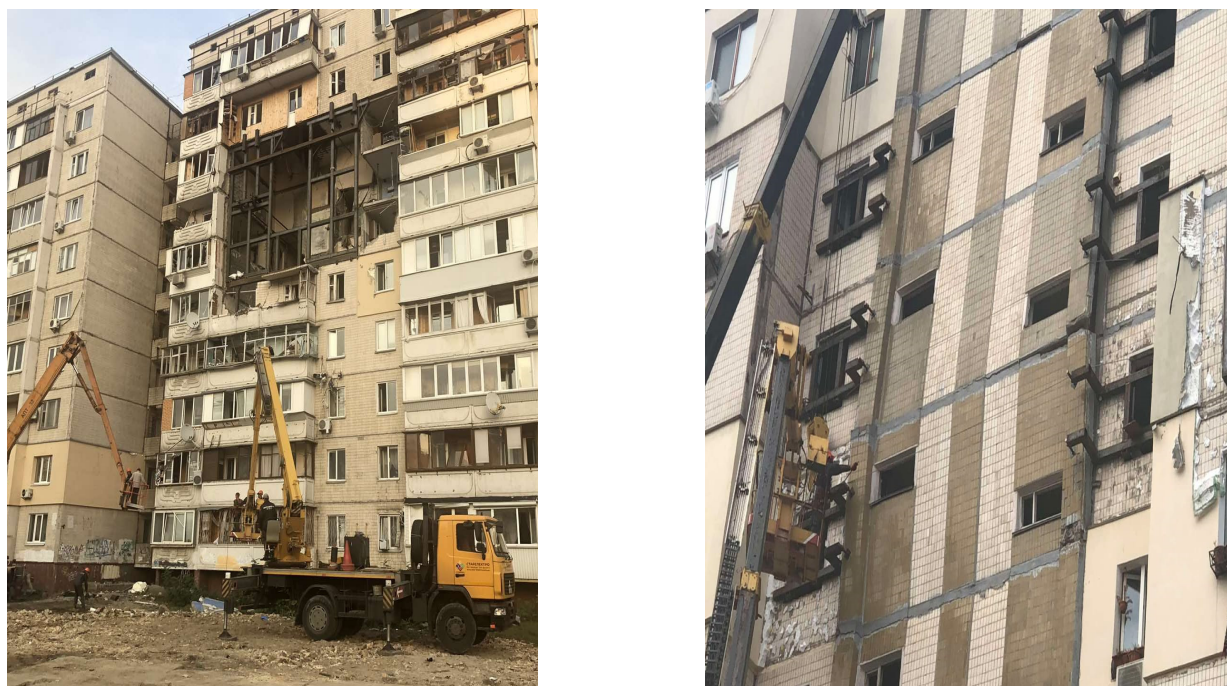
**Figure 10.** Urgent temporary stabilization of a large-panel building damaged as a result of a gas explosion (Kyiv city, S. Krushelnytska Street, June–October 2020).

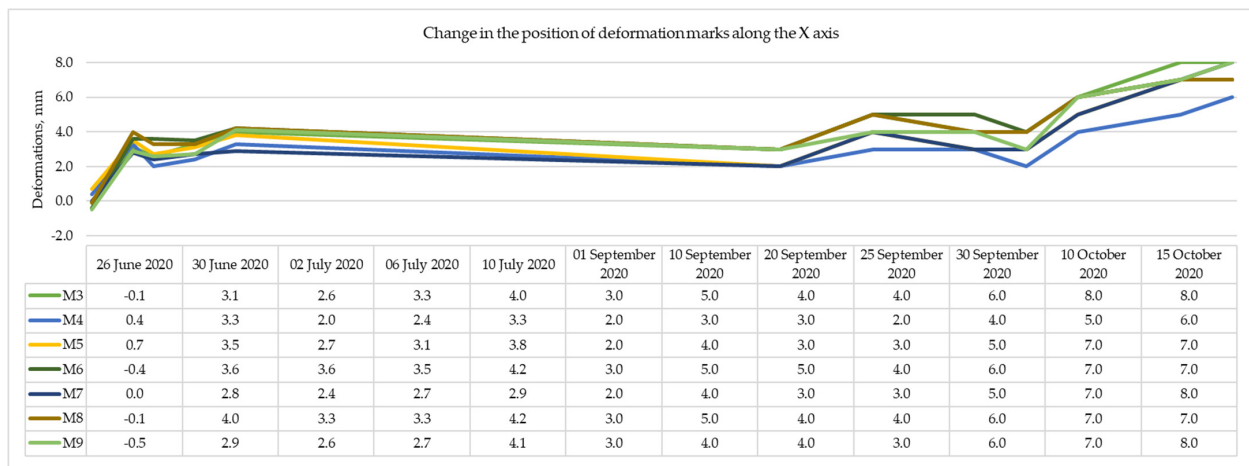
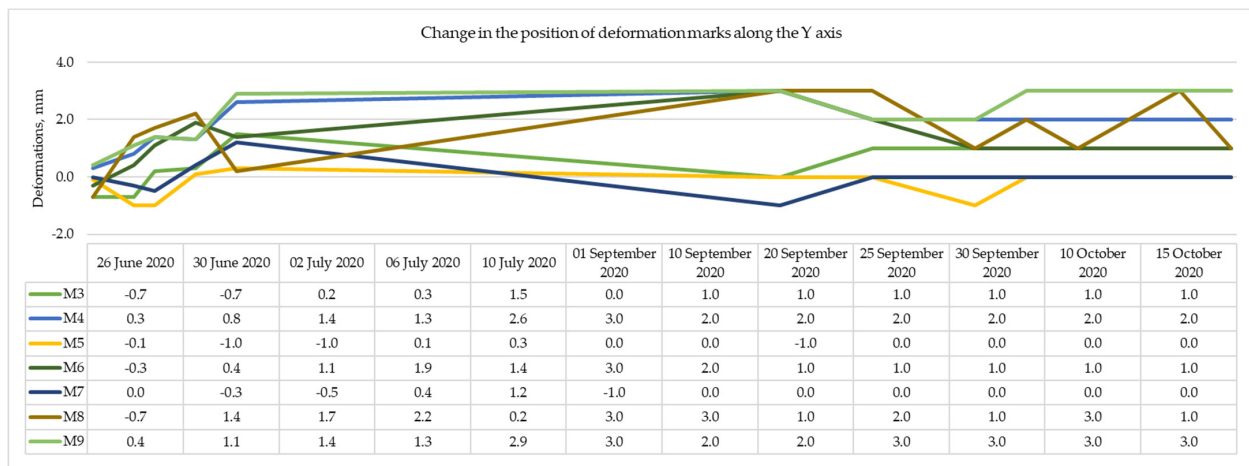
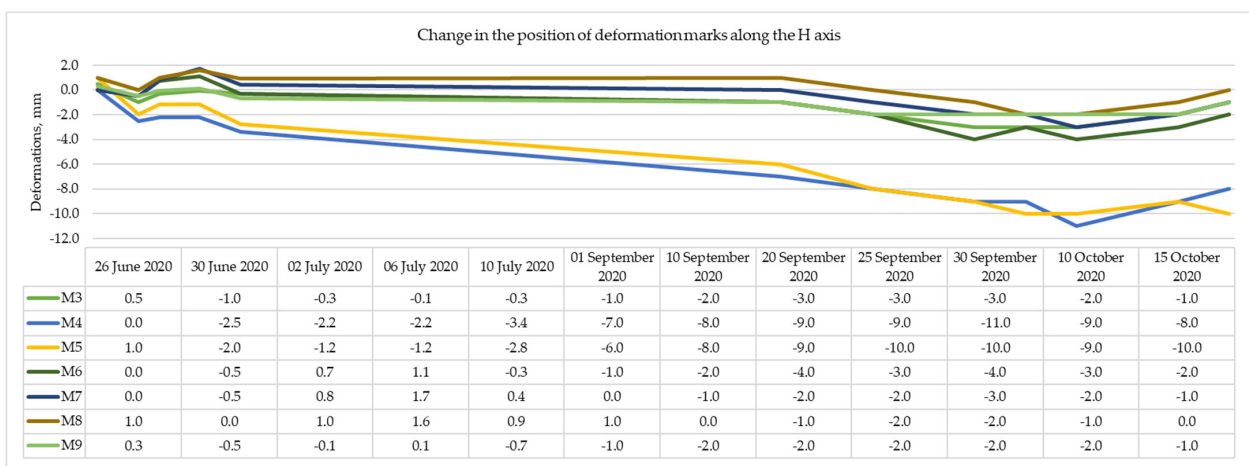
**Figure 11.** Graphs of subsidence of deformation marks fixed on the facade of a large-panel building damaged as a result of a gas explosion (Kyiv city, S. Krushelnytska Street). Two sets of observations: immediately after the explosion (June–July 2020) and after strengthening the structures (September–October 2020). Change in position of deformation marks along the X axis (a), Y axis (b), H axis (c).

The analysis of the obtained data (Figure 11) shows the deformation dynamics for each of the axes (the orientation of the coordinate system is shown in Figure 9a). The value of the deviation of deformation marks for each cycle of observations was determined as the difference between the coordinates measured in the current cycle and the coordinates of the deformation mark at the time of its installation (0-cycle):

The determination of the coordinates of the deformation marks is influenced by a combination of factors: weather conditions, the reliability of fixing the marks, the method of performing work and the equipment used, deformation of the structural elements on which the marks are installed due to damage, displacement of structural elements on which deformation marks are installed as a result of strengthening works, etc. In the current case study, the main purpose of geodetic observations was to monitor the dynamics of development and control deformations in order to prevent the uncontrolled collapse of structures at the time of work. Geodetic monitoring, as an additional method of controlling the stability of the building, confirmed that the chosen method of strengthening the structures provided the necessary time and safe conditions for a detailed survey of the damaged building by specialists and increased the safety of residents during evacuation.

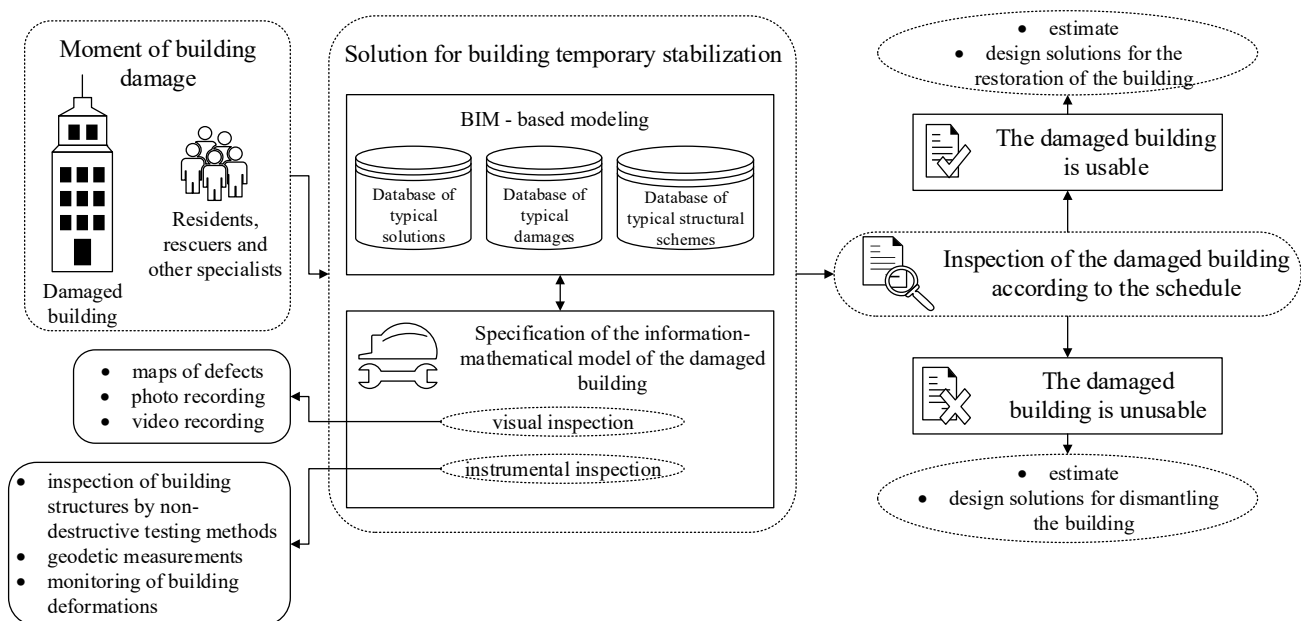
**Figure 12.** The proposed conceptual scheme for assessing the technical condition of a damaged large-panel building using a database of typical solutions and a preliminary remote assessment at the stage of emergency and rescue operations.

Calculations of the bearing capacity of the building as a whole and the development of solutions for strengthening and repair should be carried out using an information–mathematical model [47–49], refined on the basis of the results of instrumental surveys and dimensional drawings, taking the established physical and technical characteristics of the building structures, based on the results of a detailed survey, into account, which involves obtaining all the necessary information for the development of the building restoration project (Figure 12).

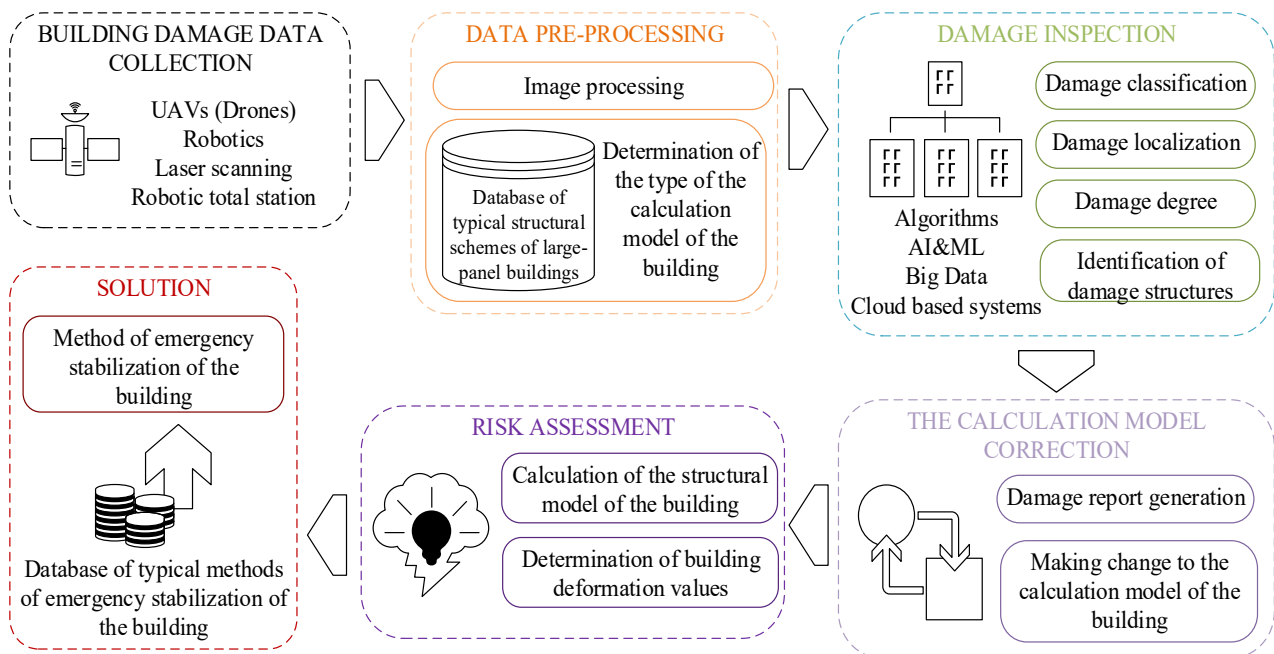
**Figure 13.** Proposed BIM-based workflow for the assessment of damaged large-panel buildings with identified processes that potentially could be automated.

changes in its structural scheme, depending on the extent and localization of damage, into account. The proposed BIM-based workflow for the assessment of damaged large-panel buildings with identified processes that potentially could be automated is shown in Figure 13.
