Study on the Microstructure and Water Absorption Rate Changes of Exterior Thin-layer Polymer Renders During Natural and Artificial Ageing

This paper presents the experimental investigation results of finishing render of external thermal insulation composite systems (ETICS). The study involved natural (long-term) and artificially accelerated (short-term) ageing including effect of UV radiation. The cycle of accelerated UV radiation ageing test, imitating the impact of one natural year in Lithuanian climate conditions, have been used. In order to determine the visual, microstructure and water absorption changes and find out the correlation between the natural and artificial weathering, the results of tested aged and untreated samples have been compared. The main attention was focused on the changes of structure and physical properties after short-term and long-term ageing tests.

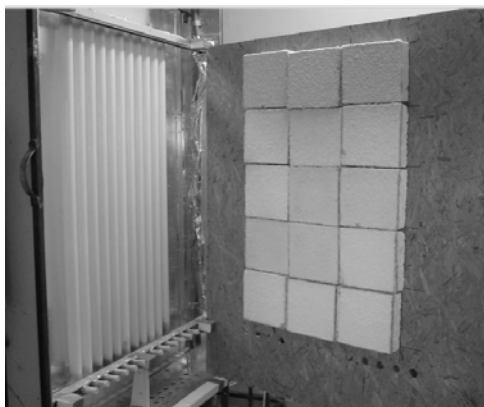
For the short-term ageing each sample was (200×200×50) mm in size. The edges of prepared samples were covered by waterproof epoxy material. Prepared samples were placed in UV climatic chamber (Fig. 1).

Fig. 1. The prepared ETICS samples for the laboratory testing in the UV climatic chamber

The UV radiation impact was imitated using UVA-340 fluorescent lamps (a wavelength from 295 nm to 365 nm). Special lamps were chosen to reproduce the natural solar

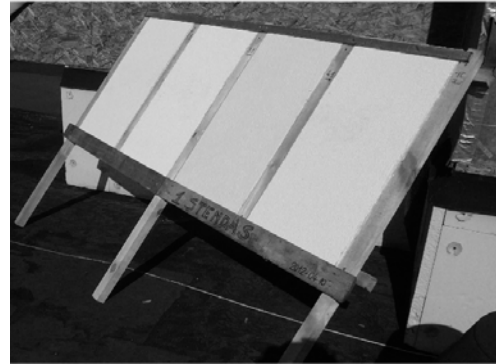
For the long-term natural ageing the samples of each type of rendering were exposed on a 56° slope of a wooden, South facing rack, placed on the flat roof of a building (Fig. 2). During the natural ageing UV radiation and other climatic impacts were recorded by sensors at the meteorological station of Institute of Architecture and Construction. All prepared ETICS fragments before the experiment were conditioned for 28 days at 60 % ± 5 % relative humidity and 20 °C ± 5 °C temperature environment.

Fig. 2. The ETICS panels (1000×500×50 mm) for the natural ageing placed on the wooden test rack
