Diagnostics of cycloidal gear speed reducers in vertical multirotor system

V. Barzdaitis*, V.V. Barzdaitis**, K. Kazlauskienė***, A. Tadžijevas****

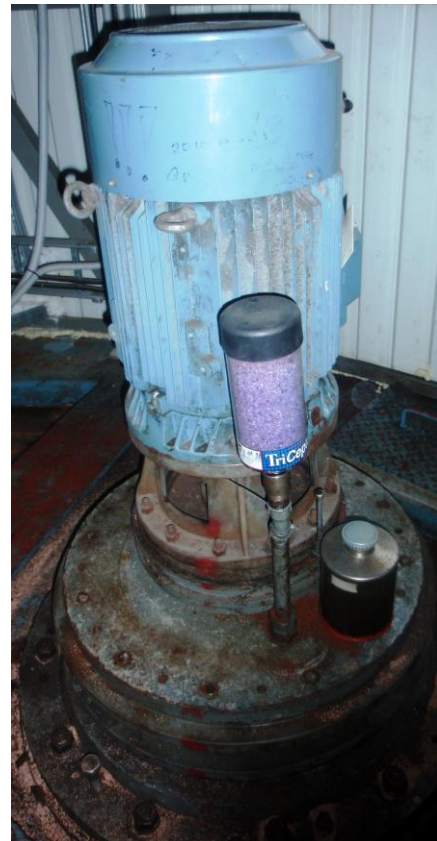
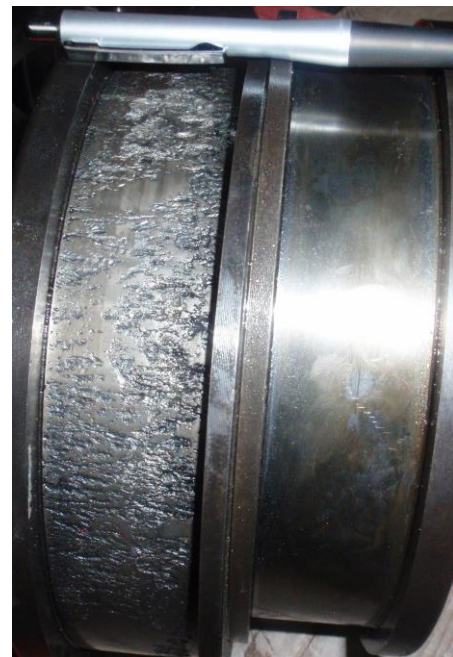
Fig. 3 The EM with CR drive and damaged eccentric bearing raceway of CR2 stage: a - CR with EM; b - CR2 damaged eccentric bearing raceway

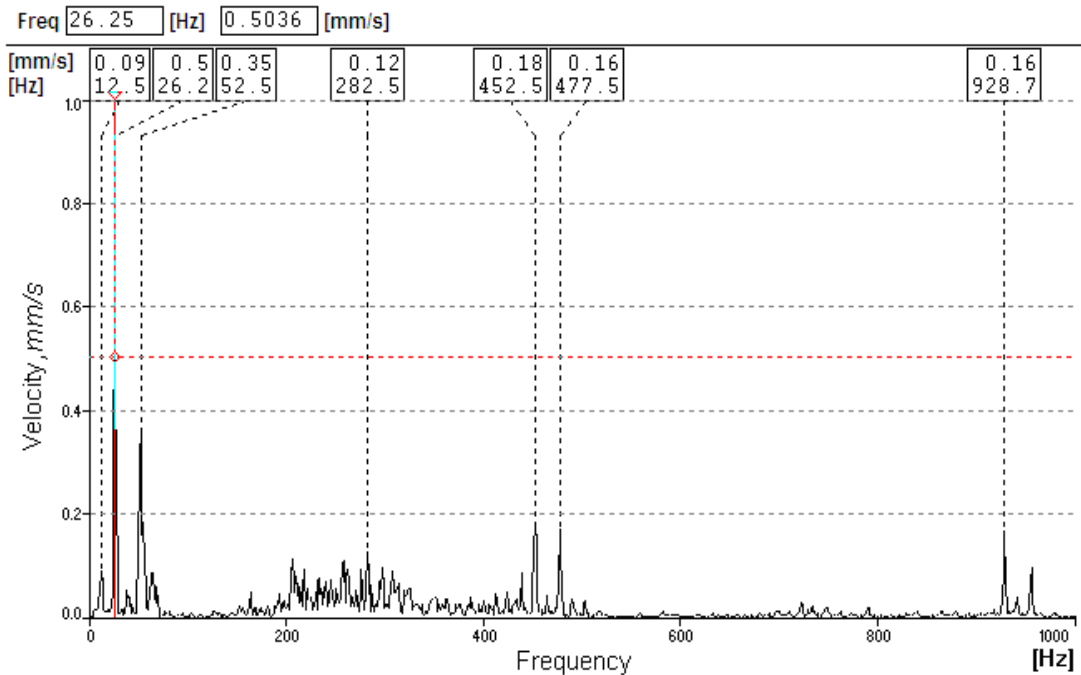
Fig. 4 Radial vibration velocity spectra of damaged 1st and undamaged 6th drives, 2PH transducer: a - damaged 1st drive, $v_{rms2GH} = 1,71 - 2,23$ mm/s, $g_{rms2Gh} = 0,25$ g, $a_{rms2GH} = 16,86$ m/s², $a_{max2GH} = 40,5$ m/s²; b - undamaged 6th drive, $v_{rms6GH} = 1,02$ mm/s, $g_{rms6Gh} = 0,18$ g, $a_{rms6GH} = 6,09$ m/s², $a_{max6GH} = 14,8$ m/s²

The damaged (1st drive) and undamaged (6th drive) drives 2nd bearings vibration velocities spectra measured in radial direction with 2PH transducer is shown in Fig. 4, a, b. Rich vibration velocity spectrum in Fig. 4, a indicates technical condition problems in vertical drive CR1 shaft 1v with two eccentric bearings. CR1 1v driving shaft 1v rotates at 750 rpm (12.5 Hz). The double crankshaft ex-

citation frequency is $2X/26.25$ Hz and vibration velocity amplitude 0.71mm/s, 265 Hz / $26.25 \approx 10X$ harmonic 0,75 mm/s and 477.5 Hz / 26.25 Hz $\approx 18X$ harmonic 0.73 mm/s and dominated in the vibration velocity spectrum, Fig. 4, a. There are no vibration velocity dominated amplitudes values that could be proportional to bearings kinematic frequencies of CR1 stage: spherical roller bearing

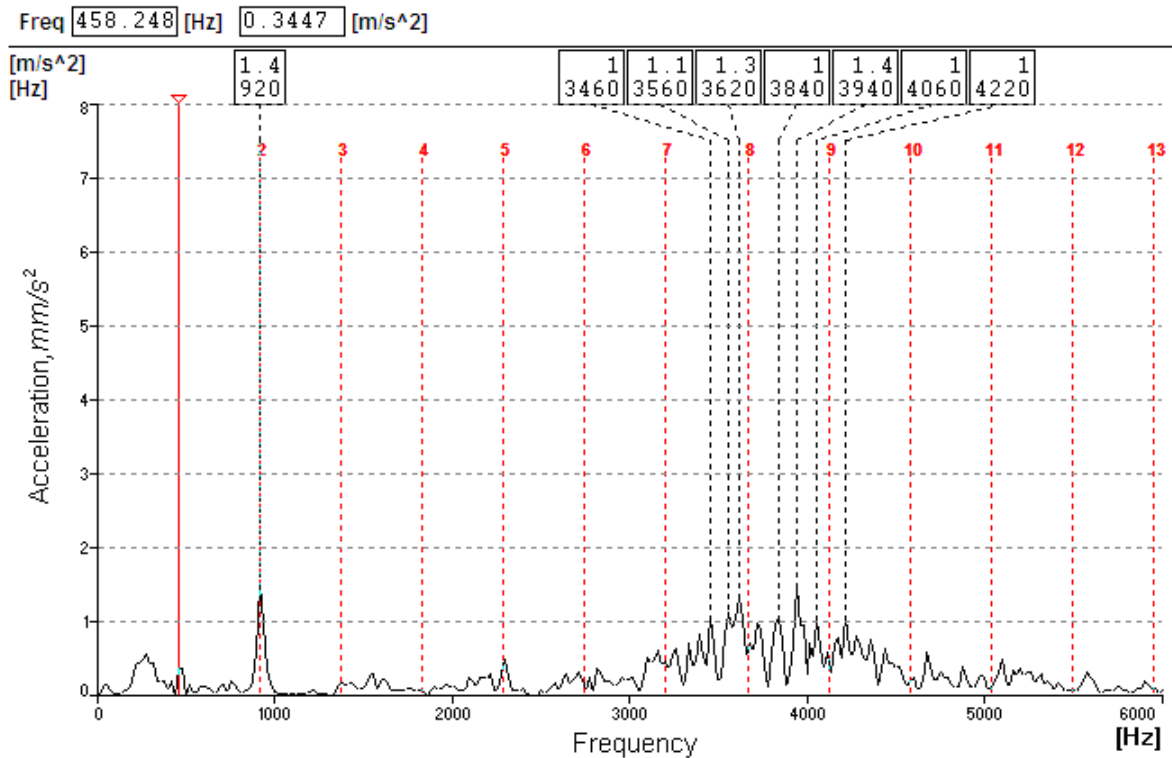
Fig. 5 Radial vibration acceleration spectra of damaged 1st and undamaged 6th drives, 2PH transducer: a - damaged 1st drive; b - undamaged 6th drive

The damaged and undamaged CR drives 2nd bearings vibration acceleration spectra measured in radial direction with 2PH transducer is shown in Fig. 5, a, b. The high frequency vibration acceleration amplitudes are more informative for identification of damaged CR drive. The

In conclusion for evaluation of technical condition of CR eccentric bearings authors suggested for practical use vibration acceleration arms parameter measured with 2PH and 3PA transducers. According to Fig. 5, the vibration severity of CR damaged 1st drive reached dangerous vibration acceleration (arms1 $\approx 18 \text{ m/s}^2$) values measured with 2PH and 3PA transducers. The 2nd, ..., 10th drives vibration severity is low. The vibration acceleration arms data that received from 5GA and 5GH transducers are less informative in diagnostics, because vibration energy at indicated locations on CR dissipated in housing material.

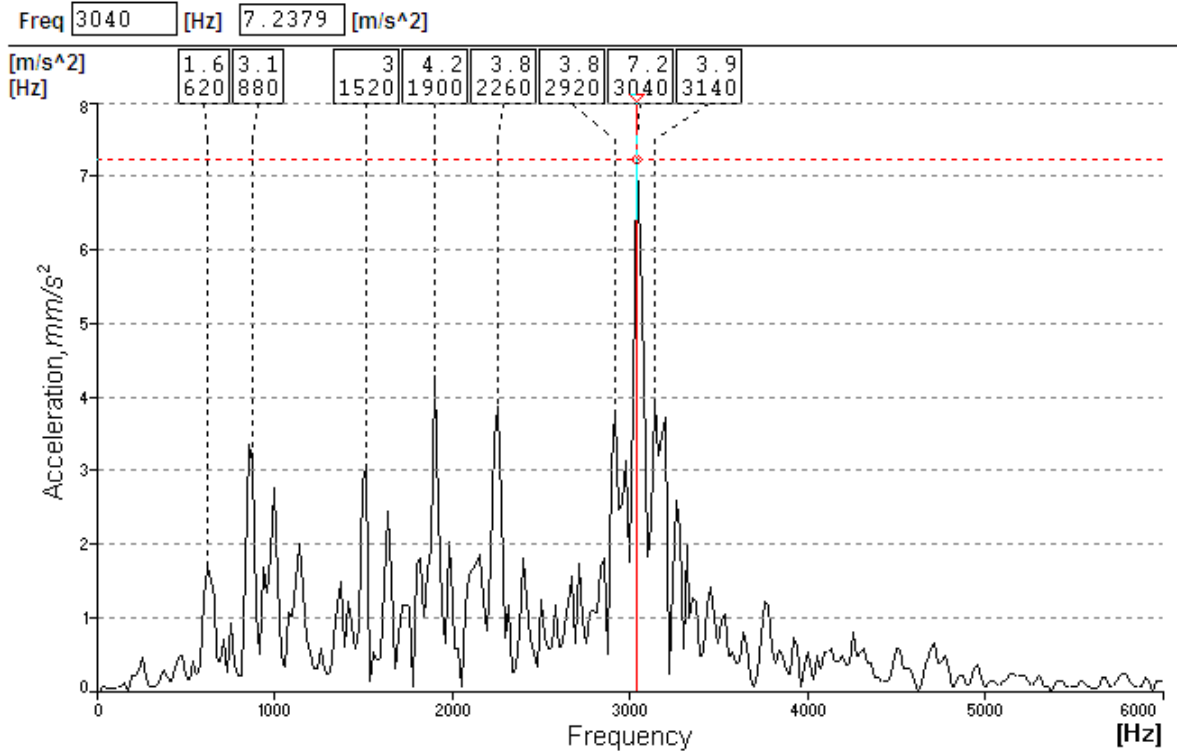
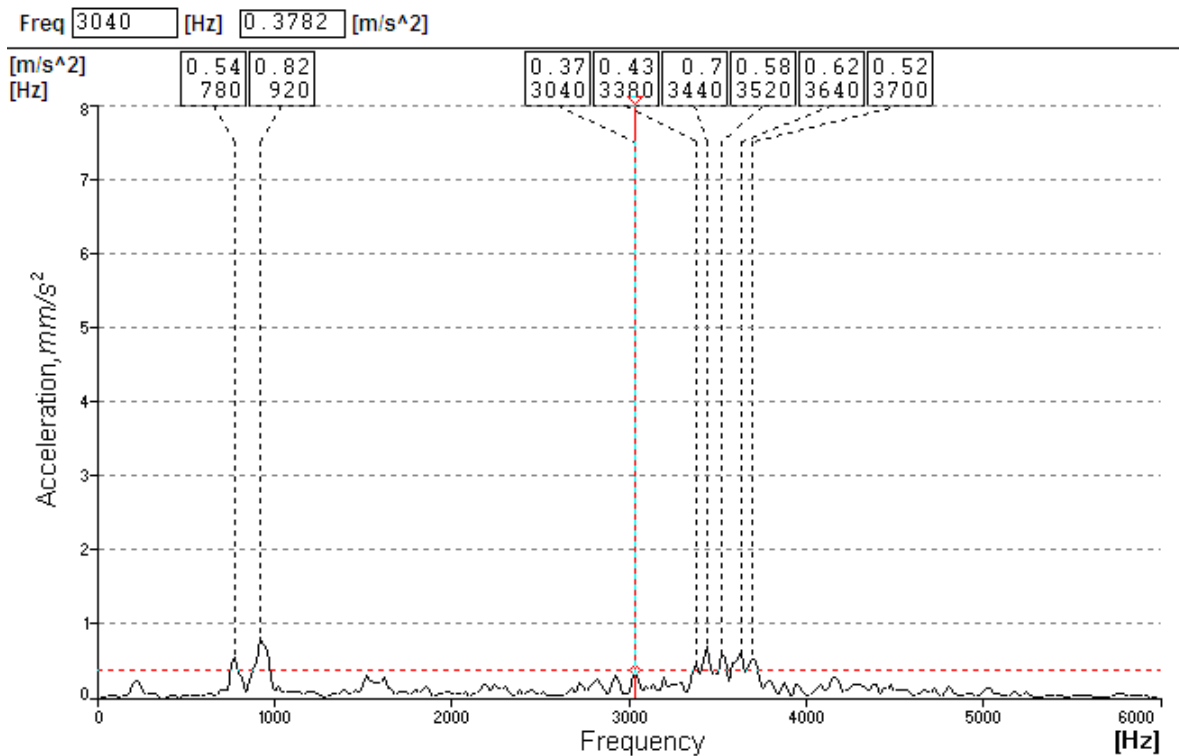
Fig. 6 Axial vibration acceleration spectra of damaged 1st and undamaged 6th drives, 3PA transducer: a - damaged 1st drive, b - undamaged 6th drive

vibration measurement data received from axial direction measurement transducer 3PA indicated the same result (Fig. 6, a, b), that high frequency (2000-5000 Hz) vibration acceleration is more informative in diagnostics in comparison with low frequency vibration velocities.
