Challenges in ultrasonic detection and characterization of small-scale structural defects in industrial metal pipelines for power generation and petrochemical Industries

Renaldas Raišutis, Vykintas Samaitis, Vaidotas Cicėnas, Audrius Stravinskas, Egidijus Žukauskas

Ultrasound Research Institute; Kaunas University of Technology (KTU), Kaunas, Lithuania

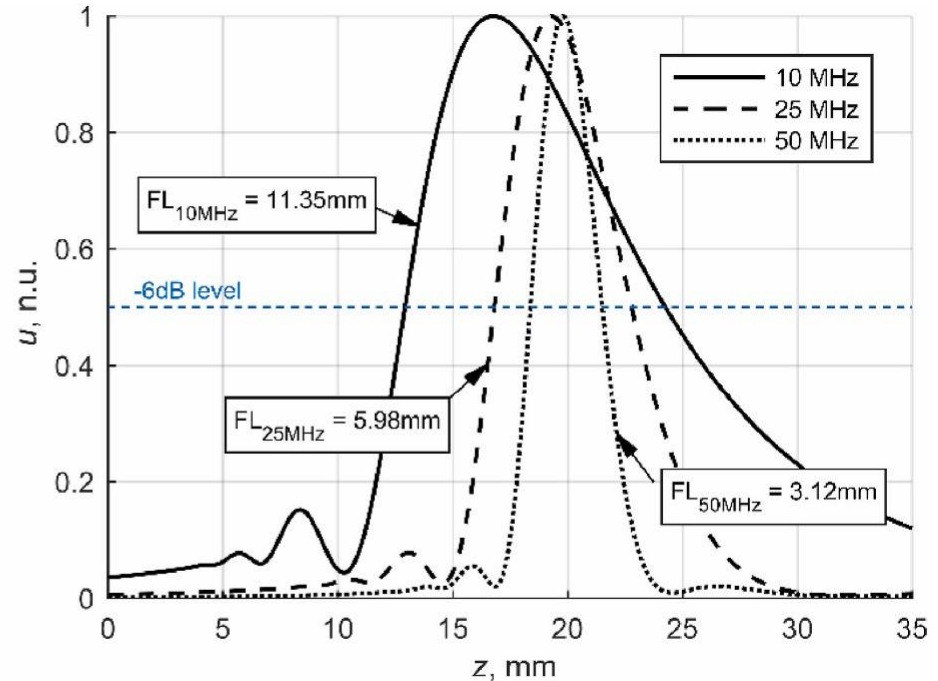
Along the ultrasonic beam (z axis)

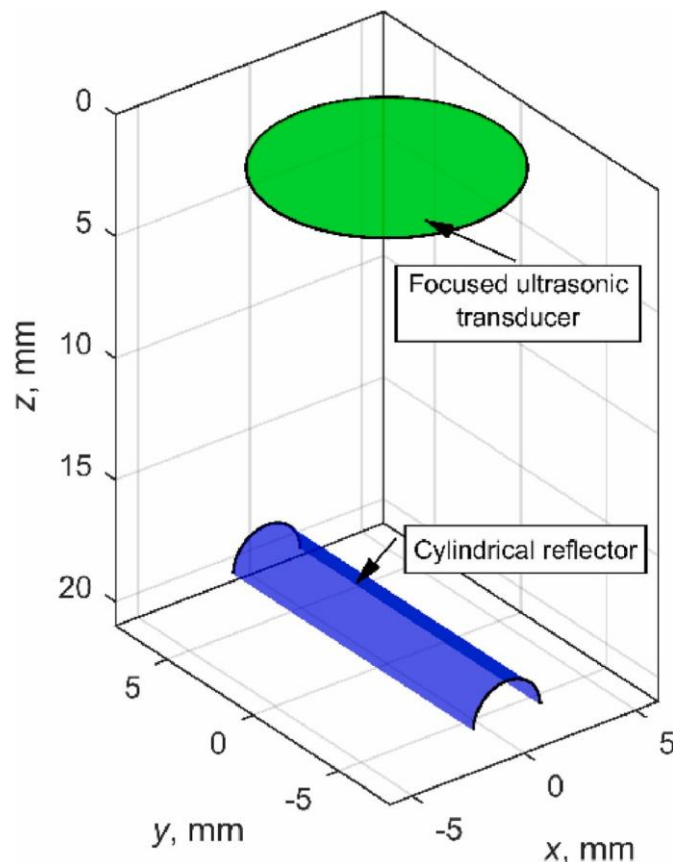
Simulation of the reflections from reflectors possessing different diameters

- Frequency of FT was 2.25 MHz, focal length 20 mm, FT diameter 9.53 mm.
- The waveform of the excitation signal was 3 period burst (Gaussian envelope).
- During waveform calculation of the reflection, the diameter of the cylindrical reflector (length 14 mm) was varied from 0.005 mm to 0.3. mm.
- The spatial steps used to create a cylindrical surface were 0.005 mm along and 0.01 mm around reflector (spatial sampling < 50 times, compared to the wavelength).

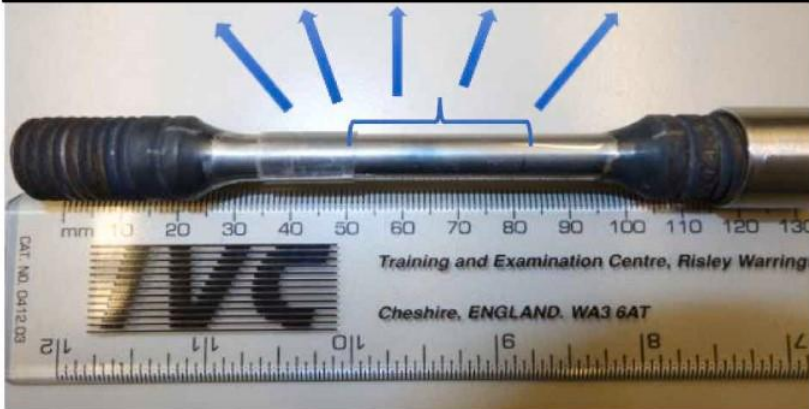
a

Parent metal – HAZ – Weld – HAZ - parent metal

Unbroken sample No.1 with the creep damage inside the weld, (b) broken sample No.2 due to the development of the creep damage

Sample No.1 contains early stage creep damage (unbroken).

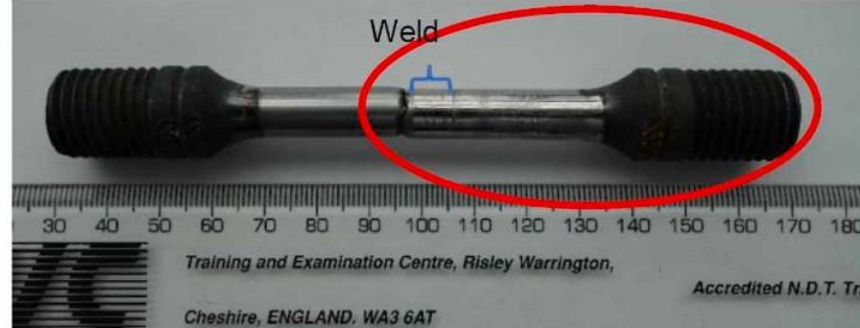
b

The sample is broken in the region of left side HAZ.

The right part of the sample, containing the weld was investigated

Sample No.2 was strongly exposed to conditions creating higher level creep damage and was used in tensile tests (was broken from one side of the weld).

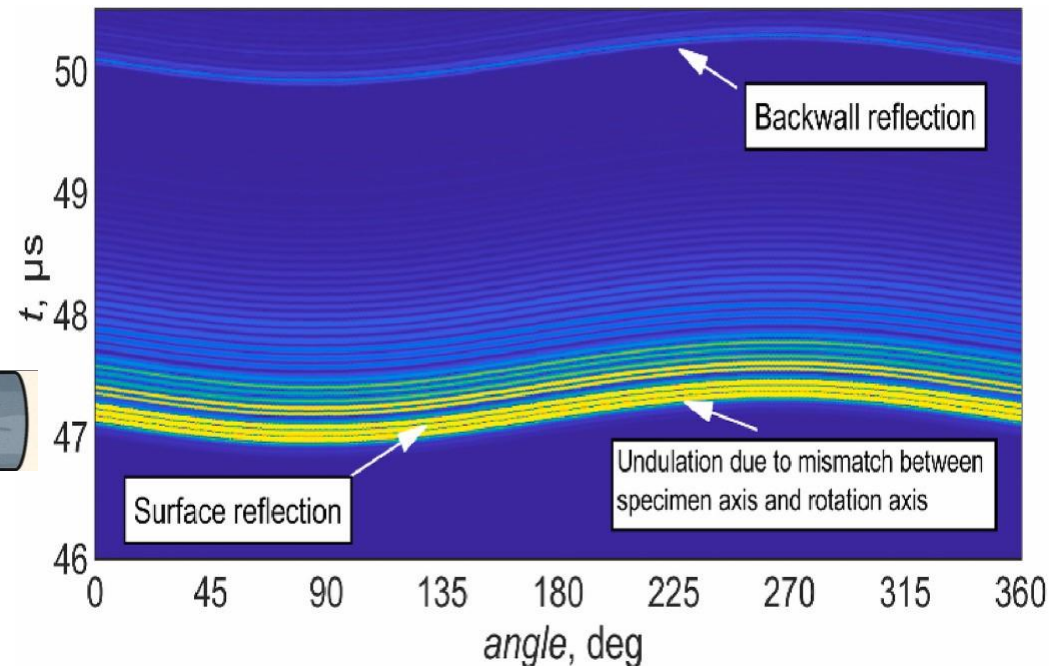
Raw B-scan images at the particular height of the sample

- The misalignment in the B-scan images of 0.2–0.3 mm is visible (complicates analysis).
- The strong front wall reflection possesses essentially higher amplitude compared to the expected reflections by non-uniformities in the deeper regions of the sample (creates a large dead zone).

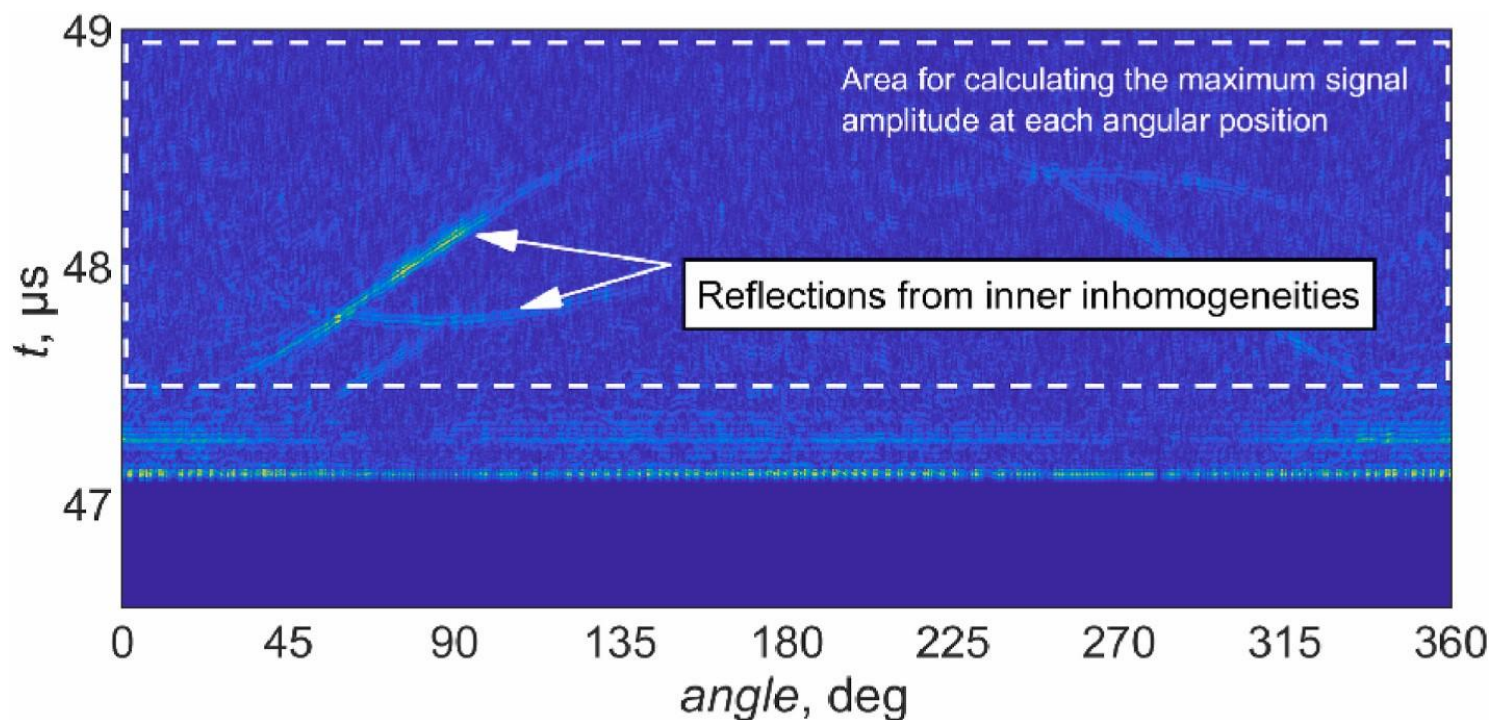
Compensation of misalignment and reduction of dead zone

B-scan image

- Band-pass filtering (Gaussian shape) of the acquired signals and central frequency corresponding to the central freq. of FT (25 MHz, bandwidth 12 MHz at - 6 dB).
- Correction of the misalignment by measuring the arrival time of the front surface reflection and appropriate shifting of the reflections in the time domain.
- The averaged signal of the front wall reflection is subtracted from each of the measured signal and enables to reduce essentially dead zone, also observe indications closer to the surface.

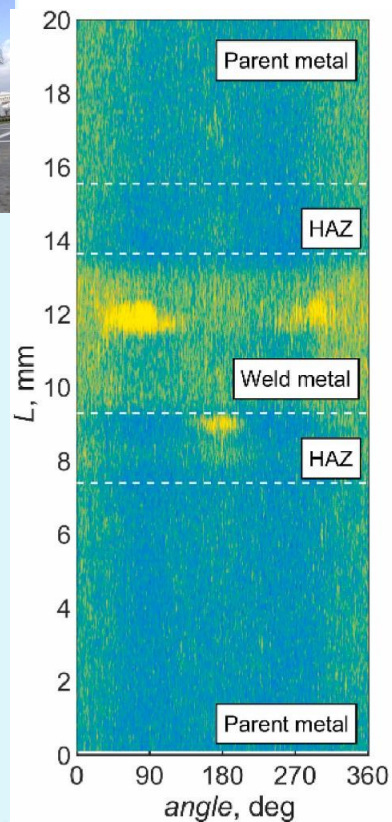
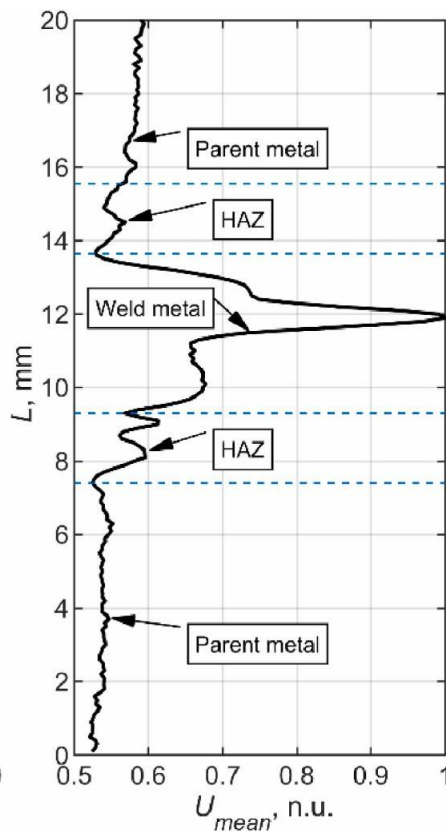
Structural noise and indications along the sample No.1 (not broken)

a-the C-scan image, b-the normalized peak amplitudes of the reflected signals from the internal structure, c-reconstructed 3D image

- The multiple micro-cracks and cavities can be seen in both HAZ.
- From one side of the weld, increase of the structural noise in HAZ (0.6 n. u.) and parent metal (0.55 n. u.).

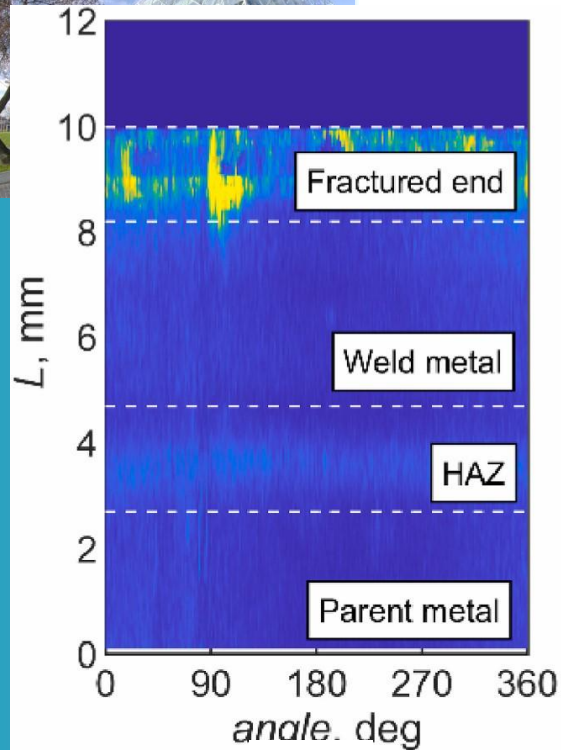
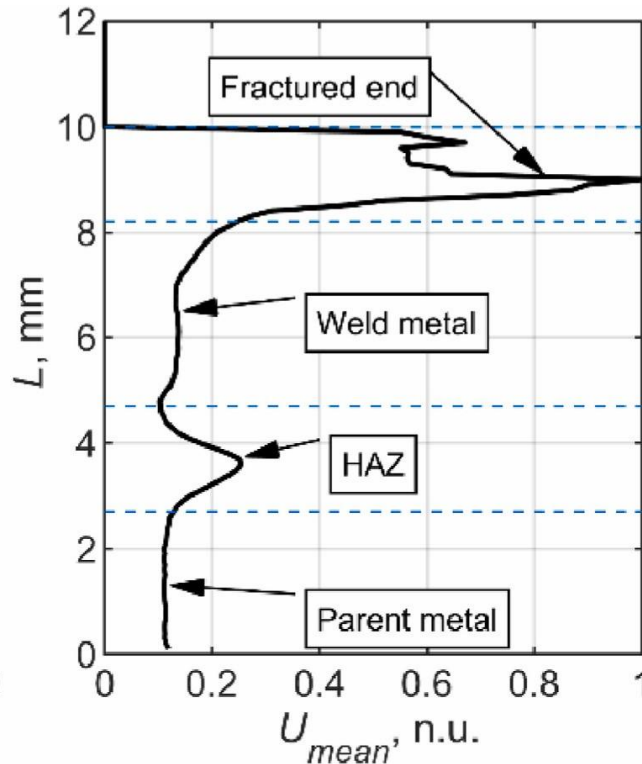
Structural noise and indications along the broken sample No.2

a-the C-scan image, b-the normalized peak amplitudes of the reflected signals from the internal structure, c-reconstructed 3D image

- The noise amplitude at HAZ is significantly higher (0.25 n. u.) compared to the parent metal (0.11 n. u.).
