Mechanics and material aspects in serviceability prediction of the heat exchangers

S. Baskutis*, V. Vasauskas**

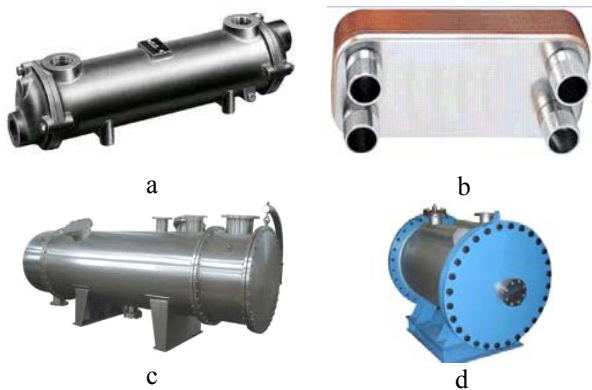
Fig. 1 Samples of industrial heat exchangers: a – tube HE, b- brazed plate HE, c – shell and tube HE, d – spiral plate HE

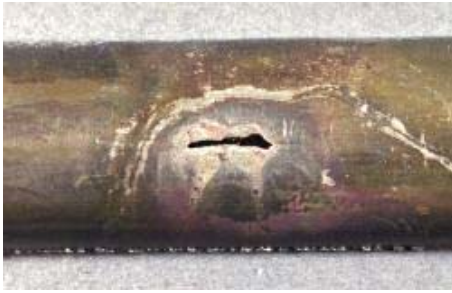
Fig. 2 Outside surface of the damaged connecting tube due to corrosion influence

Corrosion, pitting of plates' metal surfaces and the build up of "crud" occurs because the quality of the city plumbing water being used is poor or the flow rate is too low or unstable. Enlarged quantities of oxygen, chloride, nitrate, sulphide, water hardness, iron content in the water stimulate corrosion process. Our experience shows, that corrosion damages occur not only inside or outside of heat exchanger, but also in the connecting pipes. Fig.2 shows typical corrosion damage of connecting pipe under the bracket which is used to stay heat exchanger and to avoid deformations of pipes and junctions.

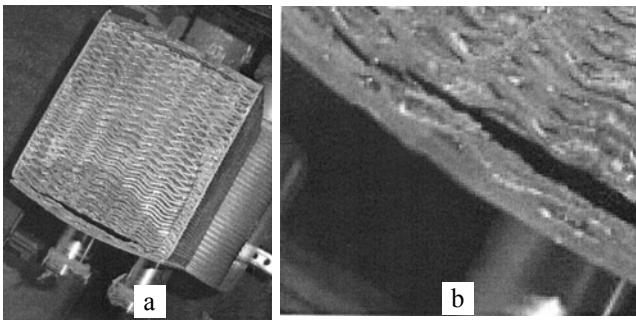
Fig. 3 Damaged copper brazed plate HE due to higher pressure than approved and corrosion of cooper caused by poor water quality or aggressive liquid: a – general view; b – closer view of the defect

Fig. 3 shows damaged copper brazed HE with plates' material of stainless steel 316. The damaged HE was in operation for approximately 2 years before being removed from service. There is a typical defect of brazed plate HE caused by poor water quality or aggressive liquid and higher pressure than approved where external leakages are observed. During the examination the heat exchanger has been cut into two parts. The reinforced end plates with plate thickness 3 mm show deformations with max height of 5 mm on both end plates. The appearance of the external leaking indicates high tensile stresses in the leaking areas. This damage the cooper brazing and the strength in the areas with the highest tensile stresses reduced, typically in the corners or the middle of the end plates. The examination also shows another defect. Cooper brazing has disappeared in the space between the plates on the secondary side of HE. Degrading of cooper in the space between the plates reduces the strength as there is no longer any brazing to keep the heat transfer plates bonded together. It also causes external leaking as the cooper in the edges of the plates is sealing the HE. Our experience shows, that tap

water temperature below 55°C will limit the risk of stress corrosion of stainless steel and hot water pitting of copper. Copper can disappear either caused by poor water quality or caused by an aggressive flushing liquid. Flushing should take place in the shortest possible time period and only until all scaling and deposits are removed. Flushing can remove the deposition and increase the ability to transfer heat, but it can also cause reduction of the life of the HE. It is very important that the HE is thoughtfully flushed with clean water immediately after cleaning. If this is not done deposits of flushing liquid can corrode the plates and the copper brazing material.

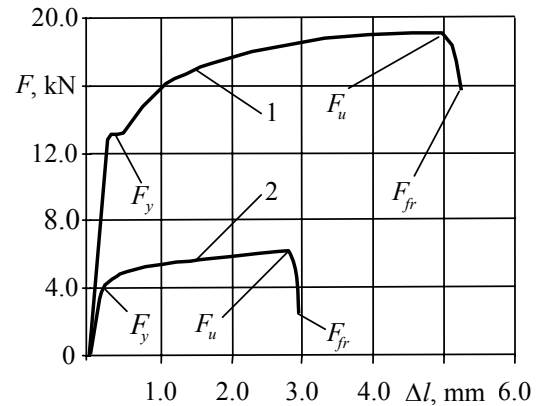
Fig. 4 Engineering $F-\Delta l$ diagrams obtained from a tension tests for low carbon steel tube 1, and for coated tube 2, where F_y – yield force, F_u – ultimate tensile force, F_{fr} – fracture force

Our examination was done with the stainless steel 304 as a clad on low carbon steel tube. An experimental definition of engineering load-displacement ($F-\Delta l$) curves obtained from a tensile tests was done for low carbon steel and stainless steel clad on low carbon steel (Fig. 4) connecting tubes. The tubes were of a circular cross-section with an outer diameter of $d = 0.055$ m, the wall thickness of tubes was 5.5 mm and 1.5 mm, respectively. Tensile tests at room temperature of the service exposed tubes were performed using 500 kN "Amsler" testing equipment. Standard tensile specimens were made of the longitudinal direction of the tubes, which were used for HE connecting; flow media - steam at temperature 200°C, exploitation time - 5 year.

Tensile tests were carried out on the tube metal only from the longitudinal direction of the service exposed tubes. The ultimate tensile stress (UTS) occurs where the nominal stress curve shows a maximum. In our case UTS for coated tube is 584 MPa, and for low carbon steel tube 550 MPa. For the 0.2% offset yield stress, we extrapolate a line with the same slope as the linear regime (which is equal to the Young's modulus) until it intersects with the curve. The stress at this intersection is the 0.2% offset yield stress, i.e. 421 MPa for coated tube and 360 MPa for low carbon steel tube.

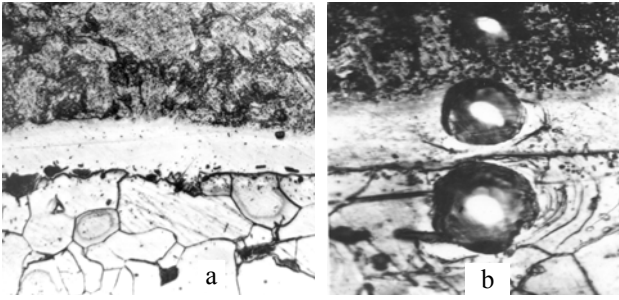
Fig. 5 Photomicrographics of the cross section of the tube (low carbon steel and clad - stainless steel), polished and etched (x500): a – before, b – after the microhardness testing procedure

Furthermore, coated connecting tubes were subjected to standard metallographic examination and hardness measurement. Hardness is a mechanical parameter which is strongly related to the structure and composition of the solids. Furthermore, microhardness is not only a mechanical characteristic routinely measured but it has also been developed as an investigation method of structural parameters in recent years [16]. Fig. 5 shows the cross section of coated low carbon steel tube and indents of microhardness testing procedure. The term "microhard-

ness” usually refers to indentation hardness tests made with loads that do not exceed 1000 g. We provided testing experiments with loads 100 g and 200 g.

Microhardness testing provides an alternative means of assessing changes in mechanical properties [17]. It can be done quickly and efficiently, without need for a large volume of sample material. While the yield stress of the thin damaged layer in coated tube cannot be measured directly, microhardness tests can easily be with high precision. With a hardness distribution in the different zones of coating substrate system, the yield stress is expected to change with depth. In practice it is very difficult to obtain experimentally the depth and local hardening distribution of the tensile strength. Here it is approximately calculated according to empirical relations. Fortunately, good linear relationships have been found between the tensile strength and the hardness, the distribution of which can easily be measured. The ultimate tensile strength can be calculated by the following equations
