Aircraft Propeller blade quality evaluation using ultrasound NDT
Master's Degree Final Project

Master's Degree Final Project
Aeronautical engineering (6211EX024)

In this work, aircraft ATR42 propeller blade consisting of composite materials and aluminium spar overall ultrasound NDT inspection technique has been determined. Propeller blade computerised inspection model has been established and experimentally examined for validation. Propeller blade each of single material acoustic characteristics have been found. Artificial flaws in all layers of the propeller blade examined experimentally and electronic scanning graphs provided. Most suitable propeller inspection probe has been concluded.

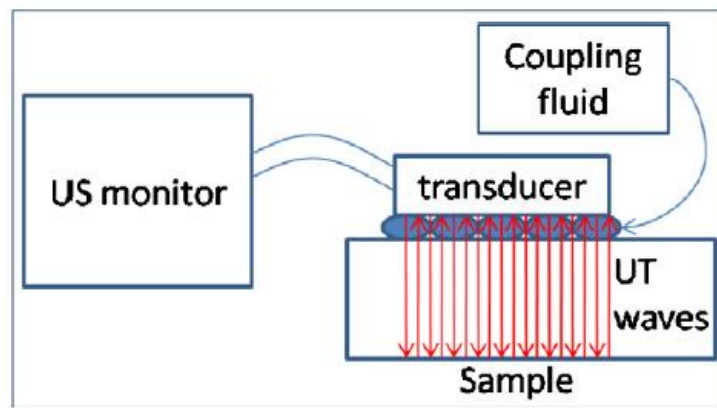
Figure 2-3. Flaw detection equipment elements [24]

Ultrasonic wave generator within the equipment electrically energize the RF pulser causing it to emit electrical pulses. The probe oscillates on receipt of the pulses and converts them into ultrasonic waves, which are transmitted through the specimen which is inspected. Any change in the acoustical impedance, caused by a defect in the materials or interface between them reflects the sound back in the form of an echo and piezoelectric crystal in the search unit receives the wave [4]. The piezoelectric crystal has two functions: - to transform the electric energy into mechanical energy (sound) - to change the mechanical energy of the return signal (echo) back to electrical energy for display and evaluation. The search unit functions as a receiver for reflected energy between pulses. [4].

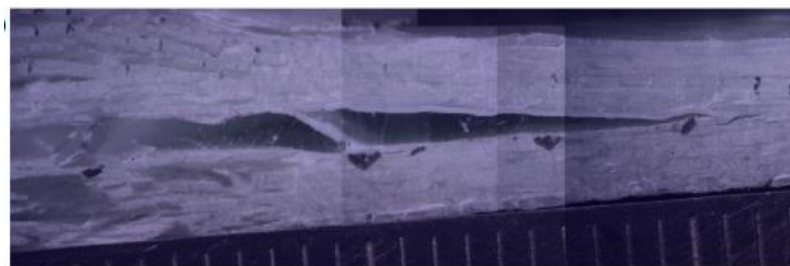
Glass fiber reinforced composites as a homogeneous materials experience thermoelastic effects during the operating life which causes the variation of material volume and causes stress. [40] Thermoelastic effects and dynamic loads throughout the propeller blade operating life are one the they main contributors to propeller blade glass fiber composite shell natural ageing. Ageing visual example is showed in figure 2.6.

Figure 2-6. Composite material ageing effects [40]

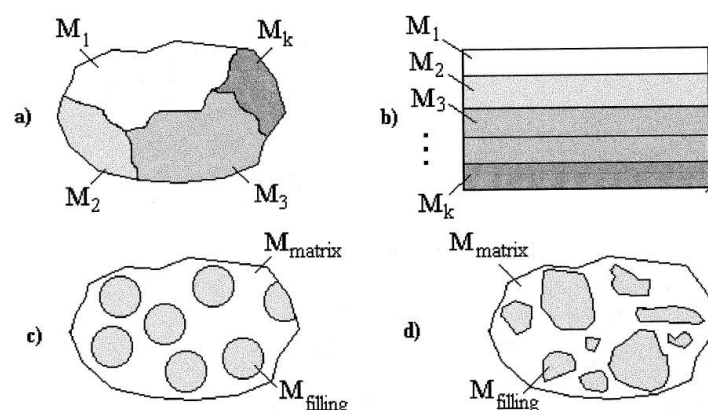
As sound travels through materials sound wave is distorted, scattered or absorbed. Scattering phenomenon is caused by sound waves reflection, refraction or diffraction in each way that each sound particle becomes new sound wave source in all directions [15]. Sound attenuation is a measure for the sound loss in the material. Sound attenuation happens due to materials viscosity and sound pressure starts to diminish over the material. Sound attenuation is highly dependable of material matrix and type, whether it is solid or composite, non-homogenous materials. Different material matrix shape (refer to figure 2.21) and arrangement gives the most effect for absorption or scatter of ultrasonic wave. Sound attenuation can be used as ultrasonic spectroscopy tool for materials physical and chemical properties detection – material particles size and concentration [15].

Figure 2-21. Molecular structure. (a) Multi-faced, (b) multi-layered, (c) two-component with regular filing, and (d) two-component with irregular filling [14]

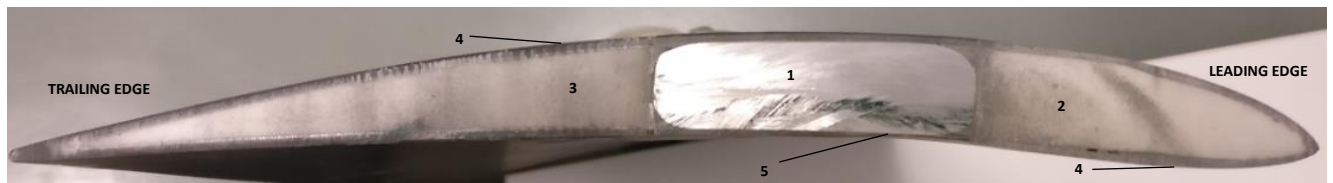
Blade which was previously rejected by manufacture due to erosion and delamination which caused too deep blend out of fiberglass shell. Below figure 3.1 represents the profile:

Figure 3-1. Blade profile section

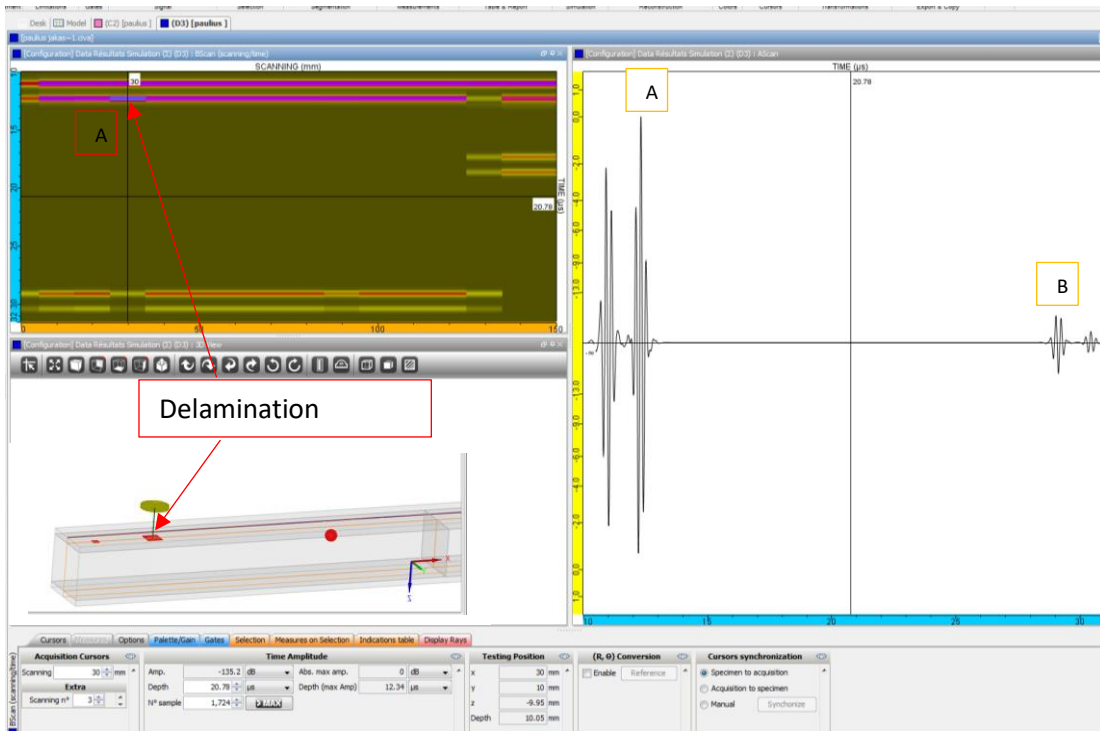
Comparing to figure 3.4 (small delamination) larger delamination size of 4 x 4 mm was detected as well in between two layers – foam and fiberglass laminate. A-scan returned even higher peak at point A in figure 10 than in 4.1.2 and even weaker back echo at point B. Entry peak does not change in 4.1.2 nor in 4.1.3 nor in 4.1.1.

Figure 3-5. Big delamination detection A-scan/B-scan

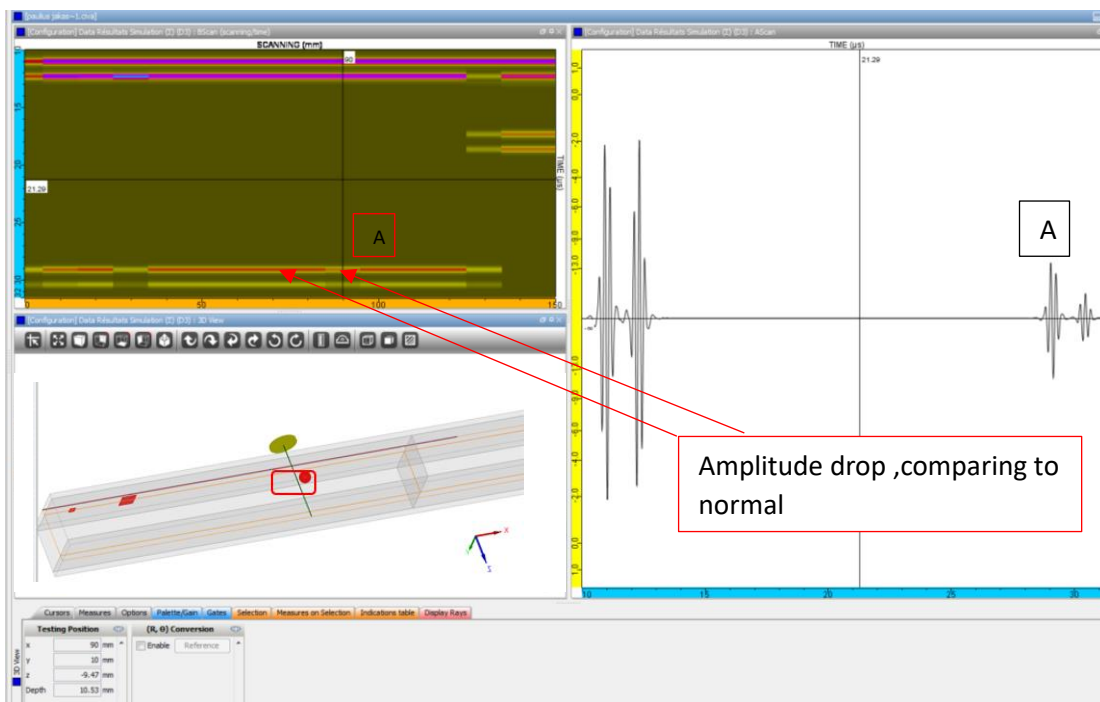
As mentioned in beginning of section 3.1 scanning was done at increments of 6 steps with 10 mm apart to each other . Therefore water inclusion was not detected (did not returned any specific echo in A scan), however it showed its presence in another way in figure 3.6. Due to part of the sound wave hidden back echo which came back from 3rd layer is weaker than normal (refer to 4.1.1).B scan showed weaker signal comparing to no-flaws zone.

Figure 3-6. Water inclusion detection A-scan/ B-scan

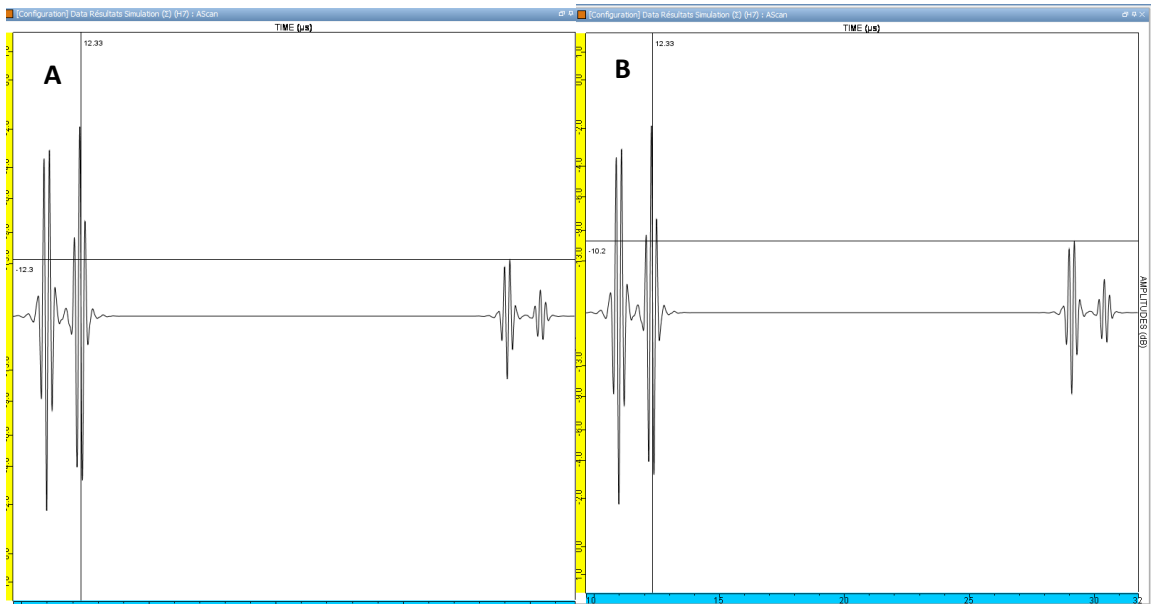
If we compare amplitude of the back-echo graphs in figure 3.7 to determine values, we can see weaker signal strength partly hidden by inclusion - back wall echo at -12.3 dB, which is 2.1 dB lower than normal zone peak at -10.2 dB.

Figure 3-7. Amplitudes comparison. A- back echo amplitude with water inclusion; B- back echo for zone without flaws.

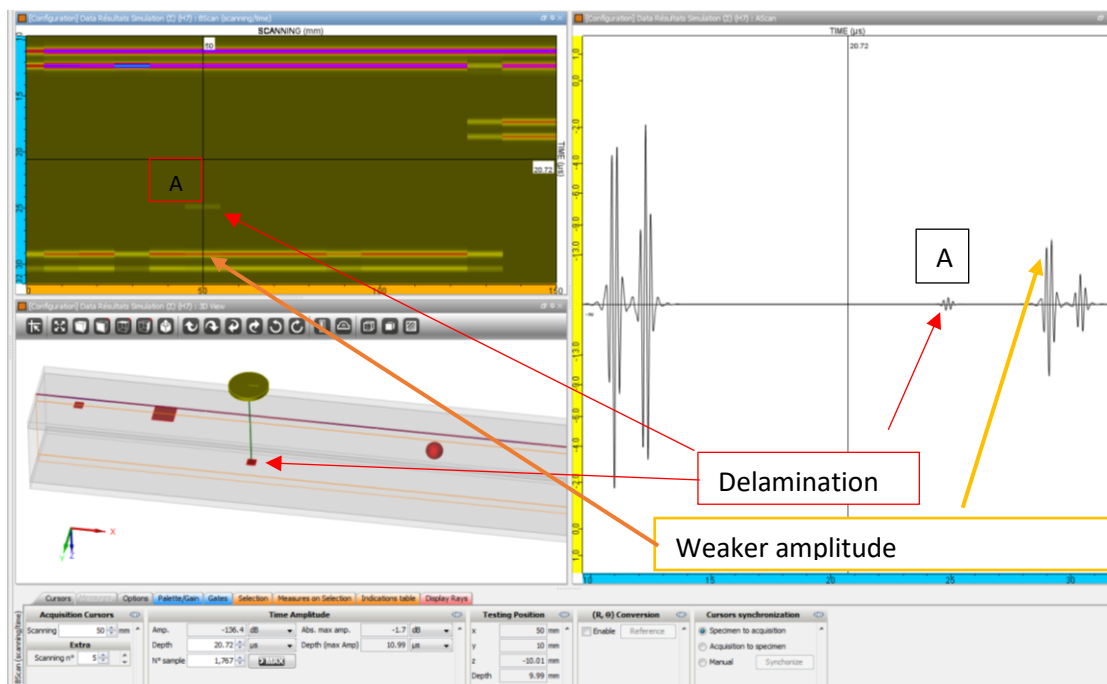
Another test was conducted with delamination deeper than interlayer and positioned specifically in foam volume. Delamination echo amplitude can be seen in figure 3.8 point A. From echo time in A-scan its possible to presume the depth – lower than centre and having true time its possible to calculate precise depth .

Figure 3-8. A-scan / B-scan for deep delamination

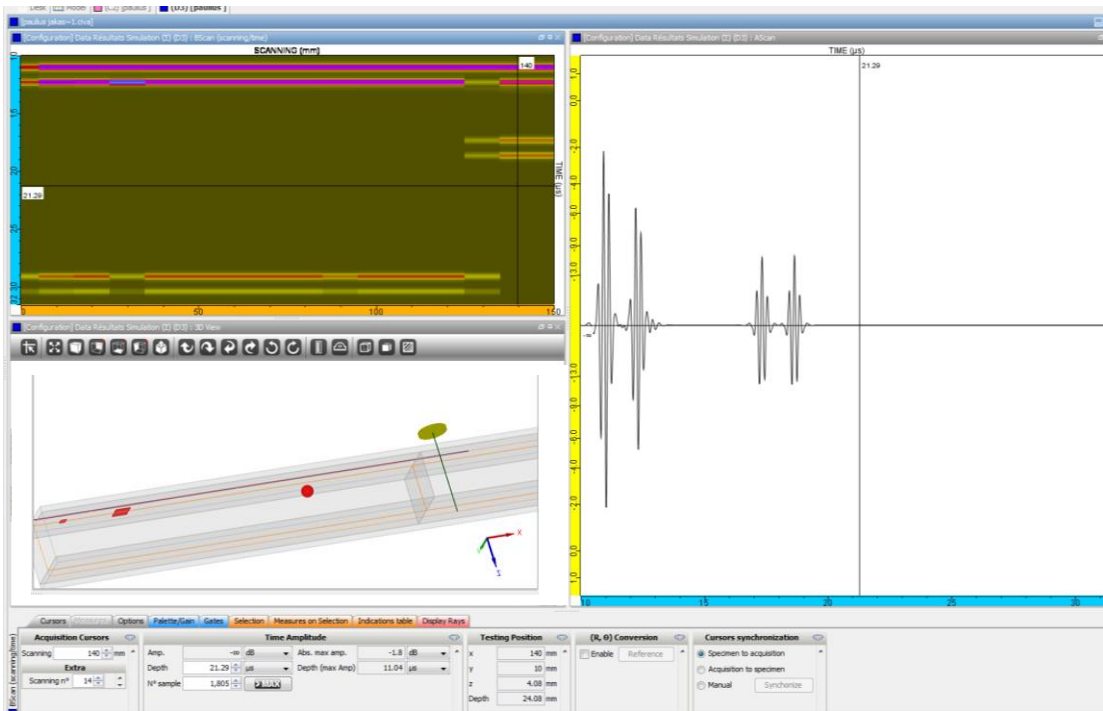
We can observe one distinctive difference comparing to only composite path – back echoes returned much faster due to sound velocity increase in aluminum and due to signal is going through aluminum and glass fiber interaction signal amplitude peaks at A scan is higher – refer to figure 3.10.

Figure 3-10. A-scan / B-scan in aluminium

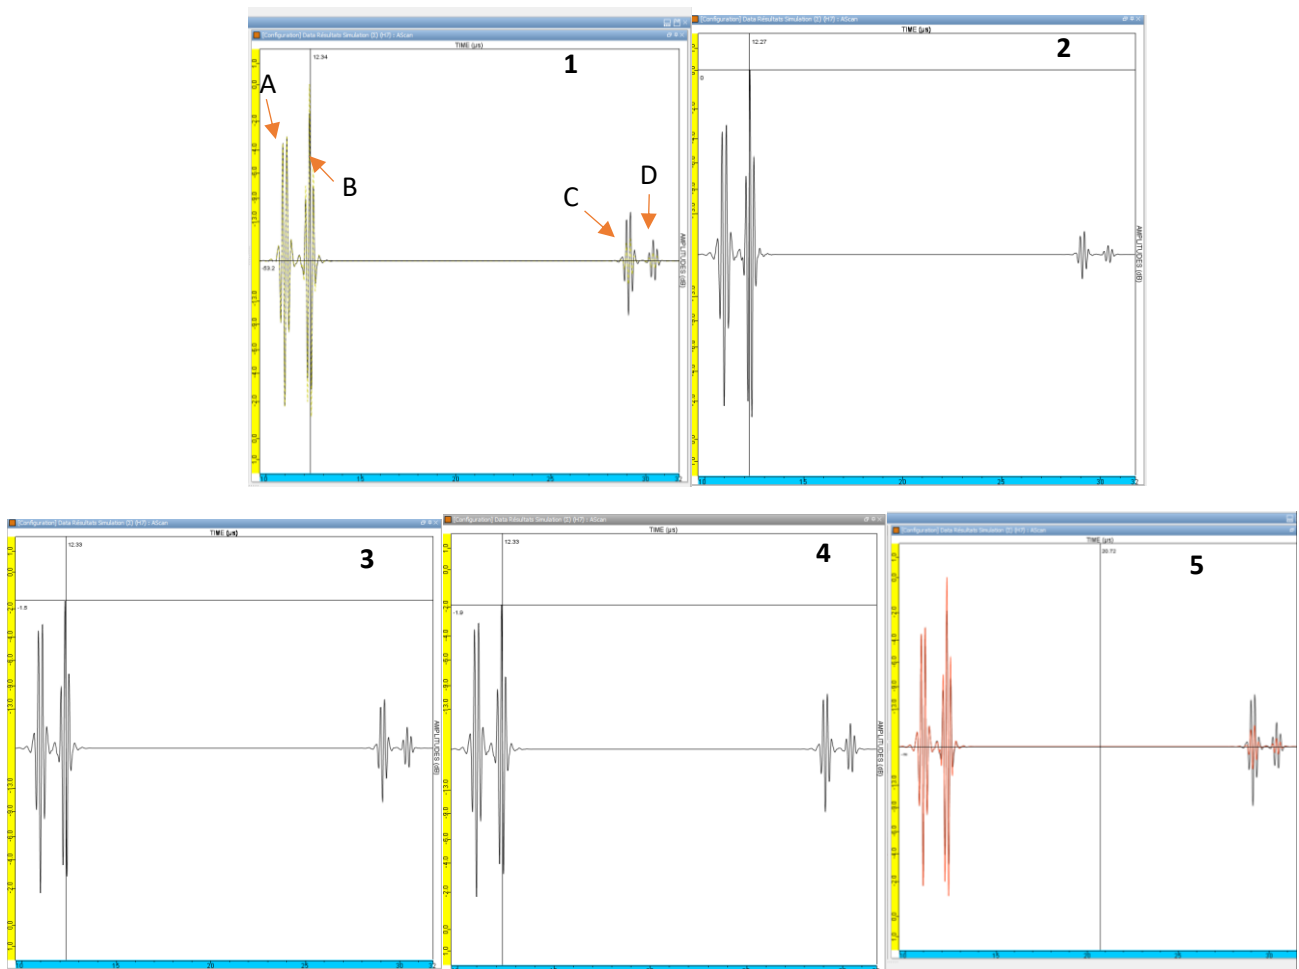
Figure 3-12. A scans comparison when transducers are positioned over different size delaminations. 1 – different sizes delaminations peak amplitudes comparison, 2. larger delamination amplitude peak; 3 – minor delamination amplitude peak, 4 – no defect zone amplitude peak; 5 – big delamination versus no flaw zone

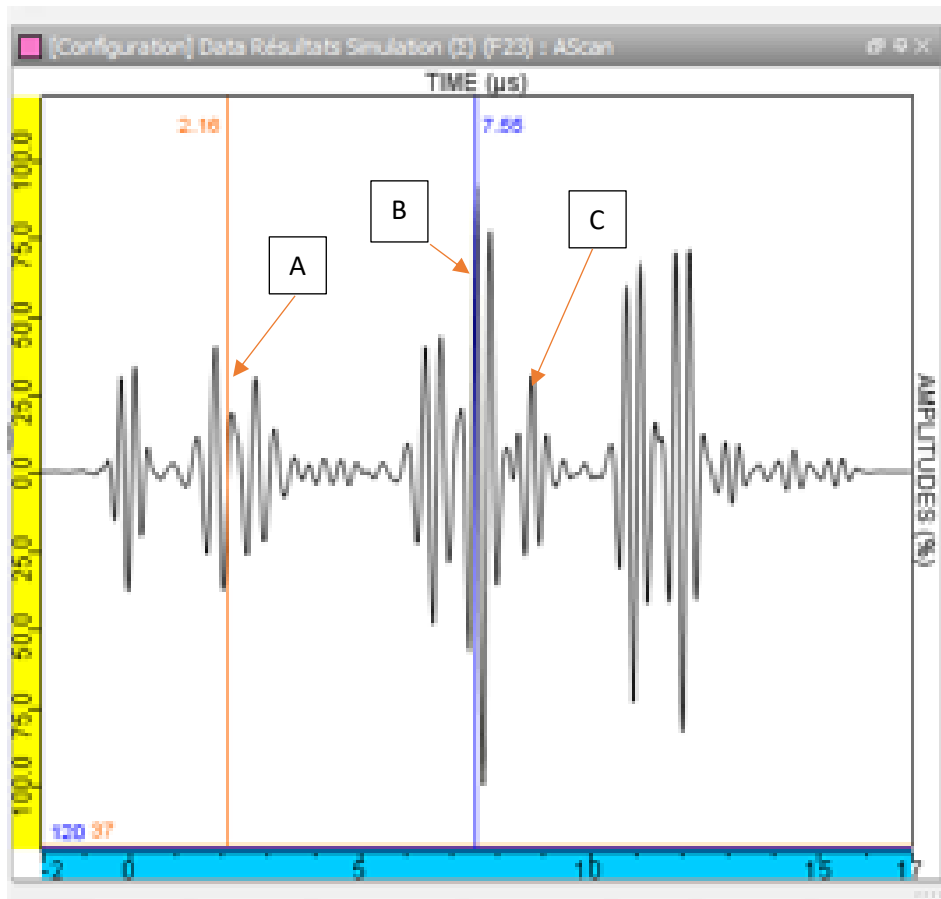
In order to understand any differences from theoretical and experimental results A-scans are presented in figures 3.18 for theoretical and 3.19 for experimental inspection.

Figure 3-18. Theoretical A scan for cross sectional scanning

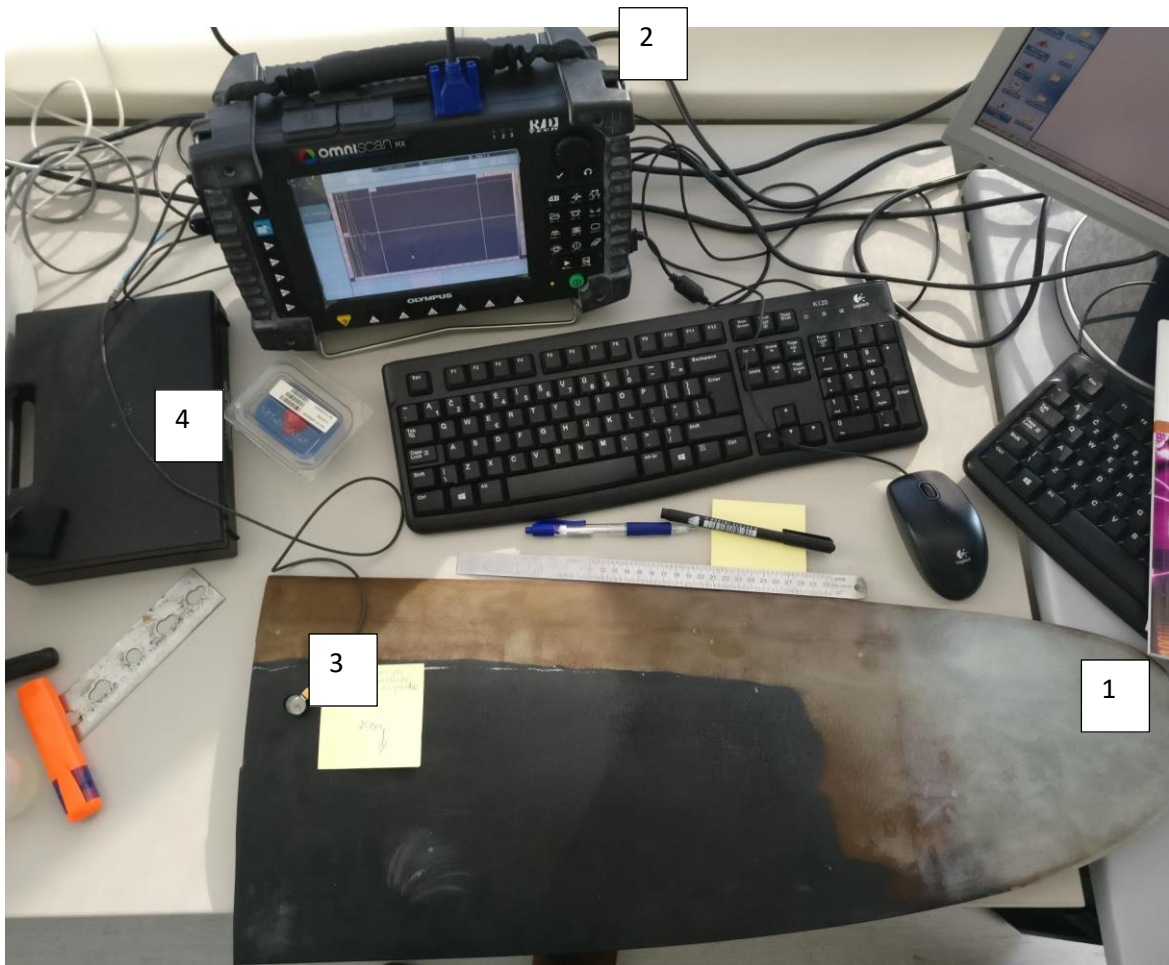
Figure 4-2. Propeller inspection set-up

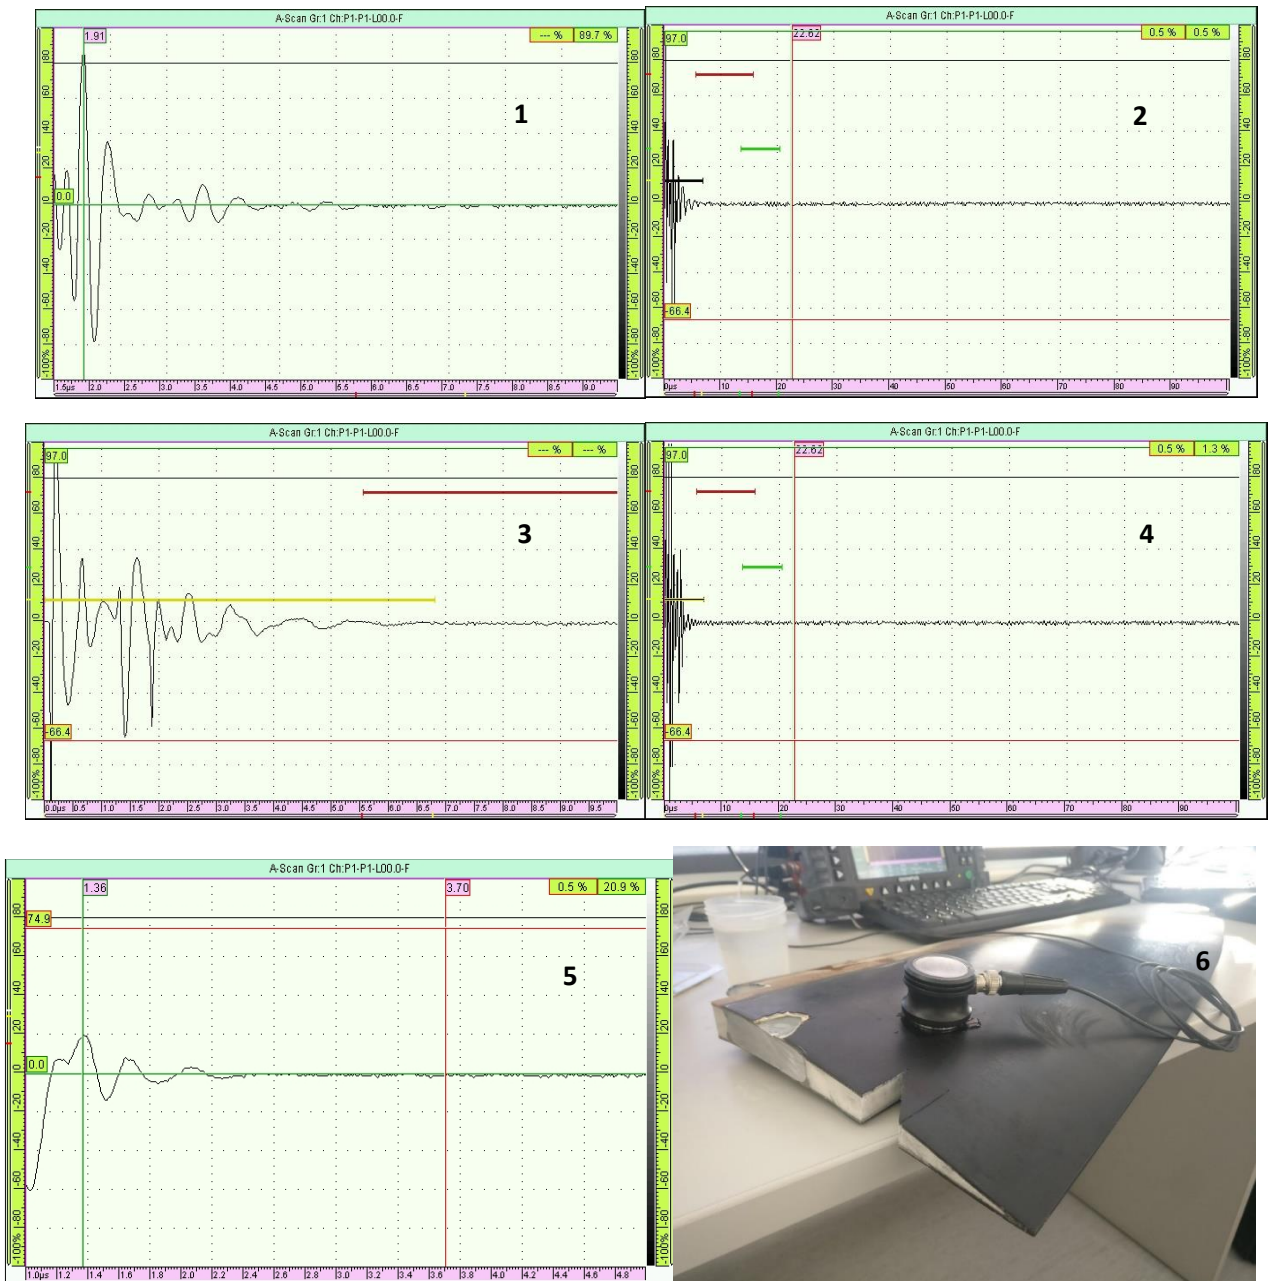
Figure 4-6. Polyurethane foam inspection. 1- point 6 , V126-RM probe, 5 MHz; 2- point 6 V-102 Probe 1Mhz; 3 - point 6 , V-102 probe, 1 MHz; 4- point 8, V104BR probe, 2.25 MHz global view; 5- point 9, 5MHz, probe V126 (no erosion paint); 6 – UT transducer location visual representation at point 8.

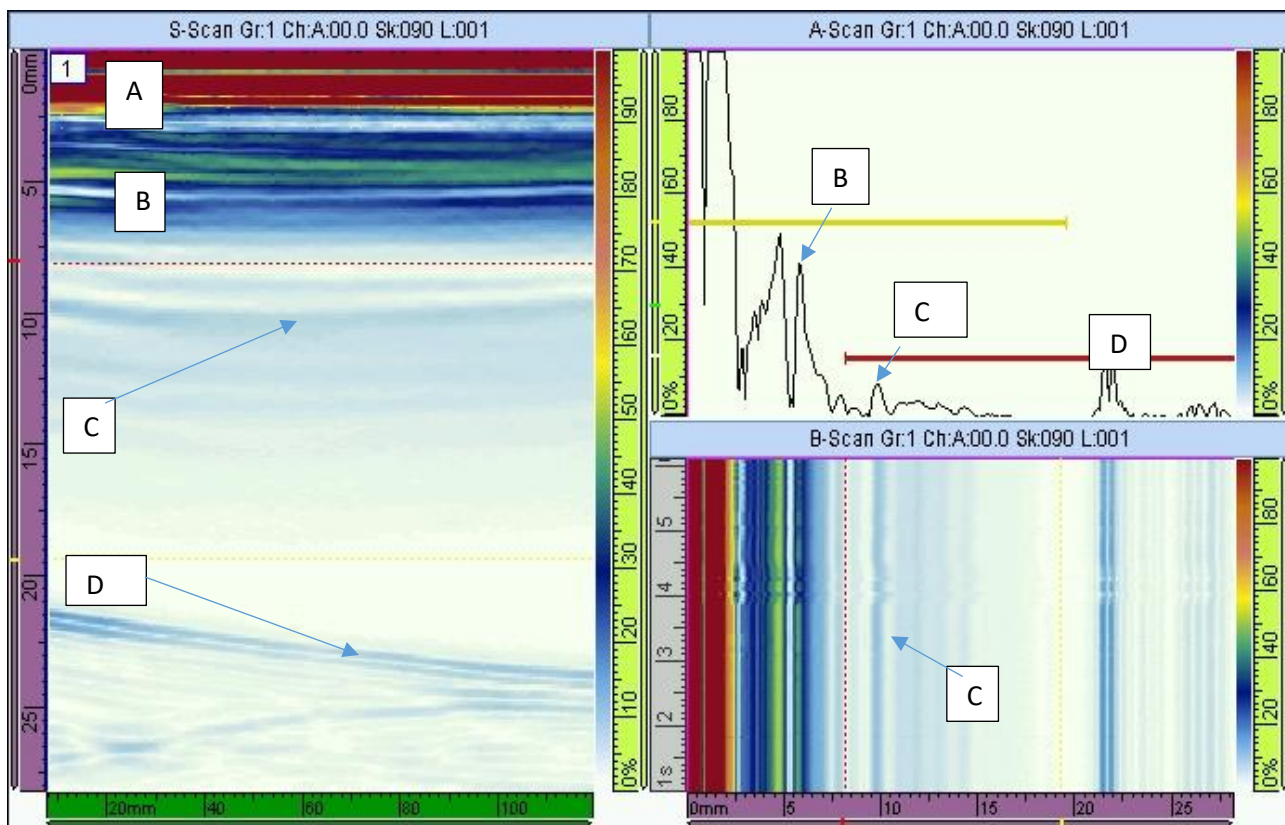
Figure 5-3. A/B/S scans of Linear phased array above the fiber glass-Aluminium- fiber glass layers.

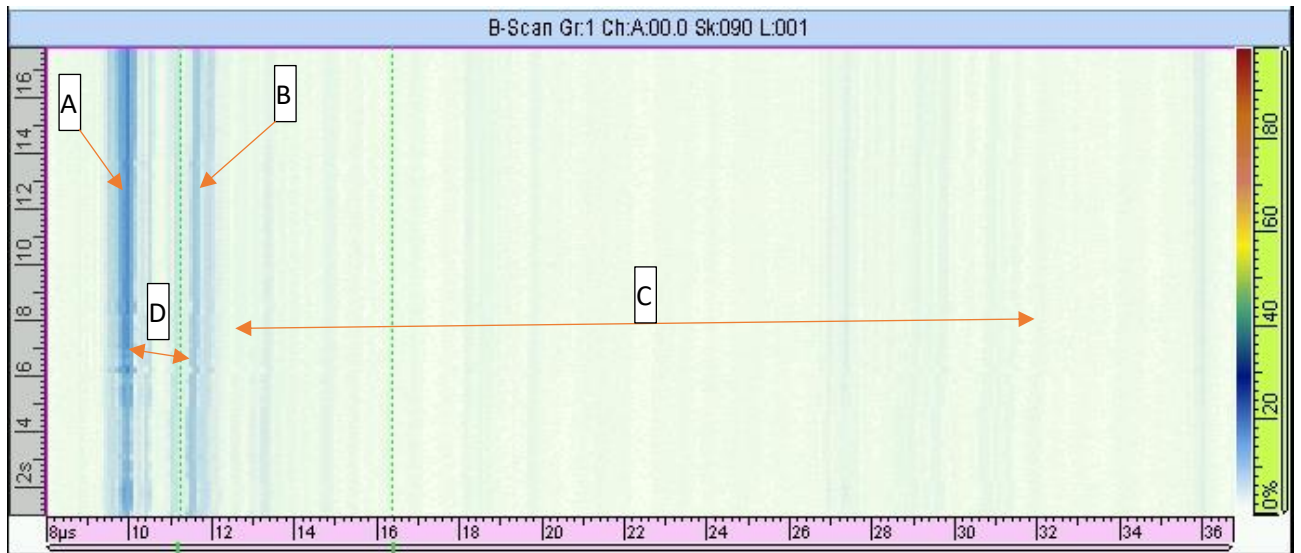
Figure 5-9. 5 MHz PA inspection for fiberglass-foam-fiberglass layers

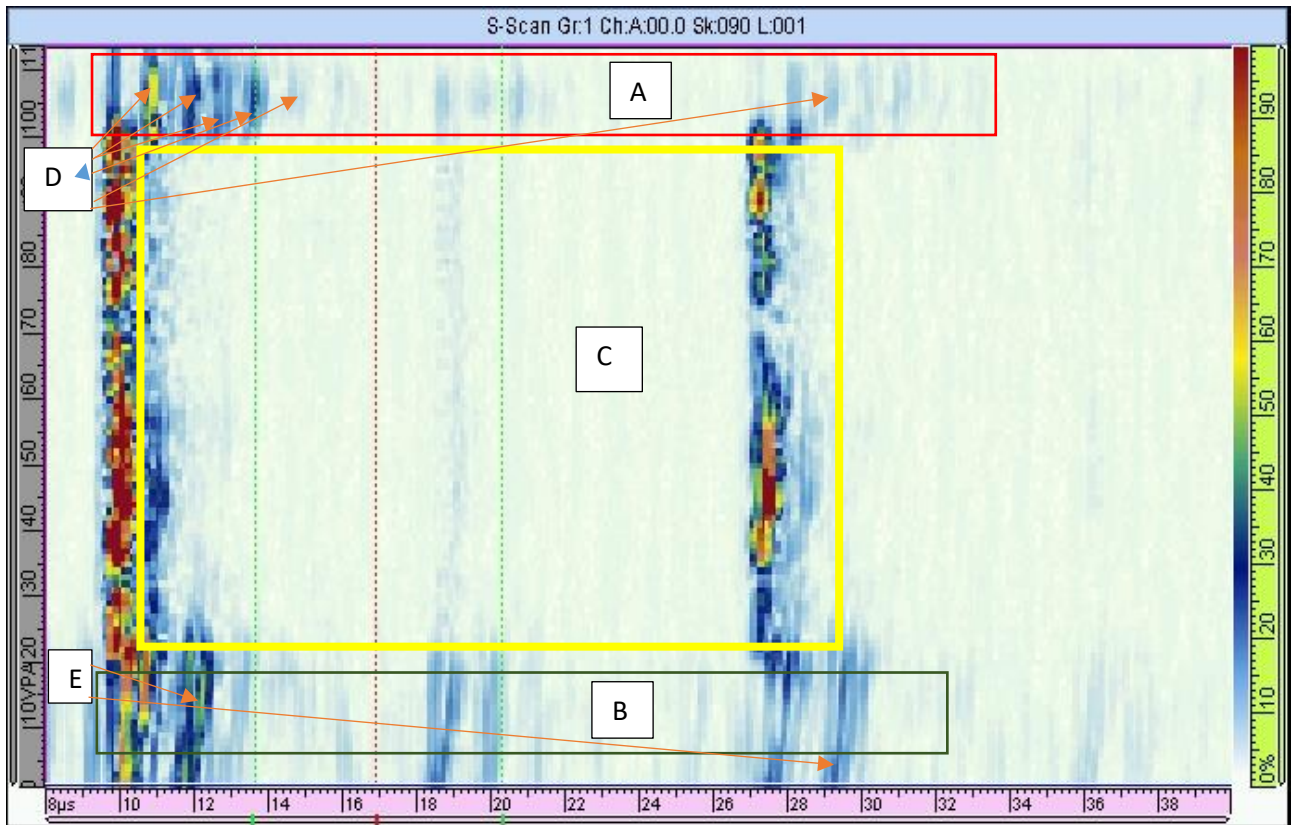
Figure 5-14. Interlayer delamination in top fiberglass (PA 5 MHz)

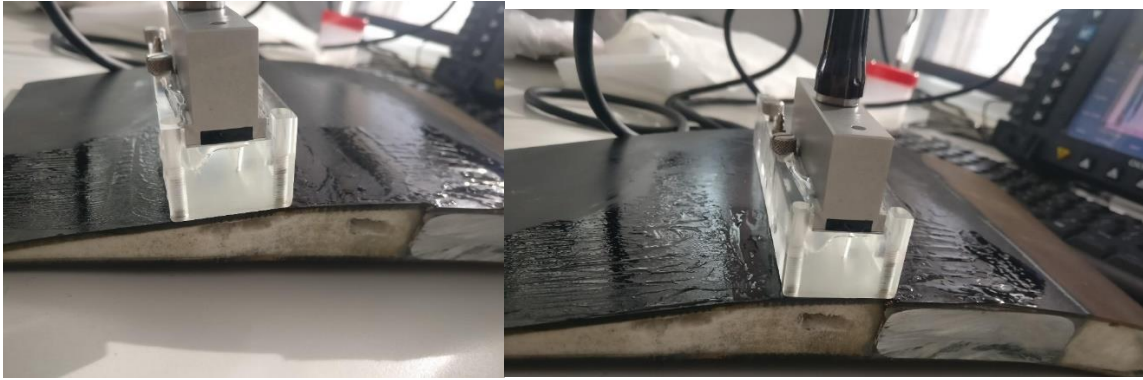
Figure 5-28. Artificial polyurethane foam defects and phased array setup during inspection

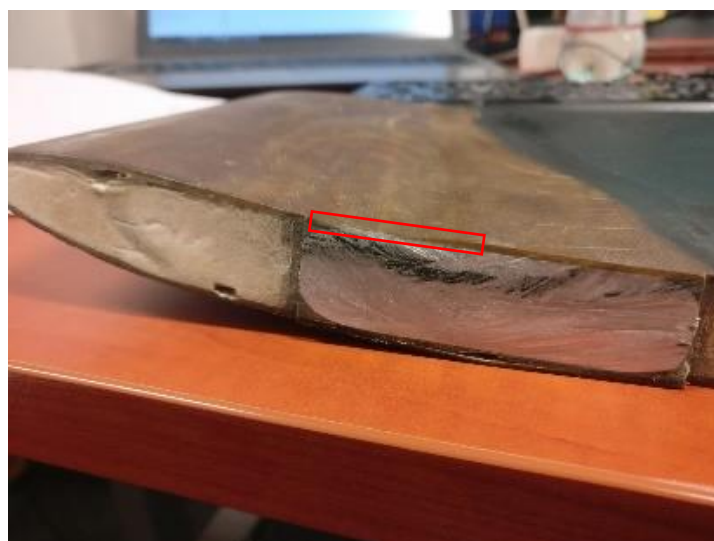
Figure 5-32 – Fiberglass shell blend-out performed to inspect the phased array resolution and sensitivity

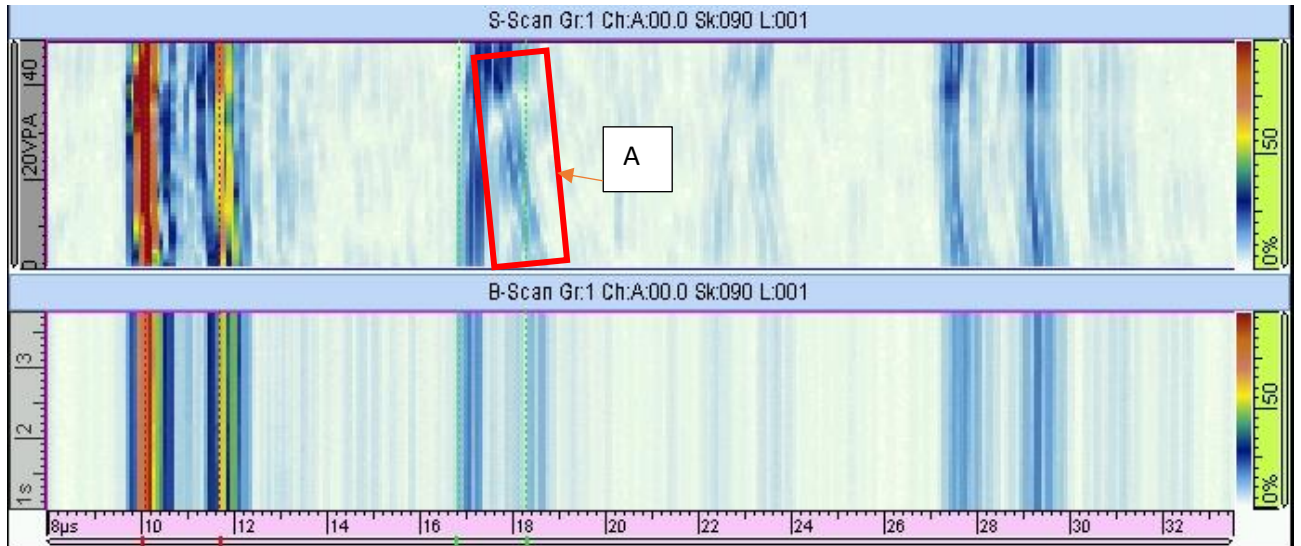
Figure 5-33. Fiberglass thickness reduction detection (PA 3.5 MHz) with focal law
