# Rod End Stress Analysis for Hydraulic Cylinder of Live Floor Conveying System

Evaldas NARVYDAS\*, Romualdas DUNDULIS\*\*, Nomeda PUODZIUNIENE\*\*\*

crossref <http://dx.doi.org/10.5755/j01.mech.26.2.24675>

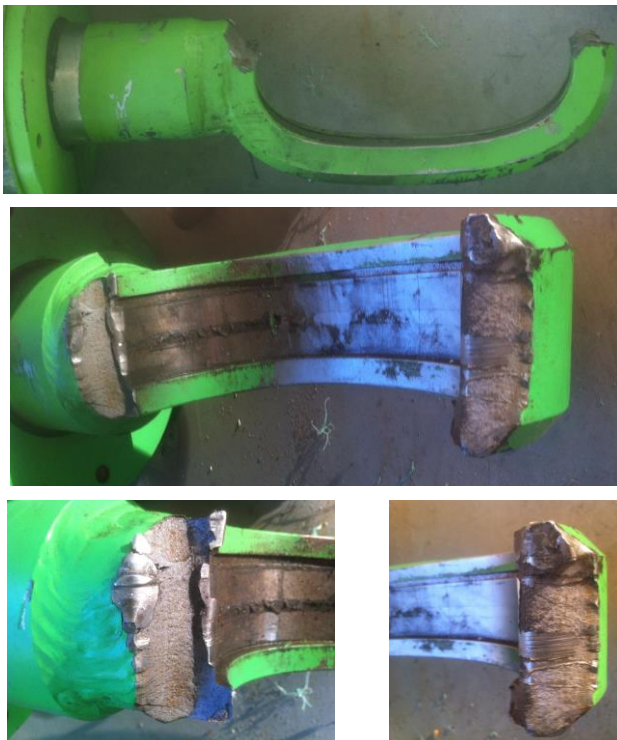
Fig. 1 Photos of the broken eye of the hydraulic cylinder rod

the stresses at the place of failure, therefore only the outer ring, weld and rod were considered for the stress analysis. Geometry of the weld (Fig. 3) was constructed according to design drawings and figures of the actual rod-eye joint (Fig. 1).
