Investigation of Ultrasonic Techniques for Non-Destructive Testing of A-320 Wing Elevator

Master's Final Degree Project

Aeronautical Engineering (6211EX024)

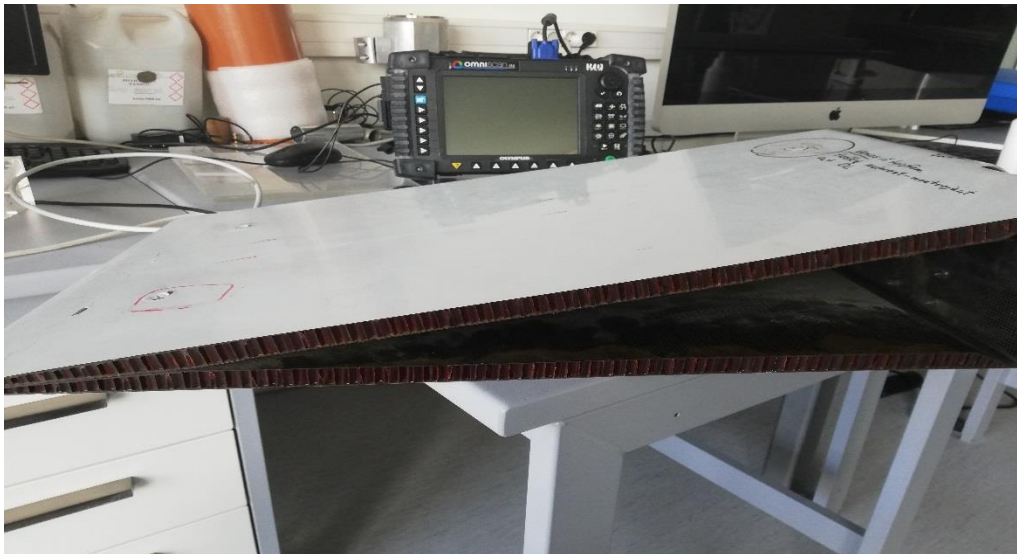
Fig. 1.1. A320 elevator.

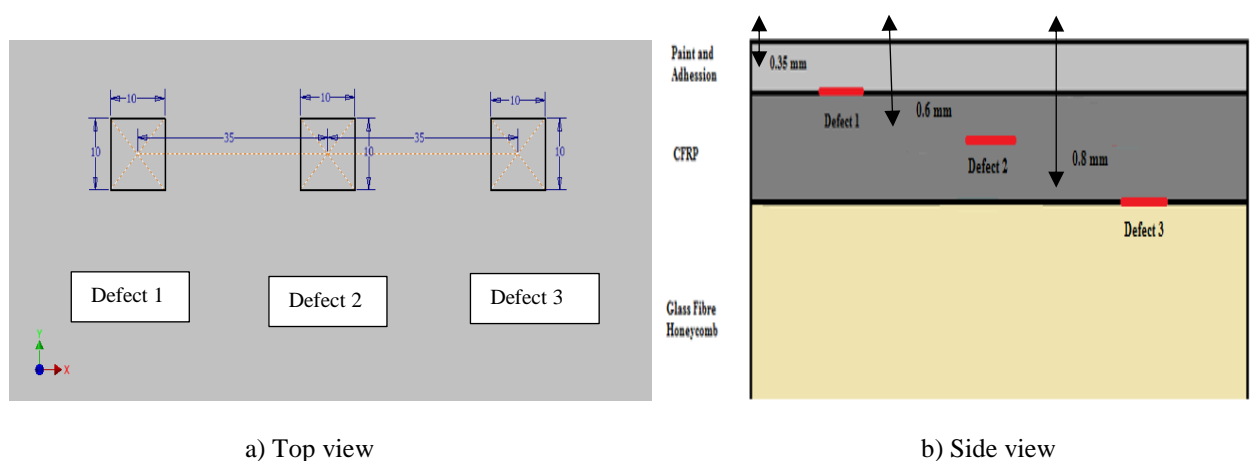
Fig. 4.2. Same size delamination at a different depth.

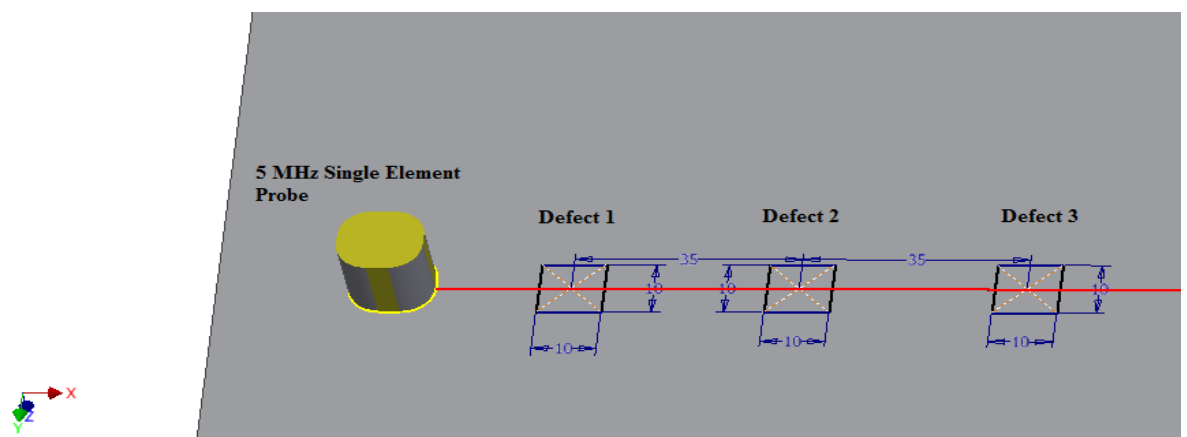
Moreover, the inspection has done on the three different delamination at different depths. the inspection is performed along y direction of a offset x=130 mm and offset y= 52 mm as shown in a figure 4.5.

Fig. 4.5. Inspection of the same size defects

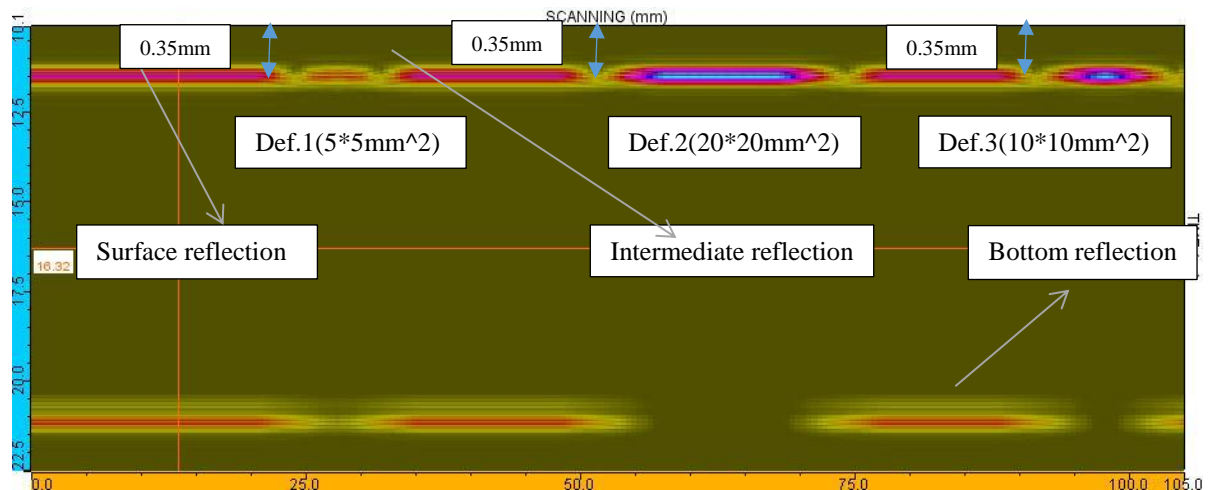
Fig. 5.10. B-Scan at a 0.35mm depth and 5MHz frequency.

Figure 5.10 shows a B-scan image at 0.35mm depth using 5MHz Single Element Transducer, where the sizes of the defects are very clear. However, the color of the intermediate reflections are different due to the variation of the intensity in each defect. The blue color shows high intensity of the defect, while the red color represents low intensity.

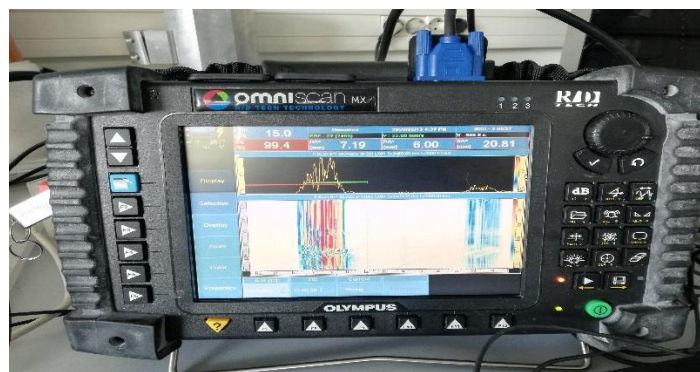
Fig. 8.1. OMNISCAN_{MX} tool.

The PA 5L128-128X7-NW3 transducer is connected to OMNISCAN_{MX} tool. The OMNISCAN_{MX} will automatically detect the type of the connected transducer. The Transducer is attached to a specific wedge SNW3-OL. The wedge is used to separate the signal's reflection between the surface and intermediate reflections of the defects because the inspecting defects are very near to the surface.
