Ultrasonic NDT of wind turbine blades using contact pulse-echo immersion testing with moving water container

E. Jasiūnienė, R. Raišutis, R. Šlīteris, A. Voleišis, M. Jakas

*Ultrasound Institute, Kaunas University of Technology,
Studentu 50, LT-51368 Kaunas, Lithuania*

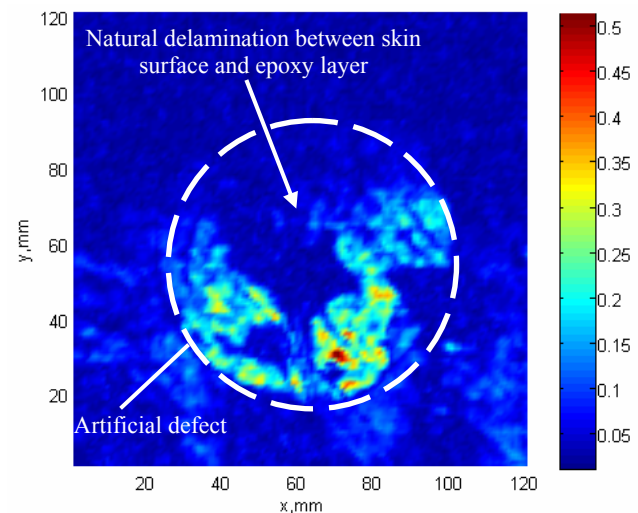
Fig. 7. Ultrasonically obtained C-scan image using the focused ultrasonic transducer (2.2 MHz) of the artificially made internal defect (diameter 81 mm)

The contact pulse-echo immersion testing (using the moving water container) of the wind turbine blade was performed using a focused transducer (Fig. 3) with the scanning step of 1 mm. In Fig. 7 ultrasonically obtained C-scan image of the internal defect (diameter 81 mm) using the focussed ultrasonic transducer is presented. In this case the shape and diameter of the defect can not be reconstructed because of a natural delamination, which was existing in the test sample.

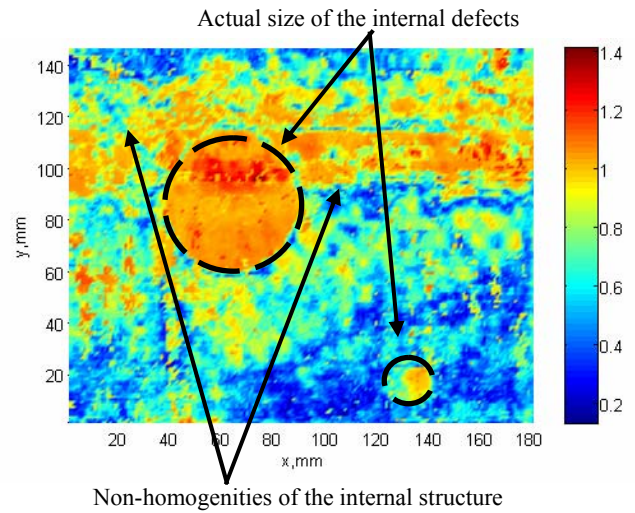
Fig. 8. C-scan image of the internal defects with diameters 19 mm and 49 mm obtained using the 2.2 MHz focused ultrasonic transducer

In Fig. 8 ultrasonic C-scan image of the internal defects (diameters 19 mm and 49 mm) obtained using the focused ultrasonic transducer is presented. In this case the shape and diameter of the bigger defect (49 mm) can be easily reconstructed. The smaller defect (19 mm) can be easily lost between other indications, which show the natural non-homogeneities of the inspected structure.

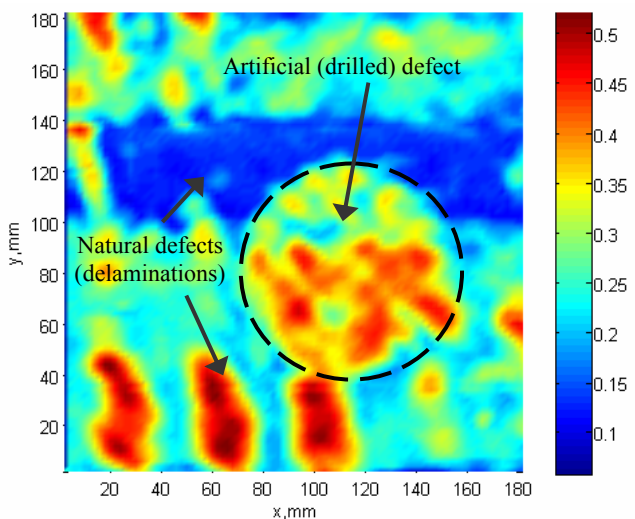
Fig. 9. C-scan image of the internal artificially made defect 81 mm in diameter obtained using planar 400 kHz transducer

In Fig. 9 a raw C-scan image of the defect with the diameter 81 mm, is presented. In Fig. 10 the corrected C-scan image (the reference signal has been subtracted from the raw C-scan image data, the averaged response of the multilayered medium were taken as the reference signal) of the same defect is presented. In this case the defect can be easier recognized and detected.
