Evaluation of Artificial Defects in Additively Manufactured Turbine Blade using Ultrasonic Immersion Testing

Abstract

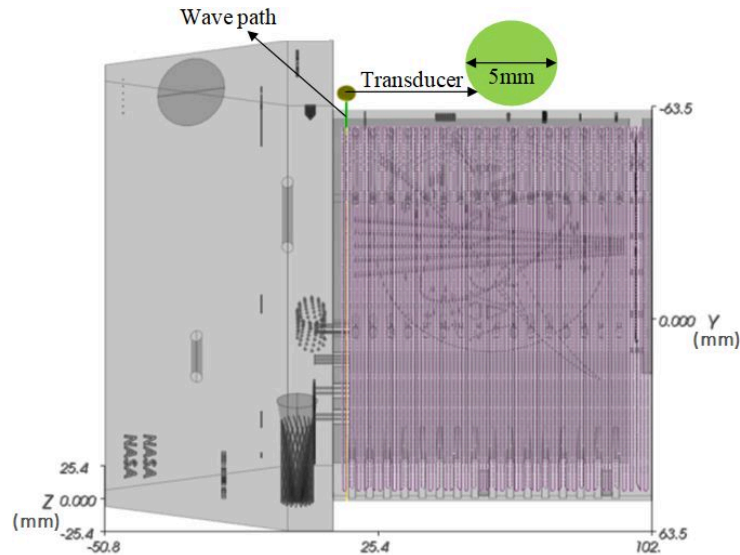
gain of -6 dB. The water path of 14 mm and longitudinal wave type is chosen for the inspection. The surrounding medium water has a density of 1 gm/cm³ and a primary wave velocity of 1483 m/s. The setup for the inspection performed is shown in the fig. 4 below.

Fig. 4 Blade back side immersion inspection setup

The scanning path step along the x axis and y-axis is 0.5 mm and number of steps along the axis and y-axis are 110 mm and 185 mm respectively. The 3D computation zone positioning is linked to the probe as such the computation zone moves along with the movement of the probe, and the computation mode is set to 3D.

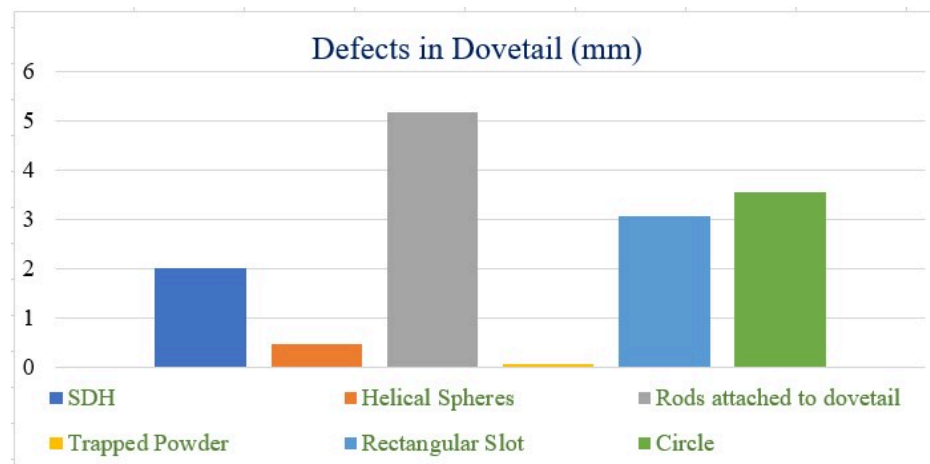
The results shown above (Fig. 3, 5) of the dovetail part with immersion inspection shows the defects in the form of the NASA logo at the top left section, a circular section at the middle, trapped powder like holes (50 microns to 3mm) near the surface of the blade and the dovetail part, rectangular slot of length 3.07 mm in the extreme right and rods connected to the tail part from airfoil (5.18 mm). The defects identified are plotted on a chart with their respective size and are shown below in fig. 6.

Fig. 6 Size of defects in dovetail

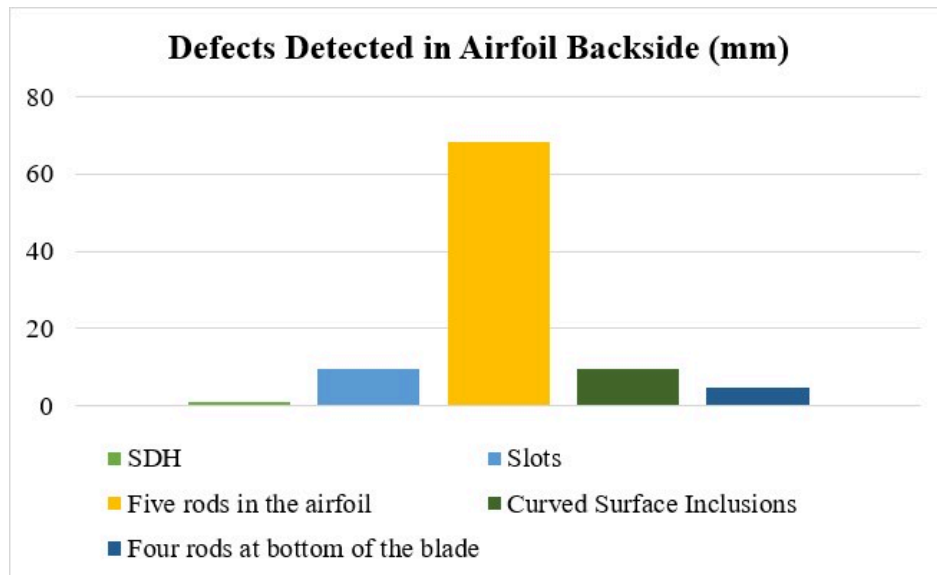
The defects and the size of the defects detected in the inspection are plotted in the chart below shown in Fig 8.

Fig. 8 Defect size in the airfoil section
