# Comparative Analysis of Ultrasonic NDT Techniques for the Detection and Characterisation of Hydrogen-Induced Cracking

**Abstract:** The article is devoted to the investigation of ultrasonic inspection techniques suitable for detecting hydrogen-induced cracking (HIC) and a high-temperature hydrogen attack (HTHA), which are of great importance in petrochemical and refinery industries. Four techniques were investigated: total focusing method (TFM), advanced velocity ratio (AVR) measurement, advanced ultrasonic backscatter technique (AUBT) and time of flight diffraction method using ultra low angle ultrasonic transducers (TULA). The experimental investigation has been carried out on two carbon steel samples cut off from a heat exchanger of an oil refinery and potentially affected by HIC. It was shown that the AVR technique did not reveal any damage and was not effective in the case of the investigated samples due to a thin damage zone with respect to the total thickness of the samples. The AUBT method enabled us to indicate and classify the presence of the hydrogen-induced damage; however, it is complicated to use in practise due to the need perform measurements exactly at the same

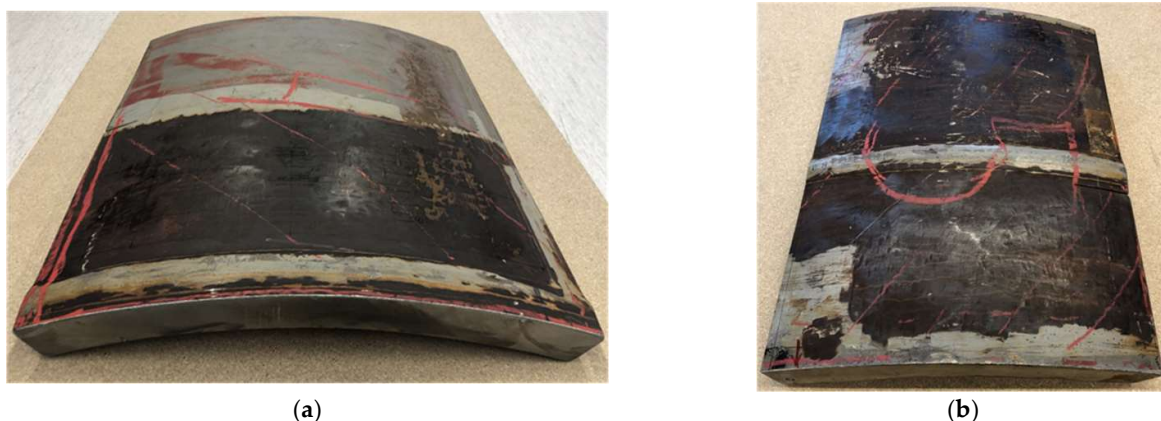
Both samples contained a circumferential weld, as can be seen from Figure 1. Among the abovementioned samples, Sample No. 4 was used for the comparison of HIC inspection techniques—AVR, AUBT, TULA and TFM—while Sample No. 5 was analysed with TULA and TFM only; the results obtained on this sample were, however, supported with a metallographic analysis.

**Figure 1.** Segments of heat exchanger pipe used for comparison of HTHA detection algorithms: (a) sample no. 4 and (b) sample no. 5.

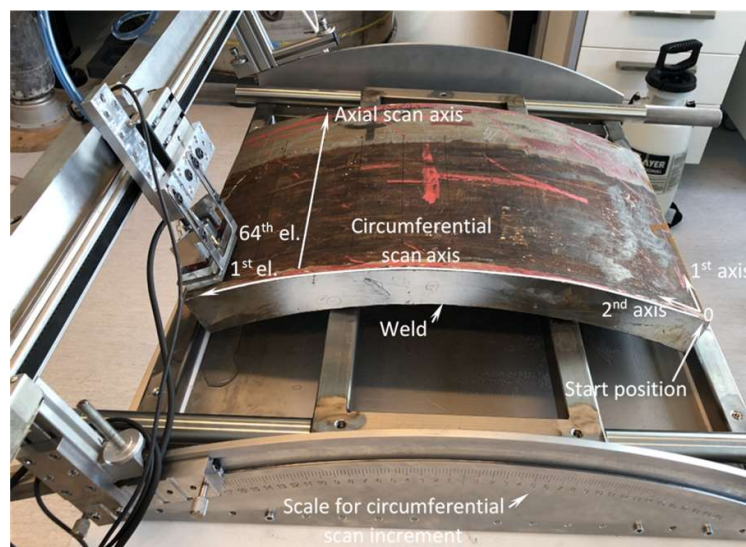
**Figure 2.** Experimental set-up for full surface TFM data acquisition.**Table 2.** Circumferential and axial scan lengths for each test piece under inspection.

The defined axial and circumferential scanning positions established a measurement grid, so each measurement using AUBT, TULA or AVR techniques at discrete positions could be compared both to each other and to TFM. The experimental set-up for full surface TFM scan acquisition is presented in Figure 2.

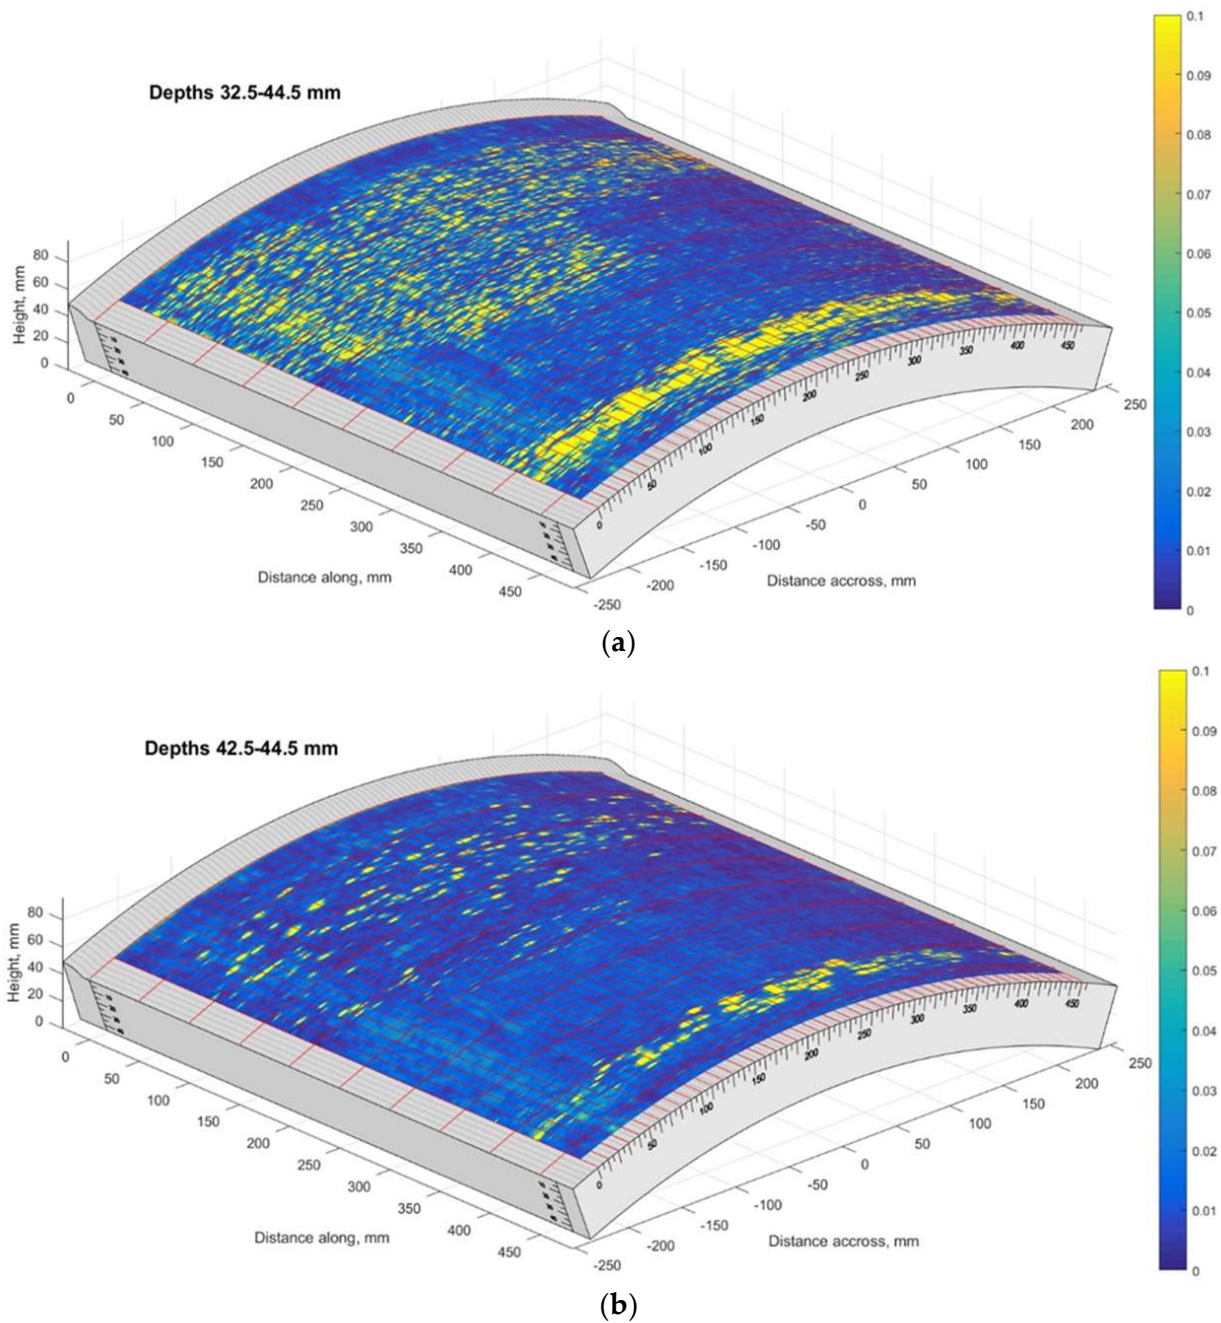
The TFM C-scan results on sample No. 4 are presented in Figure 4. The first part of the figure (Figure 4a) shows the aggregated TFM response over the depth range of 32.5–44.5 mm. The second part of the figure (Figure 4b) presents the likely indications of subsurface blisters (depth range of 42.5–44.5 mm). Here, 44.5 mm corresponds to the overall thickness of the mock-up No. 4.

The results presented above suggest that the HIC damage is distributed non-uniformly. There is a wide non-regular zone close to the weld and an extensive, concentrated region around the circumference 400 mm away from the weld. The TFM B-scan images corresponding to the first (0 mm), middle (229 mm) and the last (457 mm) circumferential scan positions are presented in Figure 5. The results clearly indicate concentrated reflectors, likely voids and cracks, that could be a result of HIC damage at approximately 40 mm depth or 5 mm above the backwall.

**Figure 4.** The TFM scan of the Sample No. 4: (a) depth range of 32.5–44.5 mm; (b) depth range of 42.5–44.5 mm. Vertical colour bar represents the peak-to-peak amplitude in arbitrary units.

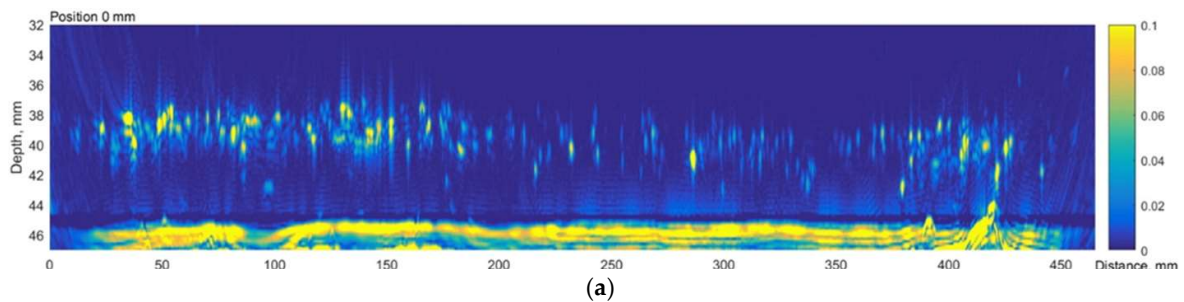
**Figure 5.** The axial scan B scan images of the TFM reconstruction: (a) at 0 mm; (b) 229 mm and (c) 457 mm circumferential locations. Vertical colour bar represents the peak-to-peak amplitude in arbitrary units.

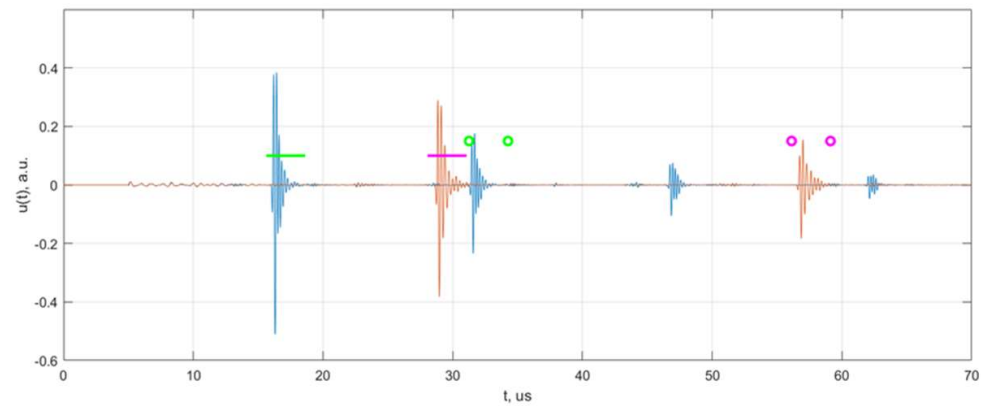
The propagation times of longitudinal and shear waves were measured using a cross-correlation method. The example of longitudinal and shear wave signals obtained at the first measurement location is presented in Figure 6.

**Figure 6.** The measured signals of longitudinal (blue) and shear (red) waves. Horizontal lines indicate the time windows for the first backwall reflection, the circle markers show time gates for the second backwall reflection.

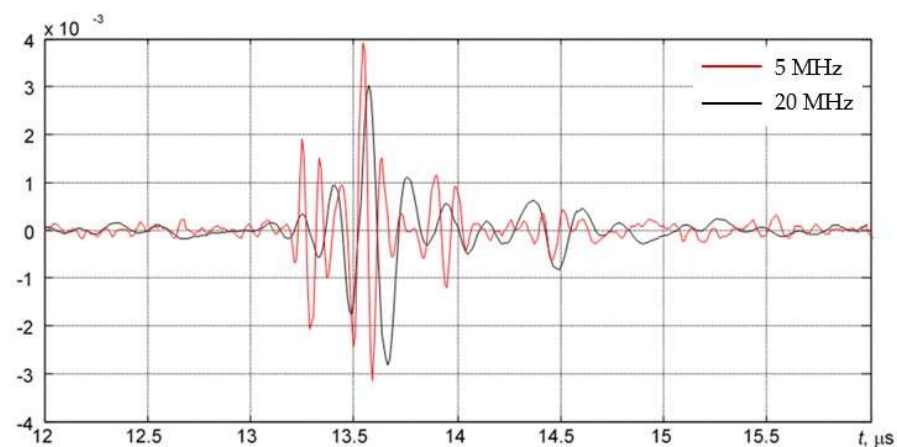
The AUBT-1 and AUBT-2 locations coincide with the AVR measurements at AVR-1 and AVR-4. The AUBT-3, AUBT-4, and AUBT-5 are acquired at different locations than AVR. The results of AUBT measurements are presented in Figures 8–12. The figures show waveforms of ultrasonic signals, obtained at two frequencies—5 MHz and 20 MHz and the corresponding TFM images—illustrating the AUBT measurement position.

**Figure 8.** The waveforms of the received signals at the point AUBT-1 with 5 MHz (black) and 20 MHz (red) transducers.

The results presented in Figures 8–12 indicate that AUBT shows the presence of HIC at some of locations. At the AUBT-1 measurement position, which, according to the TFM image, is HIC free, the amplitudes of the noise behind the first reflection are similar, which, according to the AUBT, indicates absence of HIC. The results on other measurement positions show a big difference between 5 MHz and 20 MHz signals; the tail amplitude of the 5 MHz signals is higher with respect to the tail amplitude at 20 MHz. In contrast to AVR measurements, the AUBT technique seems to be capable of discriminating HIC defects. For example, at the coinciding measurement point (AUBT-1 and AVR-1), both AVR and AUBT were absent of HIC. In the case of the AUBT 2 and AVR-4 measurement point, HIC was detected by AUBT only.

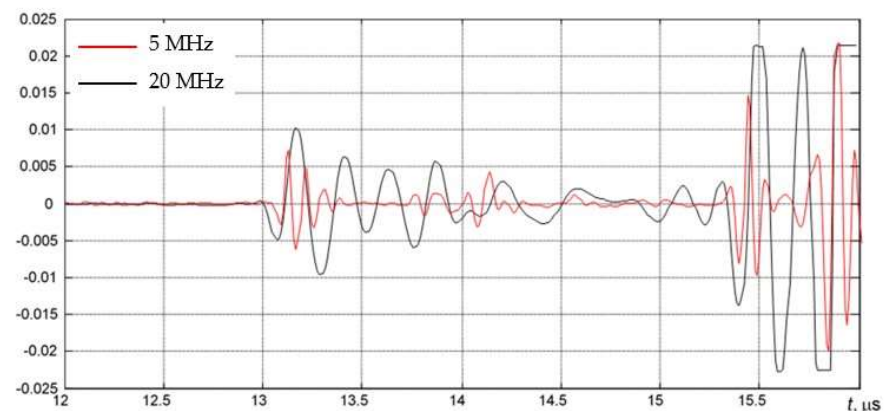
**Figure 9.** The waveforms of the received signals at the point AUBT-2 with 5 MHz (black) and 20 MHz (red) transducers.

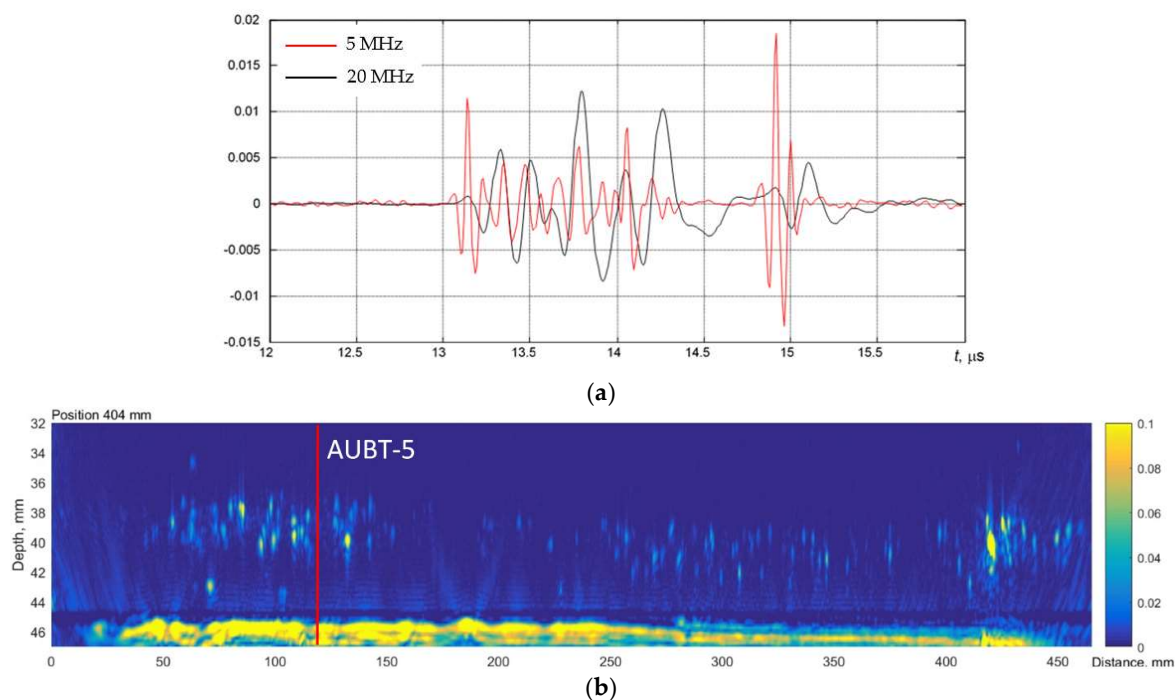
**Figure 12.** (a) The waveforms of the received signals at the point AUBT-5 with 5 MHz (black) and 20 MHz (red) transducers and (b) the corresponding TFM image, showing the appropriate AUBT measurement location. Vertical colour bar represents the peak-to-peak amplitude in arbitrary units.

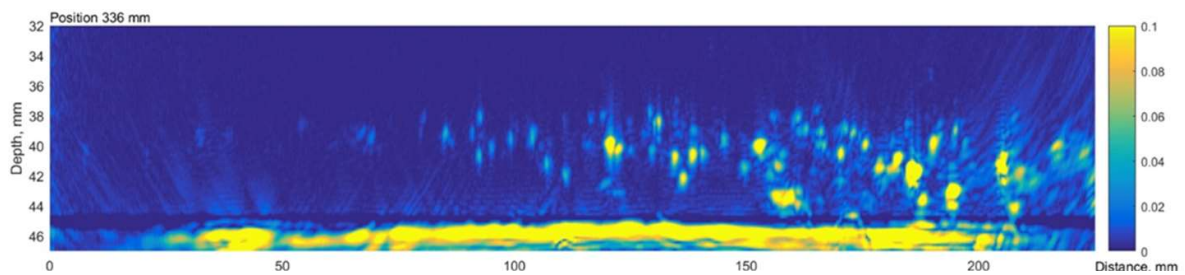
**Figure 19.** B-scan of the sample No.5 along the edge obtained by the TFM. The B scan corresponds to the section line, where the pipe was sliced before the metallographic examination. Vertical colour bar represents the peak-to-peak amplitude in arbitrary units.

The results presented above show that at a distance of 0–50 mm from the weld there are no indications at all; however, from 60 till 210 mm, the B-scan shows a significant amount of reflections located at depths from 35 mm till 44 mm.

A comparison of metallographic images (Figures 21–29) with the results obtained using TFM (Figure 19) revealed a good correlation. In the first section (distances 60–88 mm), TFM images did not show any indications. At the same time, metallographic analysis found only a minor number of small blisters with dimensions around 20 μm. Such size defects are not visible for ultrasonic inspection at frequencies used in this study. An additional problem is caused by the fact that they are situated very close to the wall of the inner surface and cannot be indicated by any of the used techniques due to strong backwall reflection.

In section No3 (distances 142–198 mm), multiple cracks reaching sizes over 2 mm can be observed, which are indicated in TFM images by a strong concentrated reflection. Such a level of HIC damage can easily be detected by TFM (Figure 19).

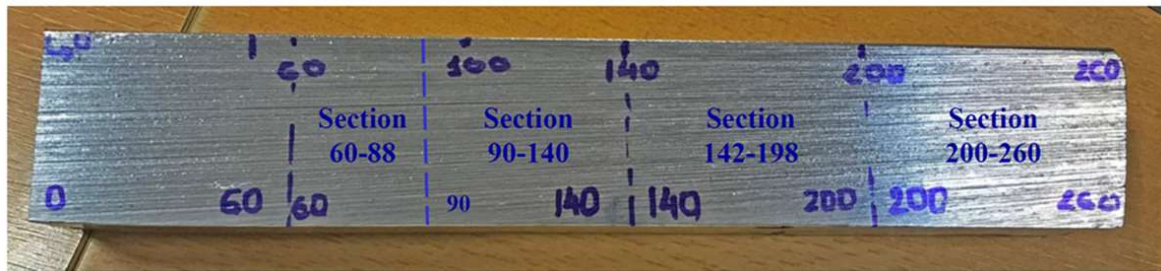
Metallographic examination of a microstructure was performed in the DEKRA laboratory to verify the ultrasonic testing results. The slice was divided in four sections (60–80 mm, 90–140 mm, 142–198 mm and 200–260 mm) as presented in Figure 20. In the following paragraphs, metallographic images of each section are presented.

Figure 20. Examined section's general view.

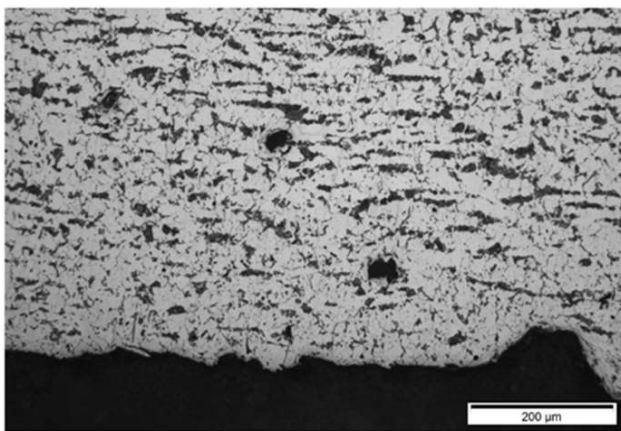
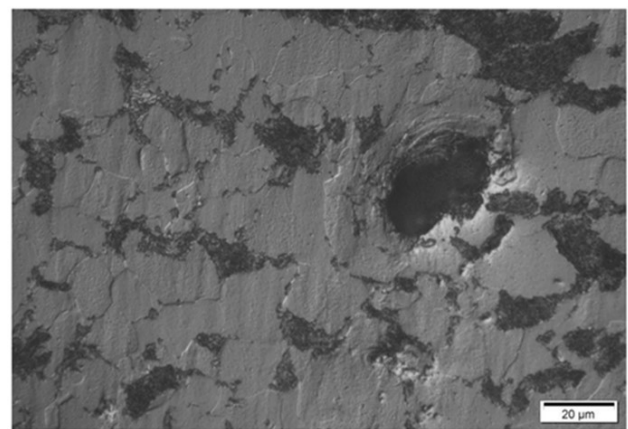
Only isolated HIC blisters were revealed at coordinates 70 mm area (see Figure 21). Discontinuities are located near the internal diameter (ID) surface (max. 0.4 mm from ID).

Figure 21. Section No1: 60–88. Coordinate 70 mm, isolated HIC blisters, micro deformation in discontinuity area, magnification 200× (a), 1000× (b).

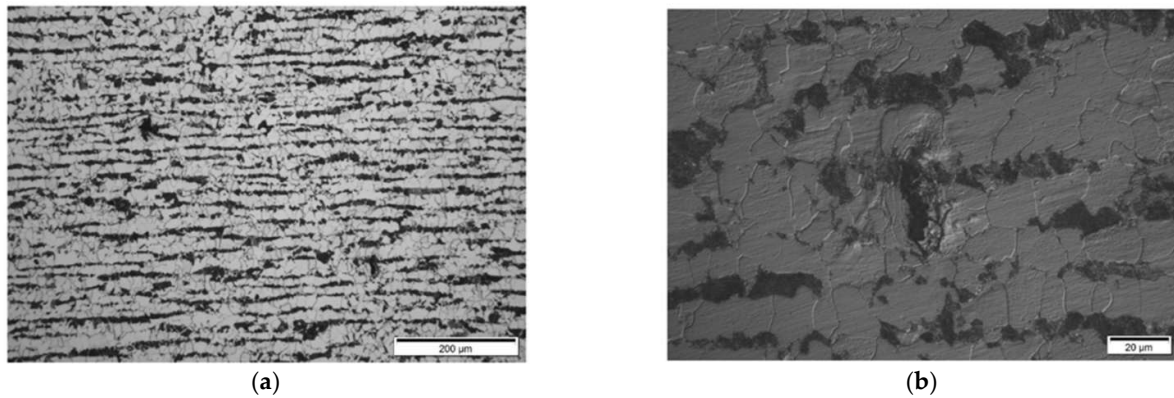
Hydrogen-induced damages such as hydrogen-induced cracking, stepwise cracking, straight cracking and blistering cracking, starting from the coordinates 120 mm onwards, were observed (Figures 22–24). The maximum depth of defects location in this section is 8.8 mm from ID (37.2 mm from the outer diameter OD, e.g., UT scanning surface). Decarbonised traces originating from the shell ID are clearly seen in the section of the steel microstructure.

**Figure 22.** Section No2: 90–140. Coordinate 120 mm, 6.2 mm from ID. Isolated HIC blister, magnification 200× (a), 1000× (b).

In section No2 (distances 90–140 mm), metallography shows multiple defects with dimensions 20 μm to 200 μm. The TFM data also show multiple, relatively low amplitude indications. So, it can be stated that the TFM method enabled the detection of HIC damage when a single crack reaches dimensions close to 200 μm. As a result of the good correlation between TFM and TULA measurements, as shown in the previous section, it was expected that TULA could also successfully detect these indications.

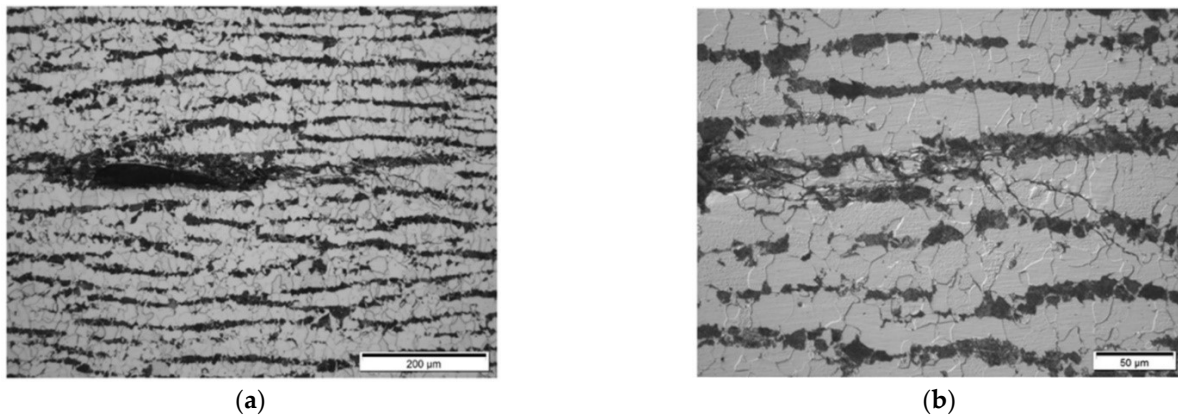
**Figure 23.** Section No2: 90–140. Coordinate 135 mm, 6.8 mm from ID, blistering cracking in pearlite band, magnification 200× (a), 500× (b).

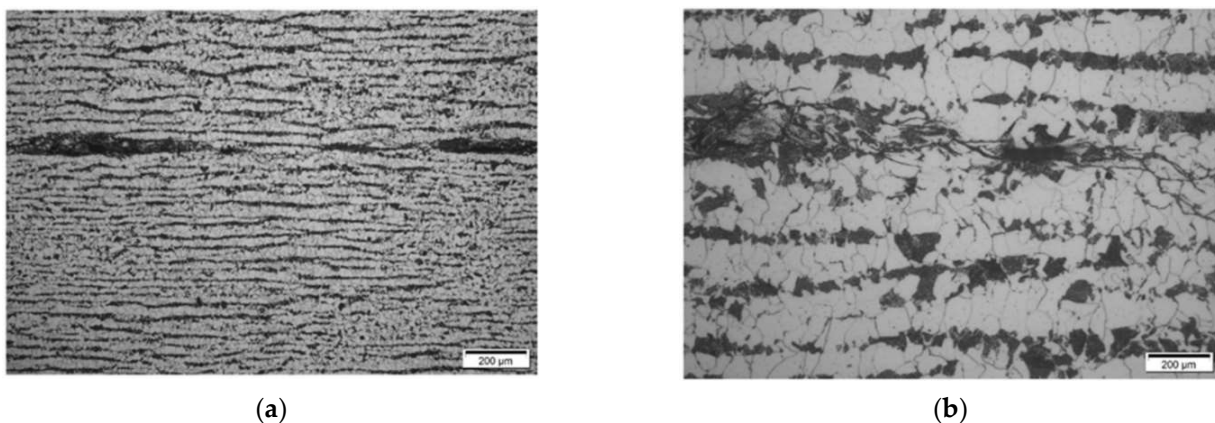
**Figure 24.** Section No2: 90–140. Coordinate 130 mm, 8.8 mm from ID, straight cracking in pearlite bands, magnification 100× (a), 500× (b).

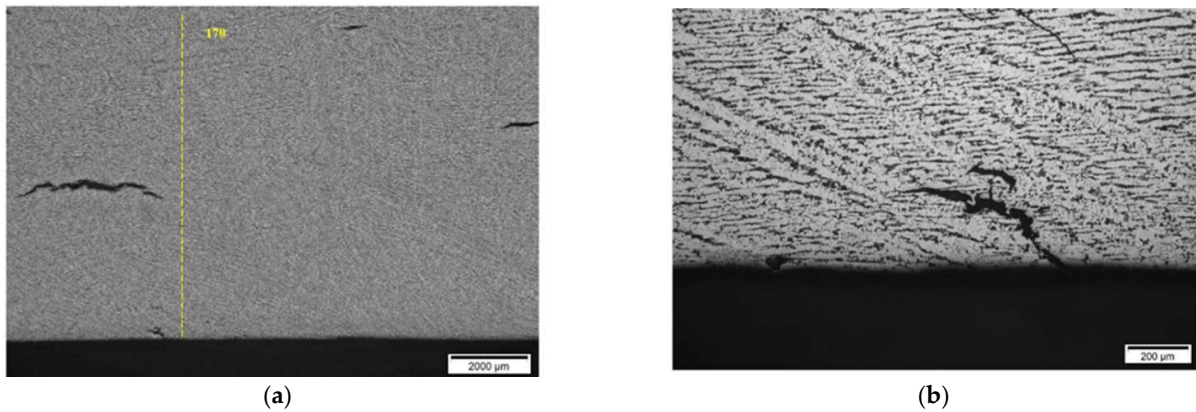
Hydrogen-induced damage such as hydrogen-induced cracking, stepwise cracking, straight cracking, blistering cracking were observed (Figures 25–27). The maximum depth of defects location in this section is 8.8 mm from ID (37.2 mm from OD). Decarbonised traces originating from shell ID are also clearly seen in the section of the steel microstructure.

**Figure 25.** Section No3: 142–198. Coordinate 170 mm. Magnification 12.5× (a), Cracking near ID surface, magnification 100× (b).

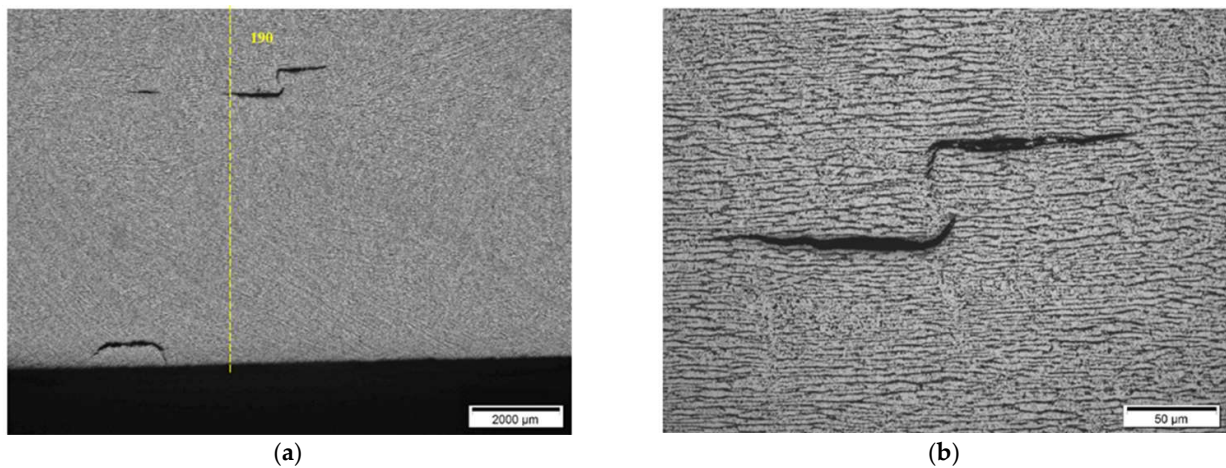
**Figure 26.** Section No3: 142–198. Coordinate 190 mm. Magnification 12.5× (a), 6.1–6.5 mm from ID, stepwise cracking magnification 50× (b).

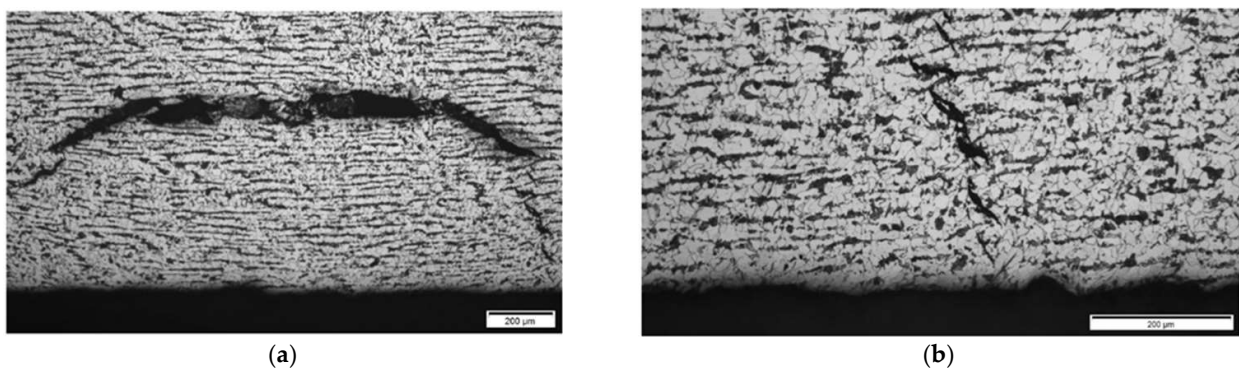
**Figure 27.** Section No3: 142–198. Coordinate 193 mm, blistering cracking magnification ×100 (a), stepwise cracking connected to ID, magnification 200× (b).

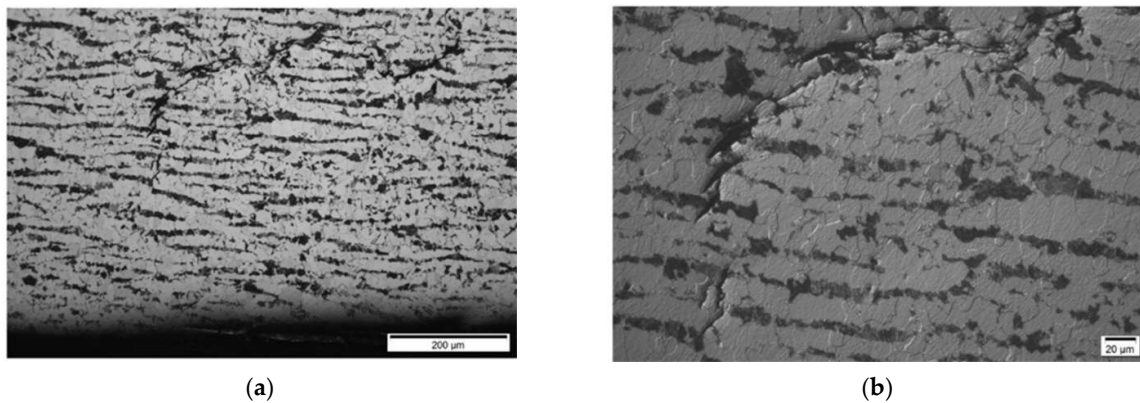
**Figure 28.** Section No4: 142–198. Coordinate 190 mm. Magnification 12.5× (a), 6.1–6.5 mm from ID, stepwise cracking magnification 50× (b).

Hydrogen-induced damage, as mentioned above, such as hydrogen induced cracking, stepwise cracking, straight cracking, blistering cracking, were observed (Figures 28 and 29). The maximum depth of defects location in this section is 8.0 mm from ID (or 38.0 mm from OD (UT scanning surface)). Decarbonised traces originating from the shell ID are also clearly seen in the of the section steel microstructure.

In the last analysed section No4 (distances 200–260 mm), cracks with sizes up to 2 mm are detected by metallography, correspondingly indicated in the TFM images, although the image is not so sharp. It can be noticed that in TFM image, the back wall reflection is almost absent, but indications of a crack are present. This is due to the fact that this section is at the edge of the sample and the phased array was not fully scanned in this zone. On the other

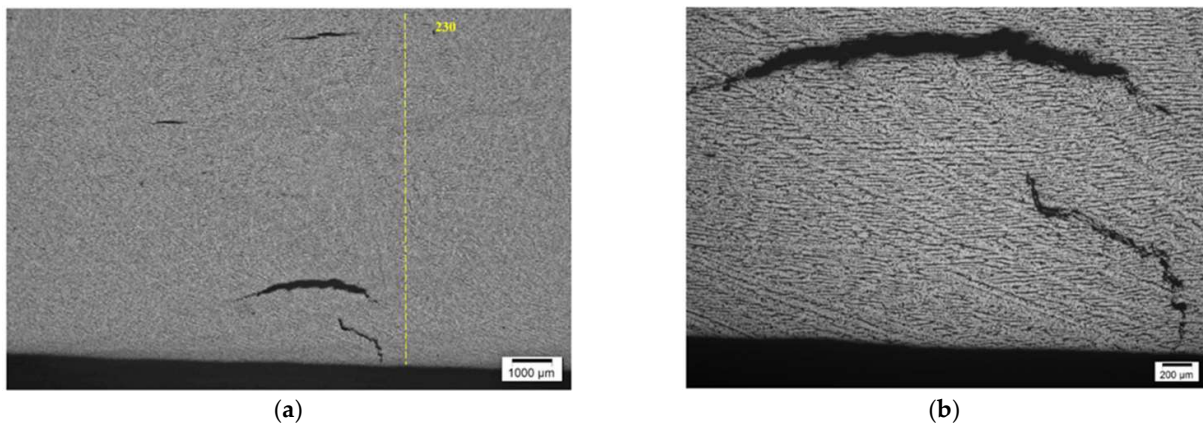
**Figure 29.** Section No4: 142–198. Coordinate 190 mm. Magnification 12.5× (a), 6.1–6.5 mm from ID, stepwise cracking magnification 50× (b).
