Experimental investigation of low-velocity impact on woven glass-fibre-reinforced plastics composites

The objective of this study is to investigate the effects of impact energy of the low-velocity impact on woven glass-fiber-reinforced composites and is to compare absorbed energy and damaged area of woven- and multi-axial non-crimp fabric composites. Here the effects of the propagation of stress waves through the material are negligible, the structure has time to respond to the impact. Following the impact tests, the laminates were examined visually for the extent of damage.

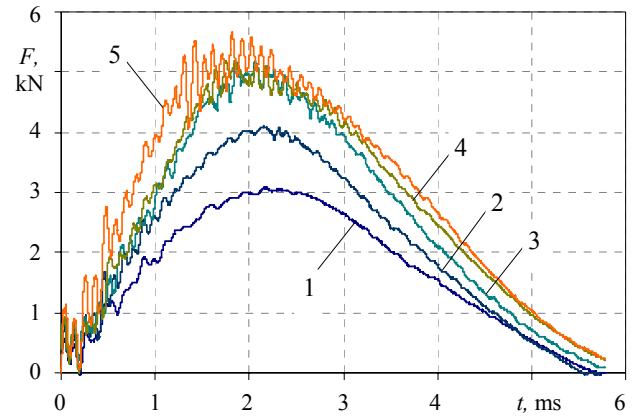
Fig. 4 compares typical load-time curves (F , kN - t , ms) for glass-fibre composite laminates with incident impact energies in the impact tests varied between 6 and 28 J and impact velocities between 2.54 and 4.63 m/s, respectively.

Fig. 4 Force-time curves of the impact test on glass fibre/epoxy matrix composites and the exclusion line: 1 - 6 J (2.54 m/s); 2 - 10 J (3.25 m/s); 3 - 16 J (4.08 m/s); 4 - 22 J (4.11 m/s); 5 - 28J (4.63 m/s)

It can be seen for the low energies impact of about 6 J that the woven-fabric laminates constantly exhibit high plateau load of 3.08 kN until it decreases gradually to zero. But at higher energies, the peak becomes sharper as damage occurs under impactor with the larger total displacement. After an impact time of about 6 ms, the force remains constant, indicating that the damage process is completed.

2. The peaks of impact load in the case of low-velocity impacts of about 10 and 16 J impact energy increase by 32 and 25% respectively. But at the impact energy of 22 J the lower increase of the peak is observed.
