The Development of Image Analysis Method for Automated Textile Quality Control System

Master's Final Degree Project

Industrial Engineering and Management (6211EX018)

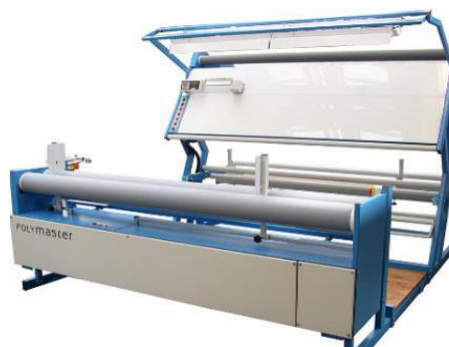
The IMR is a machine that is capable of inspecting a full-size material and also there is add on advantage for the inspector to have a close look of the material. This IMR lets the operator work safely in hands as the fabric gets rolled in the powered rollers behind them with automated edge cutting technology. This machine is available in compact forms and comes with overhead lighting for the supervisor to detect the flaws. The speed of the material rolling here can be regulated accordingly [5].

Fig. 7. Polymaster IMR[11]

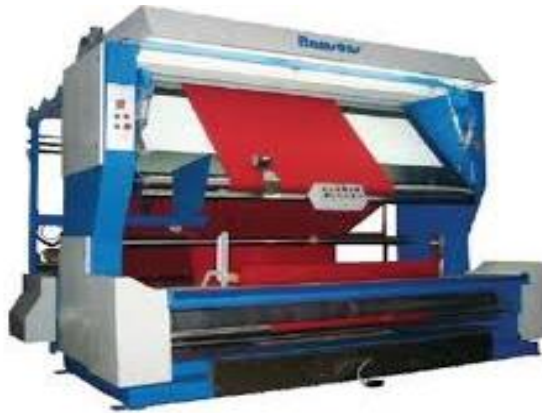
Ramson's checker is a machine which can visually inspect the defects in the fabric material; this is a more developed machine than the machines discussed before in this section. The inspecting machine has more features compared to the later; it holds an illuminating light brighter enough to expose the flaws on the rolling fabric. The gearbox on the front is used to regulate the speed and measure the

length of the fabric entered here. This machine is being used globally all over for the purpose of inspection. After the inspection of the material, the defects are measured and noted in the fabric inspection chart and later sent to the next level of the quality department for calculating defect points, which is compared with the 4-point inspection system according to ASTM D 5430-04 standards and then material is evaluated by the supervisor.

Fig. 8. Ramson's checker

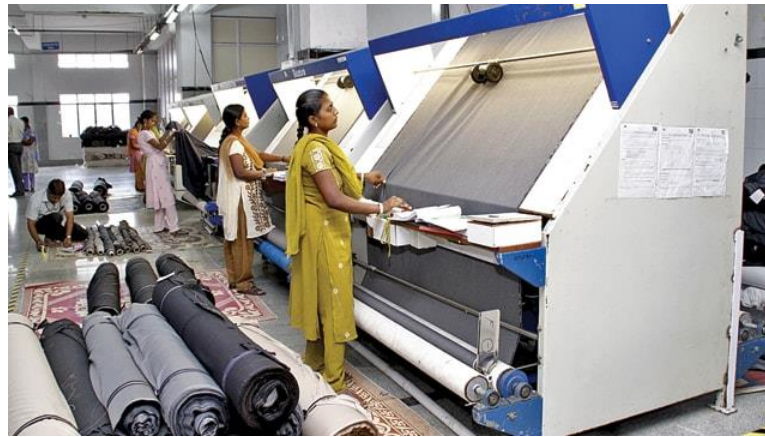
The rolled fabric is installed inside the fabric inspection machine. The company uses Ramson's checkmate (Fig.11). The checker stands here and examines flaws under the light to view the defects

Fig. 11. Ramson’s checkmate

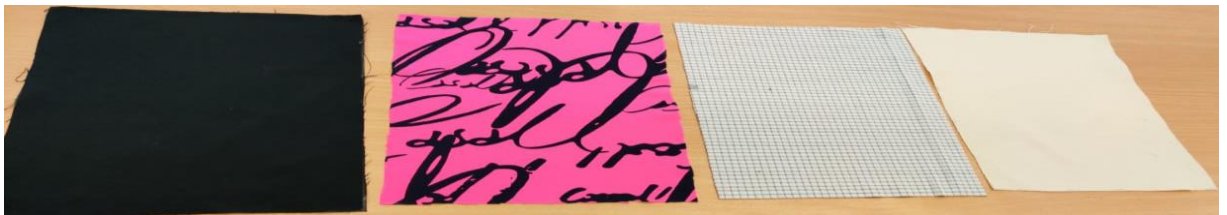
Fig. 12. Knitted fabric samples

For the Experiment analysis, various types of knitted fabric were chosen (Fig.12.) The sample fabric is cut in a dimension of 21×29.7 cm (A4 paper size) from the whole lot. The samples are of different kind of composition and properties (Table.3)

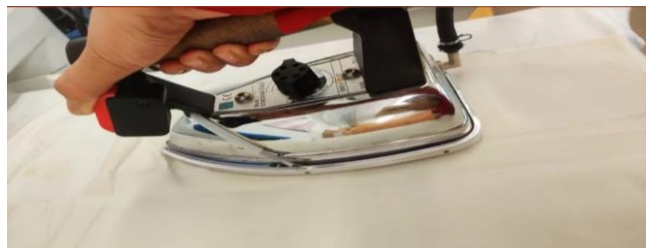
The selected material has to be wrinkle-free with a good shape to attain this; we use an iron box and gently press the material with care and make it steam pressed (Fig.13).

Fig. 13. Making the fabric wrinkle-free

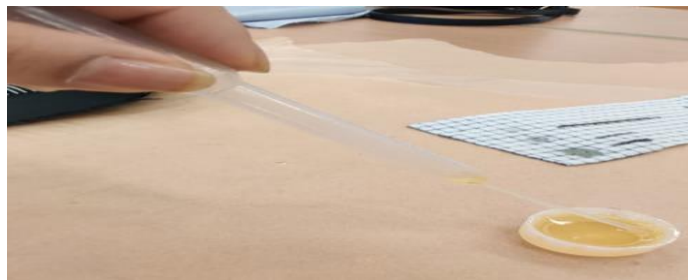
Fig. 16. Filling the dropper with oil

1. Take a little amount of oil with the help of a dropper, as shown in Fig .16.
2. Drop it in the testing material in a desired shape and size (Fig .17).

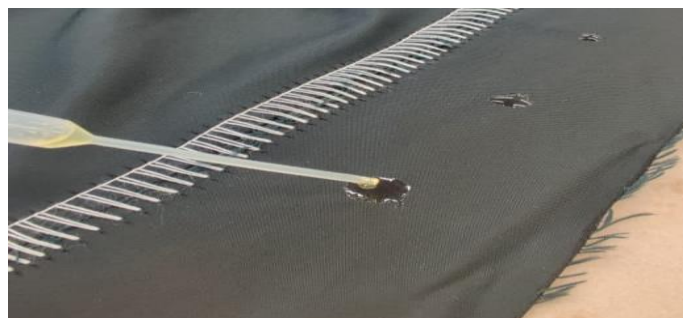
Fig. 17. Dropping oil to make stains

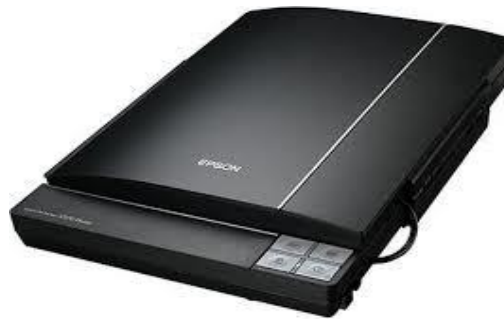
Fig. 23. V370 Epson scanner

For the experimental purpose, we use this(Fig.23) scanner since the sample size is (21×29.7) cm that is of an A4 sheet paper dimension. After scanning these images, the fabric is analysed with the help of Image J software, where the fabric material is analysed with different kind of filters for easy analysing technique.

This process of accumulating the image sometimes fails in capturing the image with the original resolution, since there are chances of image dispersion due to the intensity of light, exposed and with quality of the camera. To eliminate this kind of abnormalities capturing the images, Epson scanner V370 is used to scan the material with built-in transparency unit for easy scanning and also operates on a high optical resolution of 4800 dpi Moreover, CCD (charged-coupled device) technology and ready scan LED technology makes this scanner give high quality and precision images. (Fig .22).

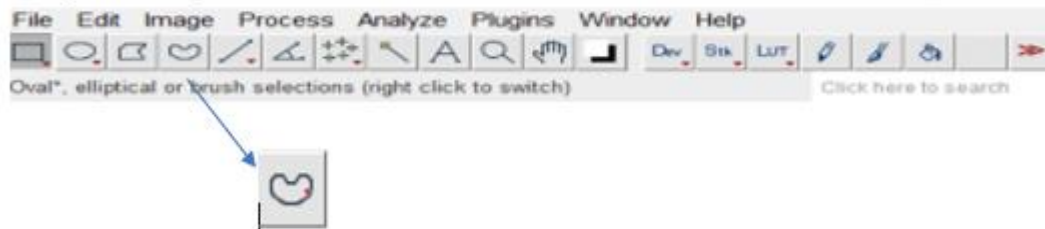
6. Some of the defects can be measured by taking outline for the image, for defects such as oil stains D3-O, use the tool as given here:

Fig. 28. A tool to measure irregular defects

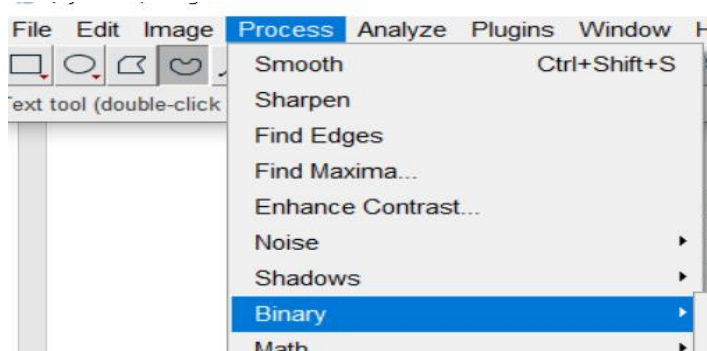
Identification of flaws from the primary image is sometimes difficult to analyse due to the complexity of the design, texture and colour of the material. Material with dark and thick material can be converted to a binary image with a binary filter option, applying this can lead to easy detection voids and contrast defects. The navigation to set this filter is depicted (Fig .31).

Fig. 31. Converting primary image to binary images

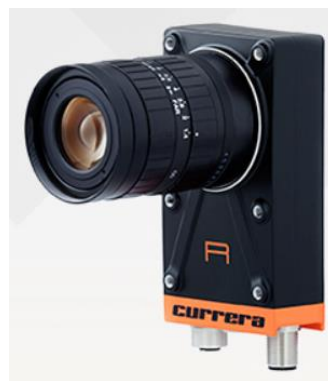
Fig.59. QEYE cameras designed for quality inspection

QEYE cameras can be used for our proposed method for capturing the image with more precision; these cameras were designed especially for quality inspection in the textile industry which comes with smart detection of coloured variation flaws, holes and cuts.

laboratory setup, for implementing the same in industries requires setup of large scanners and big screens. The *Image-J* software plays the main role in the analysis of the flaws here, with better methods of scanning suitable for large industrial purposes it could serve as an efficient tool. This method can be performed with more ease if the image scanning is done using scanners which can scan the materials in large quantity for industrial production. The scanned material if viewed on big screens can be more efficient in finding the flaws since the defects, even if minor, is enlarged on the screen. The experiment we performed here was under laboratory setup which if done with big scanners and viewed under big screens for example high resolution 4K HD projectors with best quality in the market can make the process, even easier and time-efficient. The incorporation of the *Image J* software method to analyse the flaws expels the error obtained due to dimensional differences, optical error and error due to human flaws. Large screen can show even minor flaws easily after the application of the filters. The scanning of the fabric material can also be tried using high-quality cameras specially designed for a quality inspection system, as shown in Fig.59.
