# **Development of an Advanced Ultrasonic Method for Inspection of Aircraft Main Landing Gear Tie-Bolts**

Master's Final Degree Project

Masters's Final Degree Project  
Aeronautical Engineering (6211EX024)

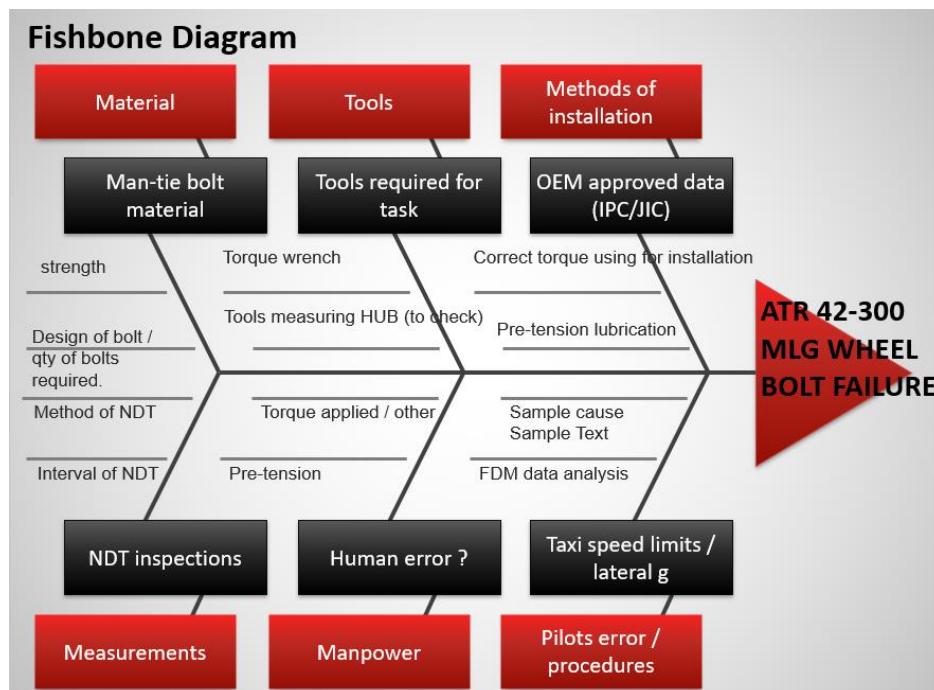
To investigate the root cause of the large number of broken tie bolts, a fishbone diagram developed by Kaoru Ishikawa was constructed. The diagram looks like fish skeleton, where the head is the problem and the causes for the problem is feeding into the spine. The fishbone diagram could be referred to as a thinking process to investigate the event's root cause. Fishbone diagram for ATR 42-300 main landing gear wheel tie-bolt failure is shown in figure 1.1.

Figure 1-1. Fishbone diagram

The factors identified in the diagram may not be significant; however, they allow them to be identified and sorted out systematically. In other words, it is better to identify all possible failure reasons and then eliminate least likely. As soon as the diagram is complete, all branches could be traced back to identify major causes and eliminate minor ones. [1]

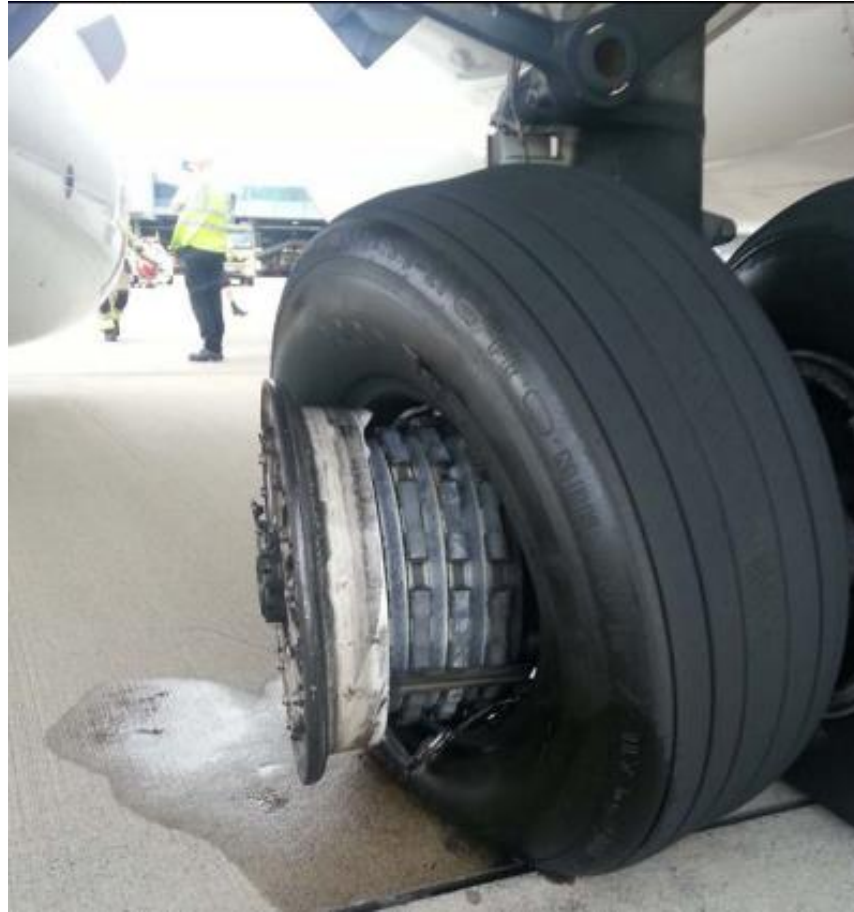
During 2017 during a Boeing 737 taxi, the crew heard a loud noise as what they thought was a tire burst on the left landing gear; however, after engineer evaluation, the left-hand outboard wheel had failed as shown in figure 1.2. During the Australian Transport Safety Bureau investigation, it was found that one main wheel ruptured due to tie bolt assemblies that had loosened while in service, which allowed two-wheel halves to move relative to each other, resulting in a fatigue crack and eventually wheel rupture.

**Figure 1-2.** Damage to the number one main wheel assembly on VUH [5]

Manufacturers performed further detailed analysis and concluded that the wheel failed because of founding fatigue cracks. A small crack was also noticed in the tie bolt hole; however, it did not appear to be the main root cause. The manufacturer visited the airline's repair shops to confirm that wheel repair procedures were appropriate. 2 out of 3 repair shops were found to be working entirely in compliance with manufacturer requirements. During the visit to one repair station, it was found silicon grease on the wheel halves' mating faces. However, this shop has not performed any repairs on the wheel mentioned in the report. [5]

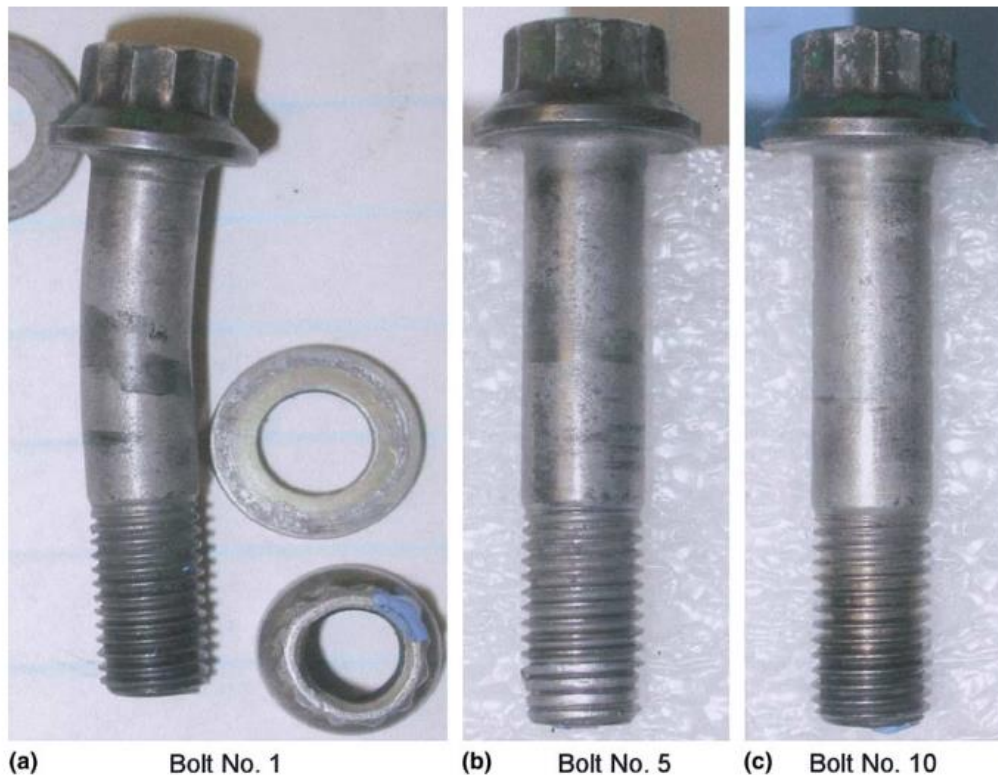
Twelve bolts of failed wheels were photographed after visual inspection with a light microscope as shown in figure 1.3. Four bolts were found bent, four bolts exhibited stripped threads near bolt ends, and four bolts had no damage as per visual inspection.

**Figure 1-3.** Photographs of bolts from each damage category: (a) bent; (b) stripped (note last four threads of Bolt #5), and (c) no apparent damage [6]

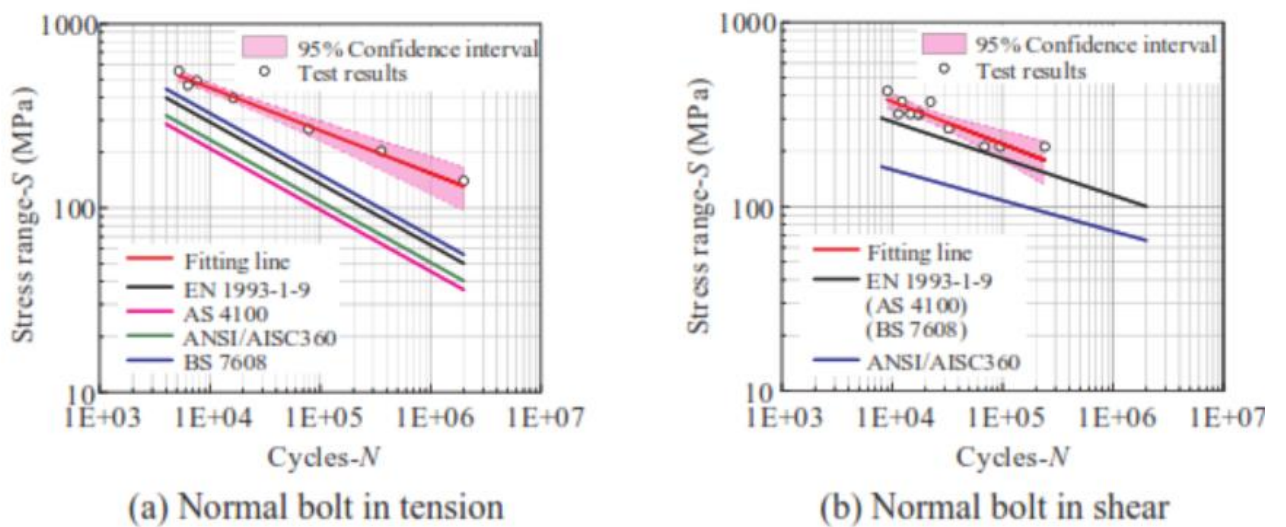
Static results for static tension of normal bolts, static shear of normal bolts, and fatigue tension of normal bolts, fatigue shear of normal bolts were received, the further relationship between stress ranges and failure cycles were collected and presented as shown in figure 1.7.

**Figure 1-7.** S-N curves of stainless steel bolts and comparison with design codes [8]

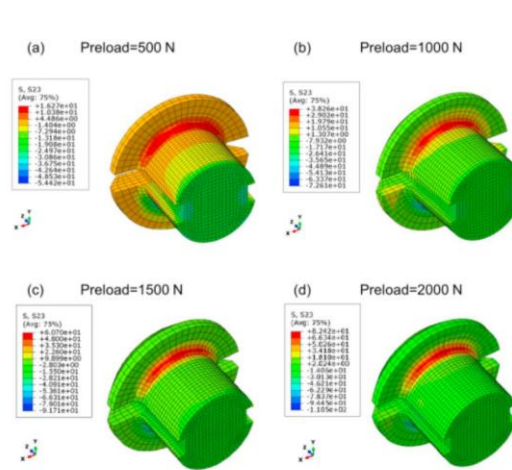
University of Naples Federico II has simulated shear behavior on the bolt under tensile and preload conditions as shown in figure 1.9.

**Figure 1-9.** Shear stress distribution in MPa on the bolt under applied tensile load  $F=1000$  N by varying the bolt preload [11]

It could be noticed that, shear stress on the bolt section to the plates decrease as the preload increase. Tensile load transferred to the bolt decreased linearly as preload increased. [11]

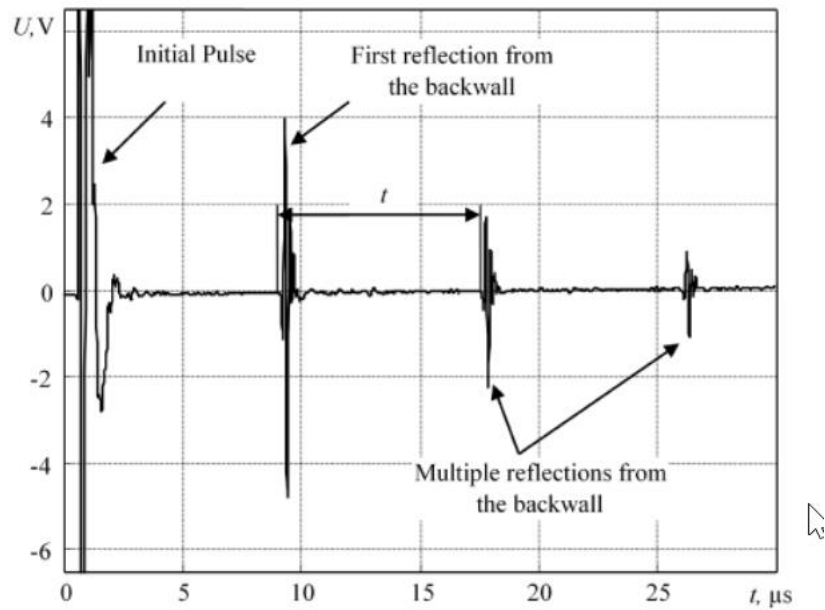
If the pulse-echo method are applied, display will indicate the initial pulse, and after some time, the pulse reflected from the back wall could be noticed, as shown in figure 1.15. [27]

**Figure 1-15.** Example of the signal in the time domain [27]

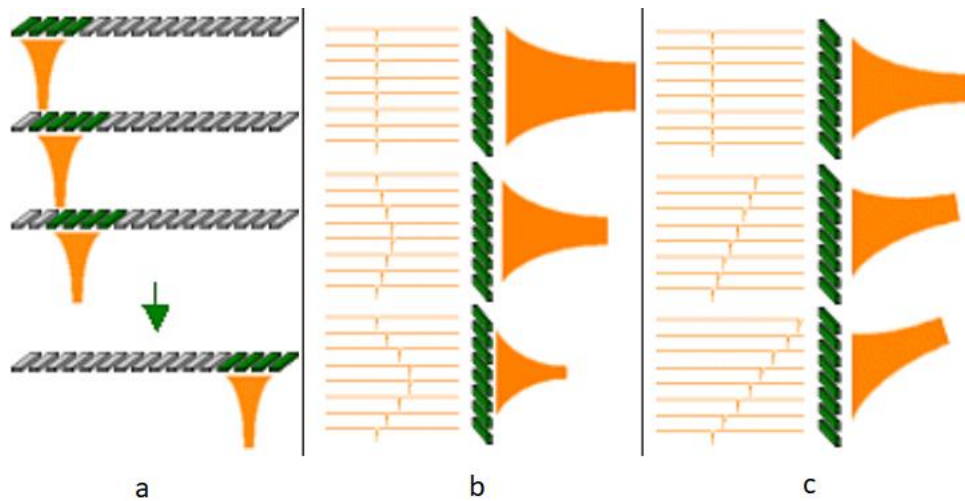
**Figure 1-18.** Indicated schematic of electronic scanning, focusing and deflection [30]

View of electronic scanning, focusing and deflection could be seen in figure 1.18. During electronic scanning group of elements are activated to move the beam with transducer. During electronic focusing delay laws could be applied to focus beam at desired area. Angle of the beam could be varied by delaying laws as well. [30]

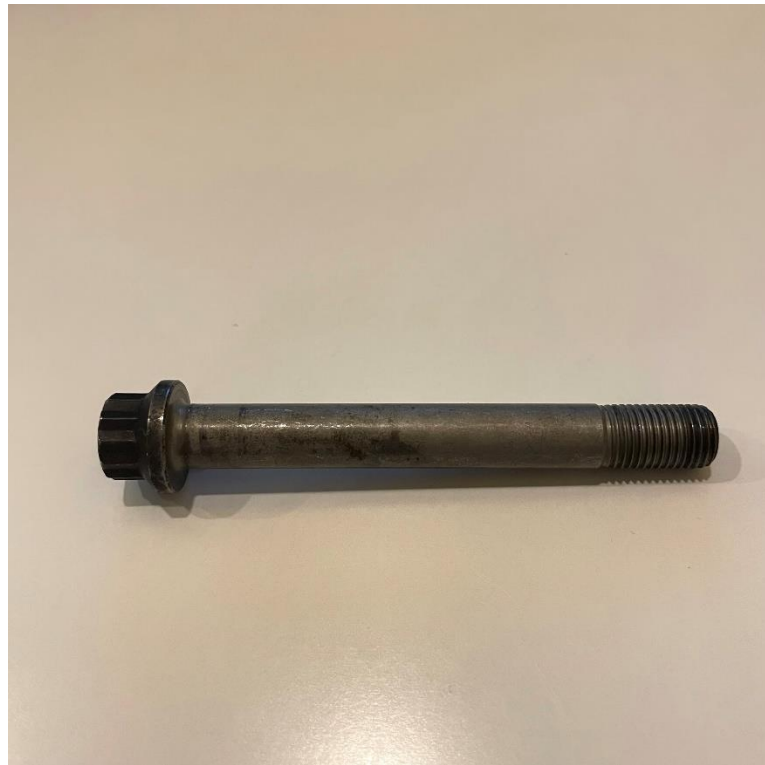
Broken tie bolt removed from DAT LT ATR aircraft, which was scrapped due to cracks found after NDT inspection could be seen in figure 2.1.

**Figure 2-1.** Main landing gear tie bolt

The technical specification indicates bolt material: Steel comp 8740 or steel comp 4140 or steel comp e4340 or steel comp 4340 or steel comp 6150.

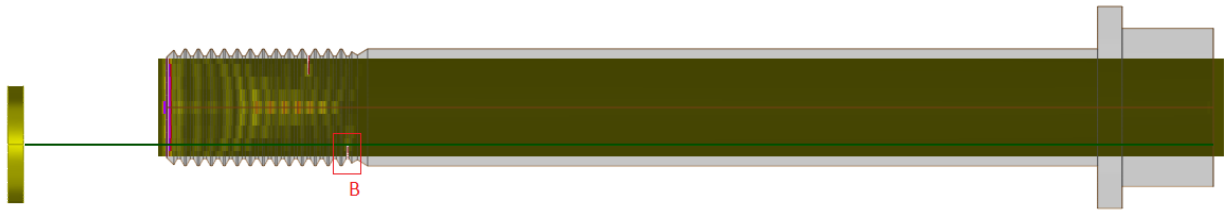
The second surface breaking flaw size that was tried to be detected was 3,8 x 1 mm and located at first incomplete thread root area as shown in Figure 2.8.

**Figure 2-8.** 3D scan view, defect at the incomplete thread root area and placed notch (B)

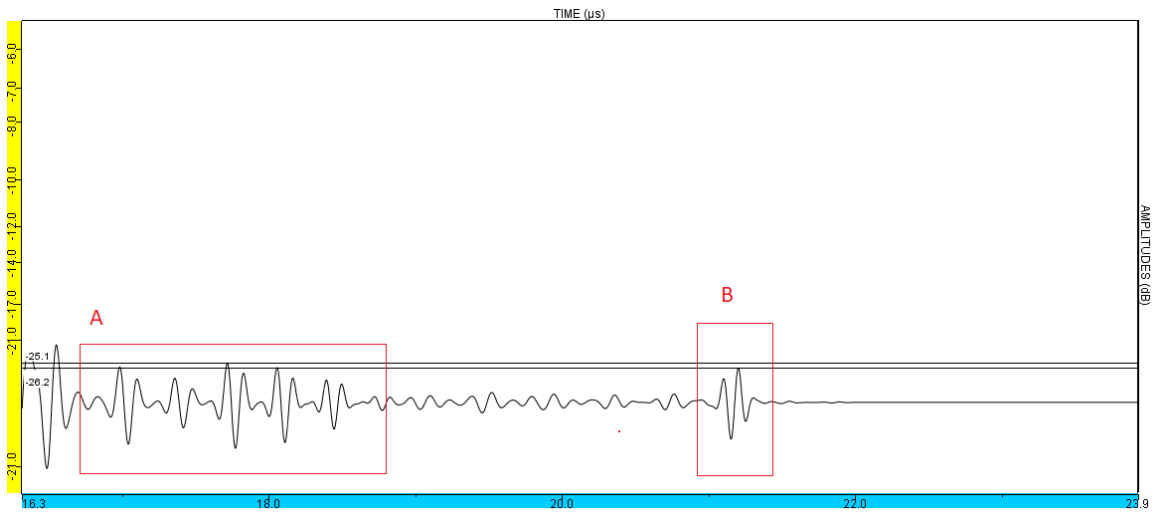
As per figure 2.10, it could be noticed that maximum amplitude from threaded area is -25.1 dB and maximum amplitude from defect reflection is -26.2 dB.

**Figure 2-10.** Maximum amplitude from the threaded area and defect reflection

In terms of amplitude the difference between threaded area and defect is very similar. Due to similarity, it would be difficult to detect the defect.

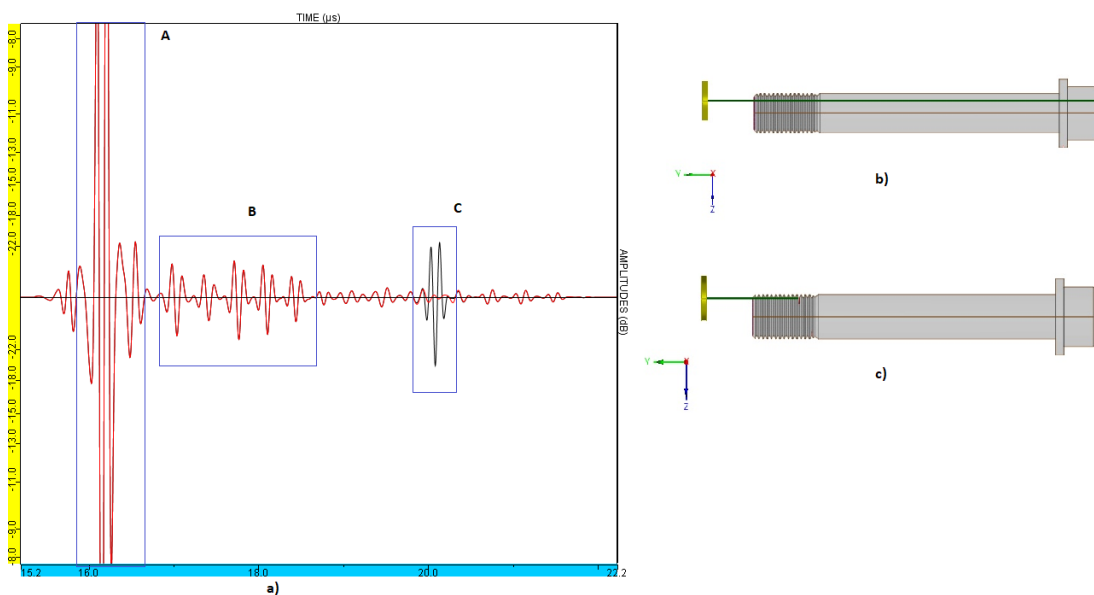
Figure 2.11 indicates combined graphs of A-Scan with defects in the third complete root thread area and A-Scan without defects at the mentioned area. It could be seen that both graphs are identical except point C, which describes the defect found.

A – Peak at entry to bolt; B – signal reflection from threaded area; C- Defect, D – Back wall echo.  
No other signals have been detected.

**Figure 2-11.** a) A-Scan of defect at threaded area comparison against scan without defect; b) bolt scanning without notch placed c) bolt scanning with notch placed in threaded area

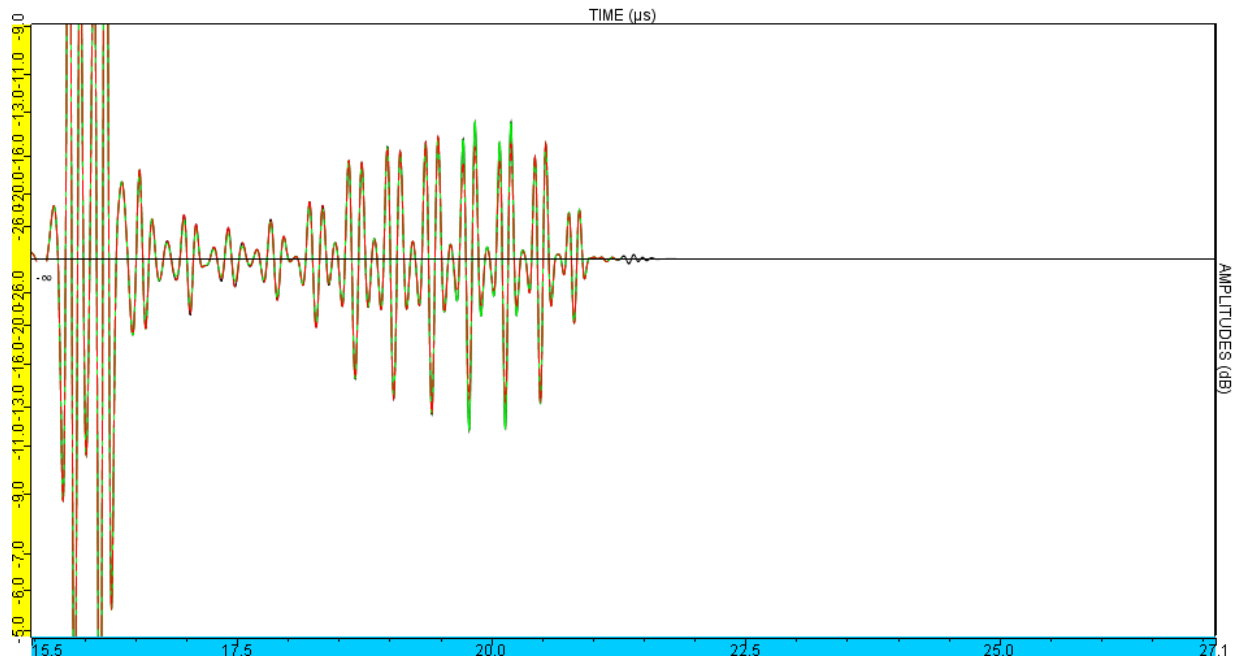
After parametric calculations, three A-Scans of most interested areas were extruded and combined in single A-Scan to see a difference in amplitude. Notch located at first incomplete thread root area were marked in black, notch in 7<sup>th</sup> thread is marked in green and notch in last thread is red. From below figure 2.15, it could be noticed, that if probe is located as shown in figure 2.14, it's difficult to identify the defects due to threads reflection. On 7<sup>th</sup> thread area, where focal point exists, slight difference in

amplitude could be seen, however without knowing this notch, it would be extremely difficult to interpret this area as cracked since threads reflection amplitude is same.

**Figure 2-15.** A-Scans of the threaded area. Black – first incomplete thread root area; green – 7th threaded area; red – last thread

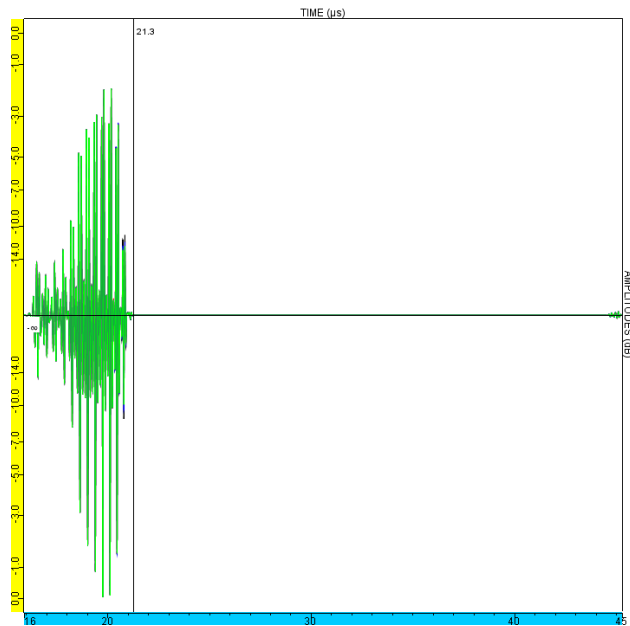
Below figure 2.18 indicates mentioned notches variation of A-Scans combined. It could be noticed that if probe is positioned at specimen center area, any difference could be seen in notch amplitude due to high amplitudes in threads reflection.

**Figure 2-18.** Combined A-Scans with flaw size of a notch at the fourth complete thread root area, when probe positioned at specimen center area.

After comparing results of A-Scans when probe is located at different positions and flaw height varies, statement could be made that if probe is located at specimen center position, it is difficult to identify notches due to high amplitude of threads reflection. If probe is positioned in parallel to threaded area, it could be possible to identify notches in A-Scan, however without knowing exact position of notches, all defects below 0.5 mm height would be difficult to identify due to high amplitude of threaded area reflection.

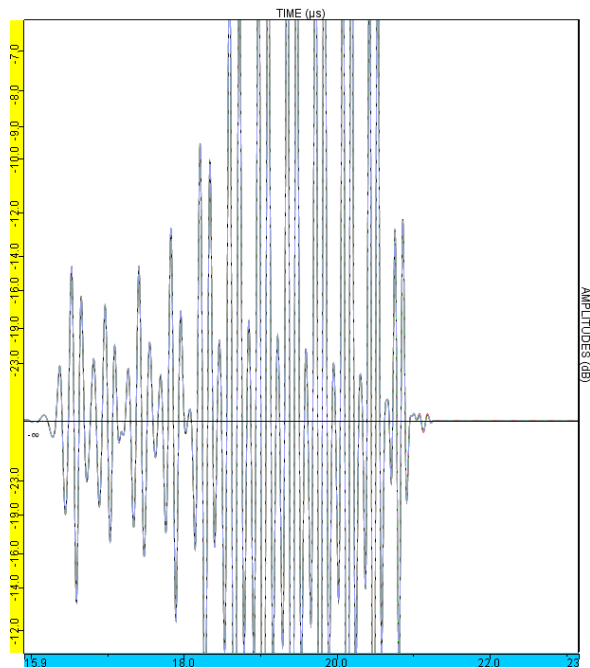
Parametric studies when notch angle varies between  $0^{\circ}$  and  $90^{\circ}$  and probe are positioned at center specimen area was performed and could be seen in figure 2.21. It could be noticed that independently from angle, no difference in A-Scans could be noted. Only threads reflection is visible.

**Figure 2-21.** A-Scans of defect angle variation from  $0^{\circ}$  to  $90^{\circ}$ , when probe positioned on specimen center area

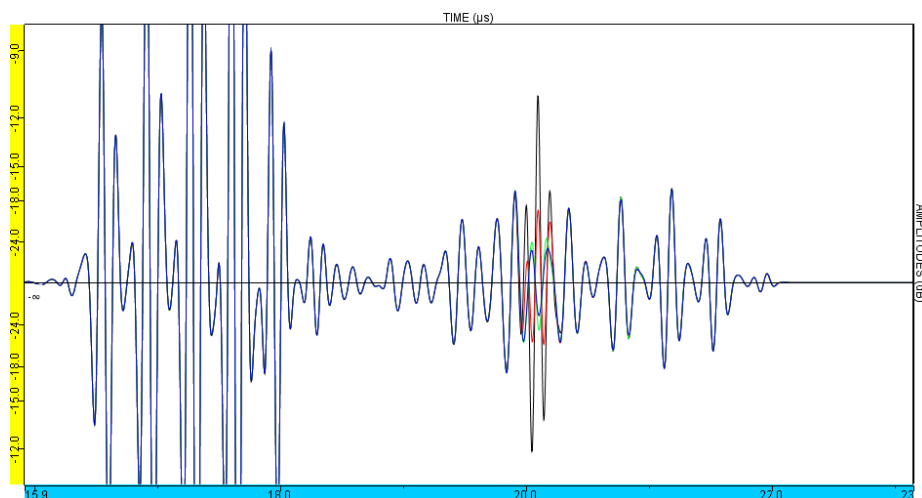
Further studies A-Scans, when probe is located in parallel with threaded area could be seen in figure 2.22. A-Scan represent 4 different angle variations:

It was noticed that notch located at  $0^{\circ}$  could be identified from A-Scan without knowing the defect position. For inspector, it would be difficult to interpret defects located at  $30^{\circ}$ ,  $60^{\circ}$  and  $90^{\circ}$  without knowing exact location, since reflection from threads amplitude is higher or same then notch amplitude. Every angle which is further from probe has lower amplitude, the reason of this is focal point area, which is parallel to beam.

**Figure 2-22.** A-Scans of defect angle variation from  $0^{\circ}$  to  $90^{\circ}$ , when probe position area parallel to the threaded area. Black amplitude –  $0^{\circ}$ . Red amplitude –  $30^{\circ}$ . Green amplitude –  $60^{\circ}$ . Blue amplitude –  $90^{\circ}$ .

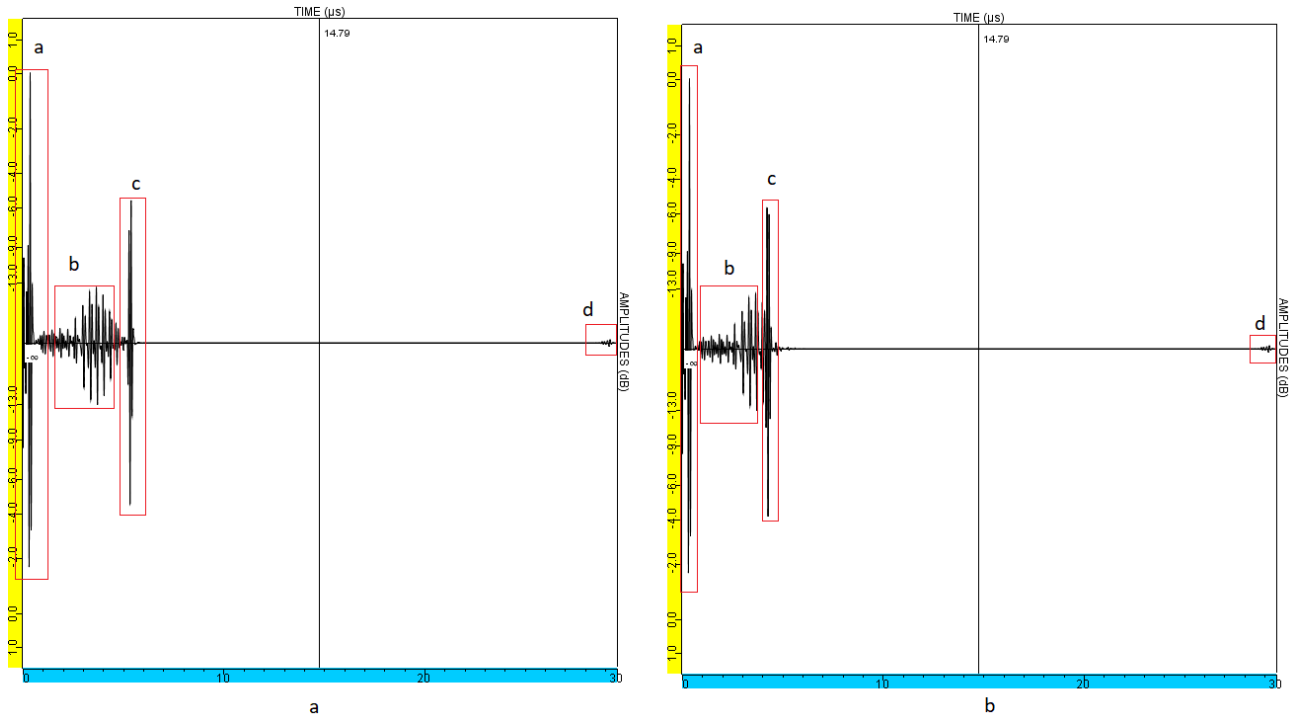
After calculations, both breaking flaws A-Scans were obtained, and defects found as shown in figure 3.5. Below points could summarize A-Scans.

- A – Peak at the entry to bolt;
- B – signal reflection from the threaded area;
- C – Defect reflection.
- D – back wall echo.

**Figure 3-5.** a) A-Scan of defect at forth complete thread root area. B) A-Scan of defect at first incomplete thread root area
