Wear of cemented tungsten carbide (WC) router cutters during oak wood milling

D. Kazlauskas*, V. Jankauskas**, R. Bendikienė***, G. Keturakis****, L. Mačėnaitė*****

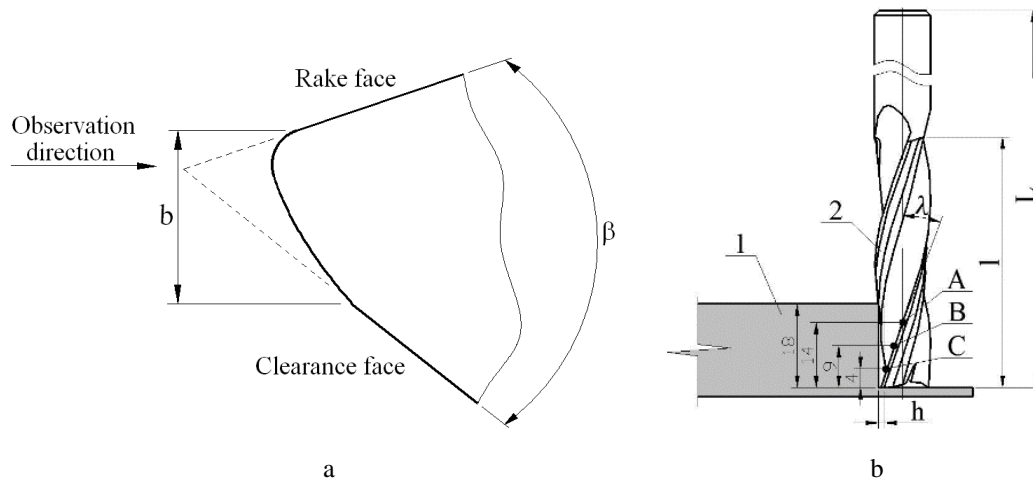
Fig. 1 Measurement schemes of the helical cutting edge width b : a - cross-section of the cutting edge; b - scheme of measurement points of the cutting edge width b ; l - sample; 2 - router cutter; A, B and C - measurement points; h - depth of milling; λ - inclination angle

The wear of the cutters was detected by measuring the helical cutting edge width b (Fig. 1, a) [21]. The values of the cutting edge width b were registered optically, using the optical microscope (Nicon Eclipse E 200) with digital video camera (Lumenera Infinity 1). The cutting edge width b was measured in the set intervals of cutting length L (Table 4). The measurements in each interval of cutting length L were done in three places (A, B and C) (Fig. 1, b). The cutting edge width b was measured in the set intervals of cutting length L (Table 3). The measurements in each interval of cutting length L were done in three places (A, B and C)

(Fig. 1, b). The received images were analysed and measured using the personal computer and software (Infinity Analyze Release 5.0.2).

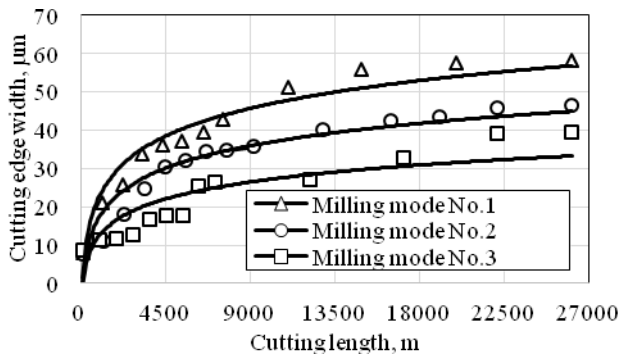
Fig. 2 Influence of the cutting length L on the cutting edge width b

that in case of the milling mode No. 1 (Fig. 2) the most intensive initial wear is in the cutting length L up to 3270 m - the width of the cutting edge b is rapidly increasing. The wear of cutting edge in the cutting path from 3270 m to 7590 m is less intensive because of transition from initial to monotonic stage. The wear is already monotonic in the cutting length L from 7590 m to 26100 m - the wear of the cutting edge is slow and constant.

In case of the milling mode No. 2, the intensive initial wear is observed in the cutting length L up to 4500 m . There the cutter gets worn the most intensively. The wear becomes slower in the section from 4500 m to 5600 m - the

initial wear is getting converted to the monotonic one. The intensity of the cutting edge wear gets even lower in the cutting length L up to 26100 m where monotonic wear takes place.

In case of the milling mode No. 3, the wear of the cutter was the most intensive in the cutting length L up to 3660 m. The wear became slower in the section from 3660 m to 6300 m. It became even slower and got stabilized in the section of the cutting length L from 6300 m to 26100 m. The second factor that affects the wear of tools is the cutting speed; its influence on wear of cutters was determined with the help of analysis of the results received in the course of milling modes No. 1, 2 and 3.

The wear of the cutters was more intensive in case of milling mode No. 1 ($v = 11.3$ m/s). In the case of the milling mode No. 2 ($v = 13.2$ m/s) the wear of cutters slows down. When the cutting edge width b reached in the case of the milling mode No. 1 was compared to the width of the milling mode No. 2, the 20.2% difference of was determined. In the case of the milling mode No. 3 (cutting speed 15.1 m/s), even lower wear of cutters was determined – the cutting edge width b was by 32.4% lower when compared to the milling mode No. 1.

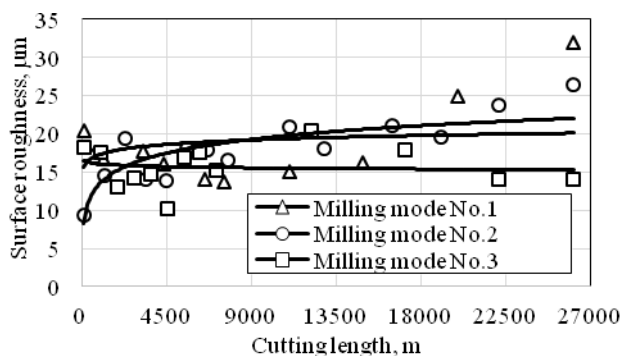
Fig. 3 Surface roughness R_z along the fiber

The analysis of the roughness results of the processed surface (Fig. 3) revealed that the increase of cutting length L and width b of cutting edge cause decreasing of the

processed surface quality. This tendency was identified with regard to all the milling mods (No. 1, 2 and 3). The lowest surface roughness is received in the course of milling up to 130 m of the cutting length. The surface roughness is increasing gradually in the section of the cutting length from 130 m to 26100 m. The tool wear increases proportionally to the increase of the cutting length. When the blunt tool is used for wood milling, the wood is ripped and the processed surface is formed through deformation and compression of internal layers of the fibre.

While increasing cutting speed from 11.3 m/s to 15.1 m/s, the processed surface quality increases. The measurements in the cutting length up to 26100 m revealed that in case of the milling mode No. 2 ($v = 13.2$ m/s) the surface roughness was by 8.96% lower when compared to the milling mode test No. 1 with $v = 11.3$ m/s. When the milling mode No. 3 and 1 were applied, the difference of the parameter R_z was equal to 51.4%.
