# Alkali-Activated Slag Repair Mortar for Old Reinforced Concrete Structures Based on Ordinary Portland Cement

**Abstract:** In this study, alkali-activated mortars were prepared using two different types of fine aggregates: natural sand and biomass bottom ash. These mortars were used as a repair material for structures constructed using old reinforced concrete structures based on Ordinary Portland cement (OPC). Experimental studies have shown that the alkaliactivated slag mortar with biomass bottom ash (BBA) from the bubbling fluid bed meets the repair mortar class R1 according to EN 1504-3. The suitability of such repair mortar is determined by the good adhesion properties of the alkali-activated slag binder to old OPC concrete. The adhesion after 28 days was 0.31 MPa and the samples broke off at the repair matrix. The AAC/BBA repair mortar had a compressive strength of 18.69 MPa, the shrinkage due to drying deformations consisted of 0.1903% after 28 days. Alkaliactivated slag mortars are effective in repairing, renewing and rebuilding damaged OPC concrete structures.

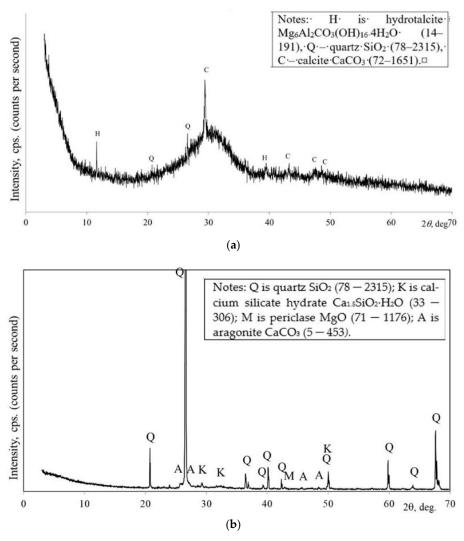
Figure 1. Mineral composition of slag (a) and biomass bottom ash (b) according to XRD analysis.

According to mineral composition, hydrotalcite, quartz and calcite are detected as crystalline compounds in the slag (Figure 1a). In the case of amorphous SiO<sub>2</sub>, a hill appears in the XRD diagram at 20–35 2q degrees of 2q. Slag is a suitable precursor for the production of alkali-activated binders due to its high content of silicon and aluminum compounds in active form [12]. Quartz, calcium silicate hydrate, periclase MgO and aragonite are the main minerals of biomass bottom ash (Figure 1b). A similar mineral composition of this ash was determined by Luna-Galiano et al. [13].

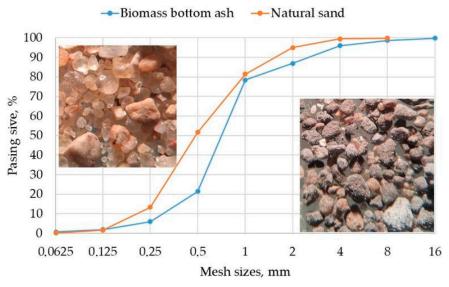
**Figure 2.** Granulometric distribution of fine aggregates: sand and biomass bottom ash, for repairing mortars.

The natural sand of a 0/4 fraction and with a bulk density of 1560 kg/m³ was used as a fine aggregate. The granulometric distribution of particles is shown in Figure 2. Similar particle granulometric distribution was seen in biomass bottom ash. The slightly higher bulk density of biomass bottom ash was 1624 kg/m³. This ash is produced from biomass. In a bubbling fluidized bed boiler, silica sand is added at high temperatures to maintain thermal inertia. The burning fuel mixes with this sand to produce a waste-type ash sand [14]. Optical microscopy images (Figure 2) show that after the combustion process a darker color change in the sand can be observed and a small amount of fine particles appear on the sand grains.

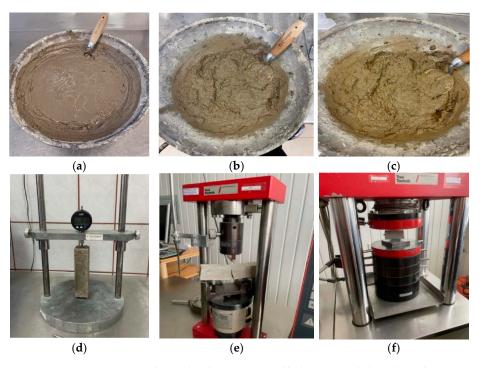
Figure 3. Repair mortar with Portland cement (a), alkali-activated slag (b) and repair mortar with alkali-activated slag (c). Investigation methods of mortars: shrinkage deformations (d), flexural strength (e) and compressive strength (f).

The reference repair mortar (OPC/sand) was prepared as follows: first, the OPC was mixed with the natural sand aggregate and then filled with water (Figure 3).

The second (AAS/Sand) and third (AAS/BBA) mortars' slag was mixed with sand or bottom ash and filled with a sodium hydroxide solution to produce alkali-activated mortars (Figure 3). An RUBIMIX-9N portable mortar mixer with a speed of 780 rpm was used for the mixing. After careful mixing, the mortars were cast in molds of the size of  $4\times4\times16$  cm and on the old OPC reinforced concrete beam (Figure 3). These samples were used for the determination of mechanical properties and to evaluate shrinkage drying deformations during the hardening process. An old concrete beam was added with repair mortar and after that the beam with repair mortar was covered with polyethylenic material to prevent water evaporation and stored at an ambient temperature for 28 days. This curing duration was chosen in accordance with EN 1015-11 [16].

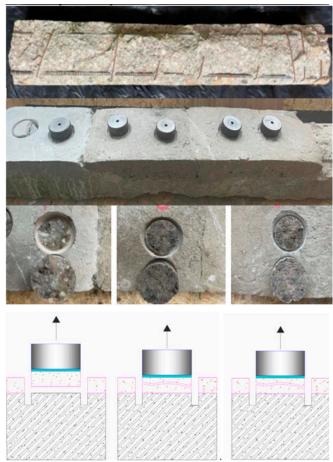
**Figure 6.** The old OPC concrete beam and visual identification of the type of failure according to a pull-off test (EN 1542) [21].

For the adhesion test, a reinforced concrete beam with a damaged concrete layer was used (Figure 6). The beam was exploited in outdoor conditions and exposed to the natural effects of various chemical and physical processes. Before the repair, organic matter was removed from the surface of the concrete beam. No adhesion-enhancing soil was used to

repair the beam. The adhesion between the concrete surface to be repaired and the repair mortars was tested after 28 days. The control sample broke off at a force of 0.59 MPa at the area of the surface to be repaired as shown in Figure 6. This test indicates an insufficient adhesion of the material to the surface to be repaired. The samples of the AAC/BBA and the AAC/sand mortars broke off at 0.31 and 0.29 MPa, respectively. The rupture occurred in a layer of the repair matrix shown in Figure 5. This indicates excellent adhesion of the material to the surface to be repaired, but poor mechanical resistance.

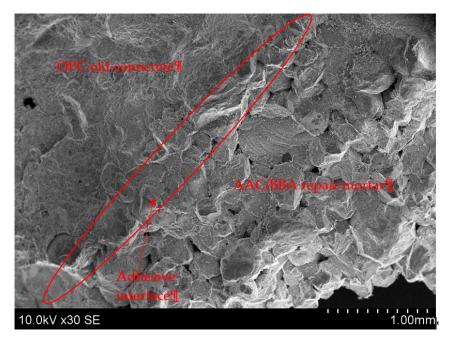
Figure 7. SEM images of adhesive interface with the old OPC concrete and AAC/BBA repair mortar.

According to the experimental results, the AAC mortar has good adhesion to the surface of the old OPC concrete and the contact area is hardly visible (Figure 7). The reason for this good adhesion could be the reaction of the AAC with the old OPC concrete: the Ca(OH)<sub>2</sub> from the OPC concrete reacted with the silicon and aluminum from the slag to form CASH and/or CNASH, which improved the bond strength. It is likely that alkaliactivated binders adhere well to the OPC surface due to the presence of calcium hydroxide Ca(OH)<sub>2</sub> on the OPC concrete surface, which reacts with the alkali binders. By forming the structure of the geopolymer, Ca<sup>2+</sup> cations balance the negative charge of Al<sup>3+</sup> cations in the geopolymer structure. Si<sup>4+</sup> cations dissolve from the surface of the aggregates in an alkaline environment and participate in the geopolymerization reaction as well. This leads to chemical adhesion between the two surfaces [7].
